Dune Maintenance and Management Plan – Gouritz

DUNE MAINTENANCE AND MANAGEMENT PLAN - GOURITZ

July 2020

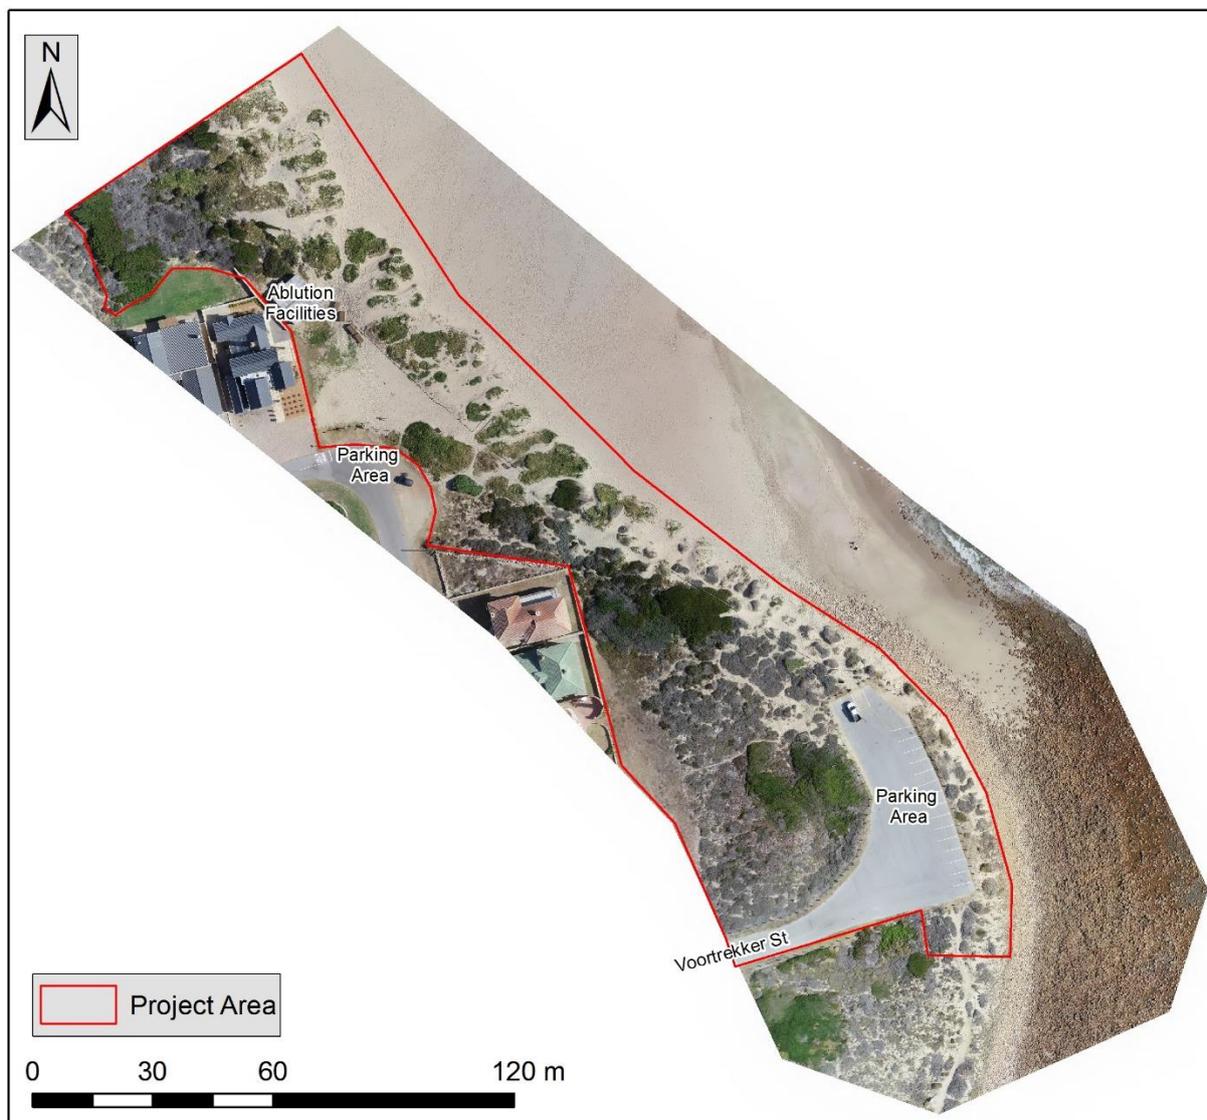
Figure 1.2: High resolution aerial imagery of the project area.

The parking area at the bottom of Voortrekker Street has been located too close to the High Water Mark (HWM). There is a very narrow strip (6m) of vegetation in front of the parking area which is above the HWM. Although the southern half of the parking area is more stable due to the rocky shore and boulders (Plate 1.1), the vegetated edge is subject to erosion from wave attack and storm surges (Plate 1.2). This situation will worsen over time as a result of climate change and sea-level rise.

To the north-west of the formal parking area there is a second smaller parking area and ablution facilities. Access is gained from either River Street or Kus Road. The 200m long dune system between these two parking areas has low vegetation cover, blowout dunes and active sand movement. Loss of vegetation cover is mainly due to recreational impacts and effects of trampling on the vegetation. Improved access control is required.

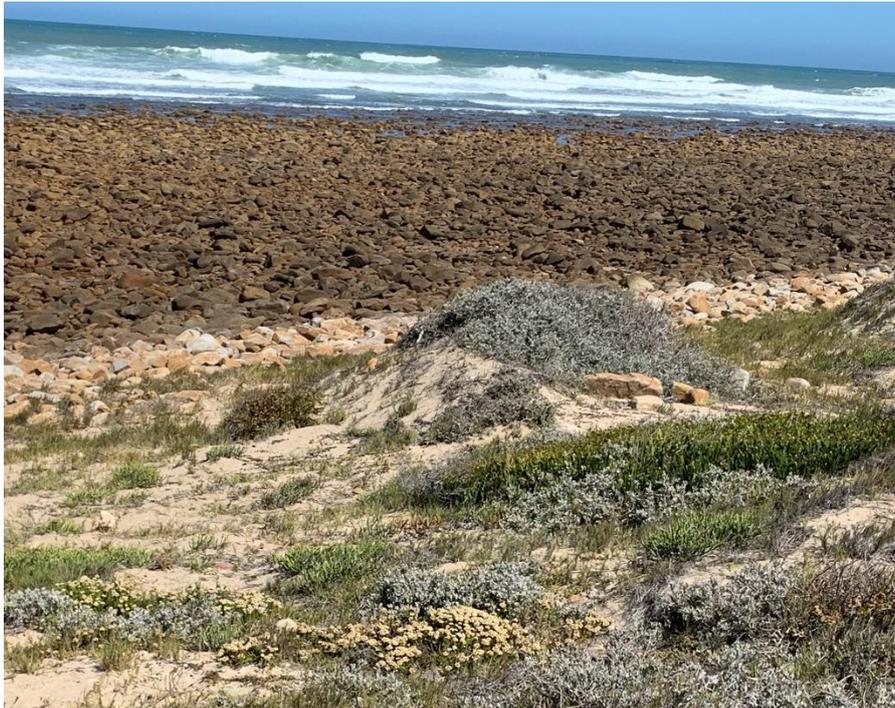
Plate 1.1: Narrow vegetated dune slope and boulder beach in front of the parking area. Edge of boulders define the HWM.

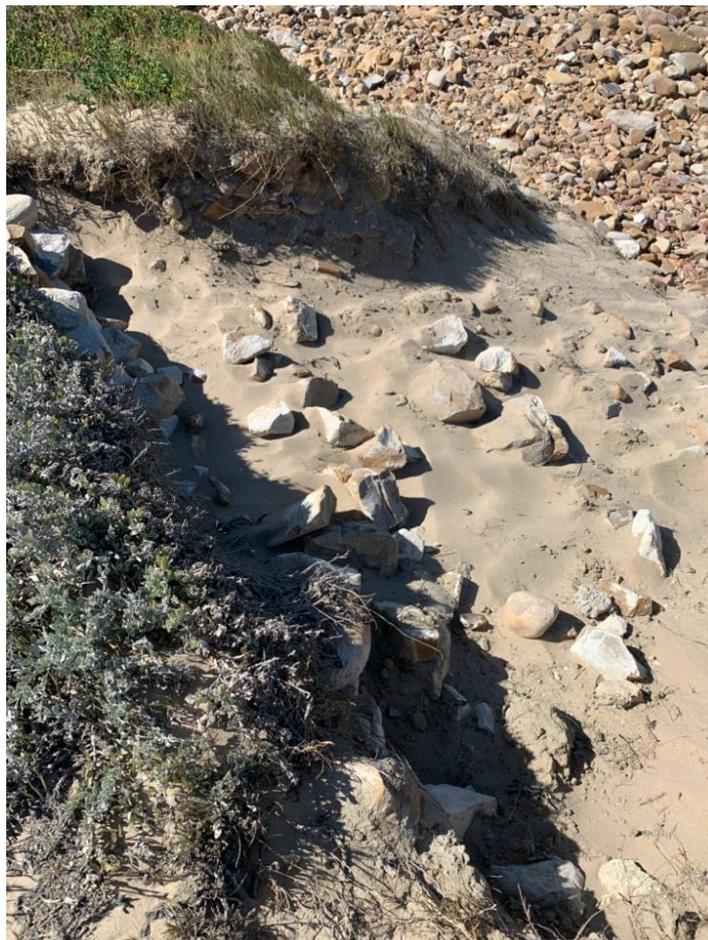
Plate 1.2: The narrow vegetated slope is subject to erosion from wave attack, and disturbance due to trampling.

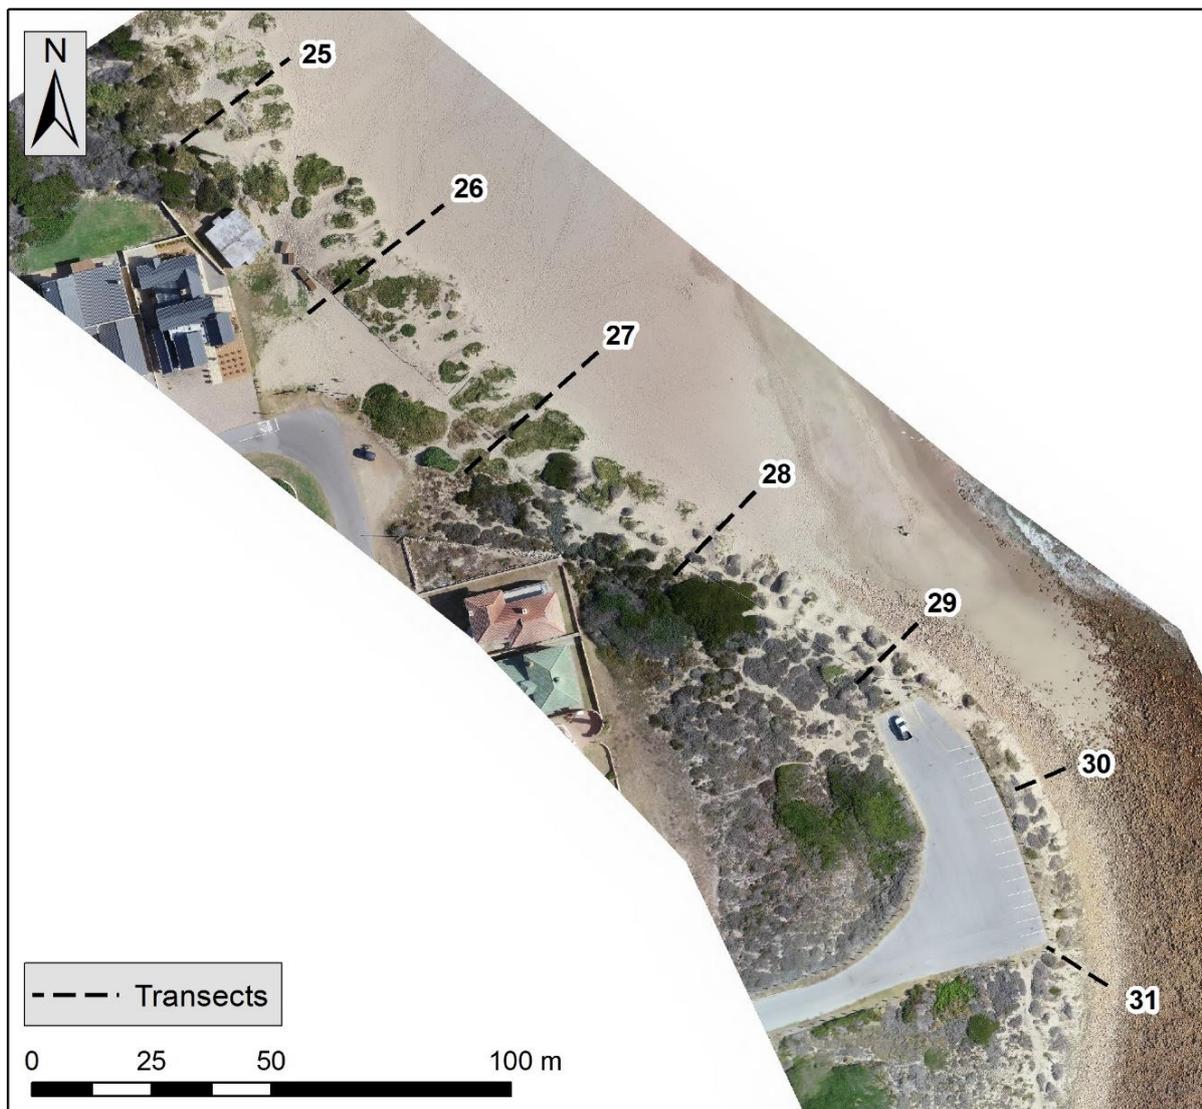
The vegetation at Gouritz was sampled along equal interval transects that were defined using ArcGIS prior to the site visit, to ensure objectivity (Figure 2.1). Transects ran perpendicular to shoreline, and the following sampling took place:

- 7 transects, numbered 25 to 31 were sampled along the 200m site.
- At each transect the species composition and vegetation cover (estimated visually) of each species was determined.
- A drone and topographical survey was undertaken to capture high resolution aerial imagery and to calculate a Digital Elevation Model (DEM) for the project area.
- Using the drone aerial survey, results were extrapolated to prepare an accurate vegetation map of the site.
- Accurate GPS readings were taken at the start and end points of the transects.

Figure 2.1: Transects used for vegetation assessment.

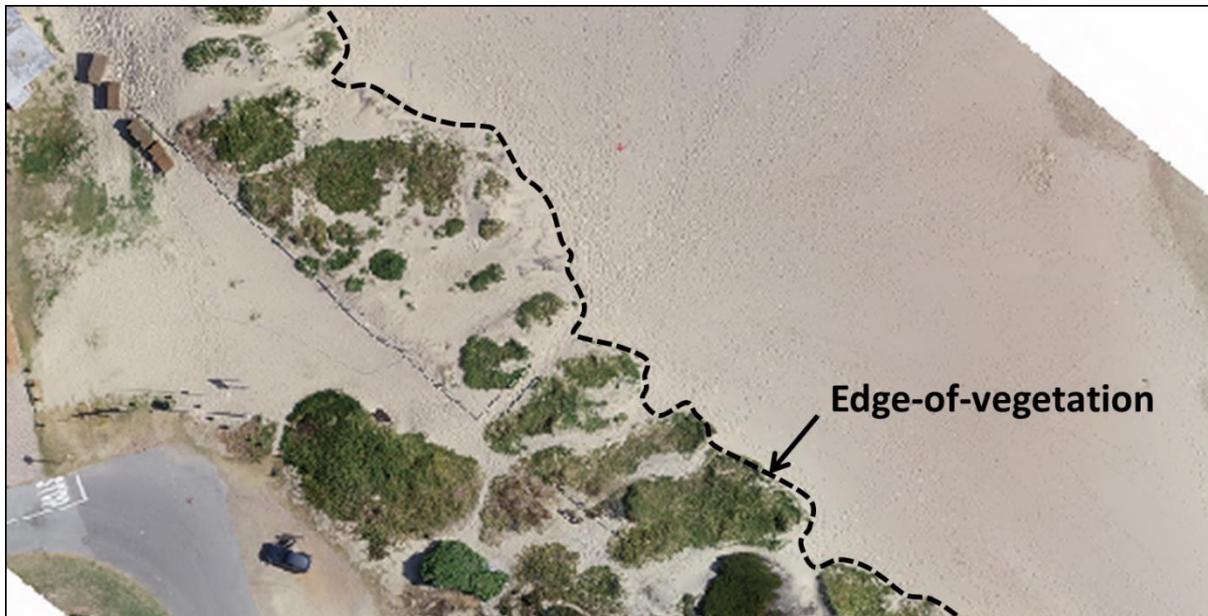
In addition to obtaining an accurate vegetation map, the edge of the vegetation line was also determined over time. Barwell & Associates (2015) have shown that the “edge-of-vegetation” line is relatively easy to observe on aerial images and remote sensing images as the boundary between the dark area (vegetation) and light area (beach) is distinct. It is a useful means of tracking beach stability over time (Figure 2.2).

Figure 2.2: Defining the "Edge-of-vegetation" line

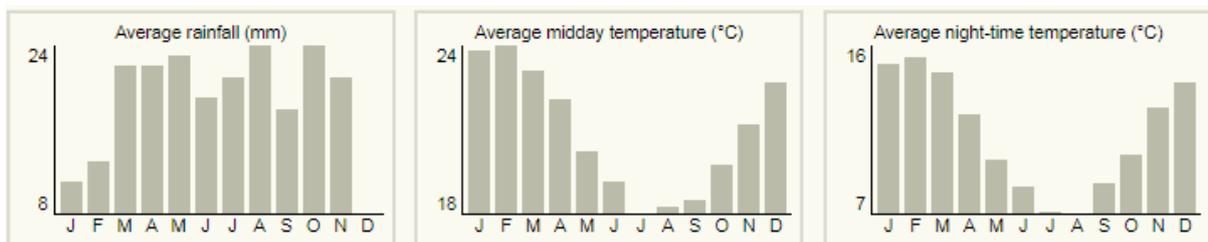
Gouritz is classified as having a cold semi-arid climate. Average daily temperatures range from 24°C in February to 17.8°C in July. The coldest night time temperatures are recorded during the month of August when temperatures drop to a low of 7.1°C. Gouritz normally receives about 226mm of rain per annum, with rainfall patterns more akin to subtropical climates, with dry summers, relatively wet winters, and even wetter springs and autumns. (SA Explorer, 2017) (Figure 3.1).

Figure 3.1: Graphs (from left to right) showing the average monthly rainfall; average monthly midday temperature; and average monthly night-time temperatures for Gouritz (SA Explorer, 2017).

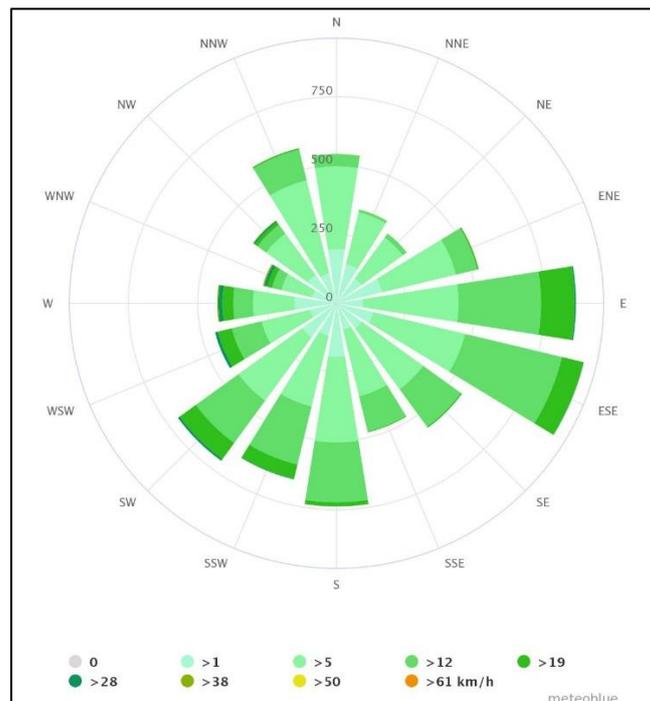
Along South Africa’s southern coast, westerly to south-westerly winds occur throughout the year. The main seasonal difference occurs during the spring and summer months, when there is a high frequency of easterly winds. Along the south coast there is also a slight sea breeze throughout the year with a moderate to strong north-west land breeze component. The windiest time of the year is from midwinter to spring (Tinley, 1985).

Figure 3.2: Windrose for Gouritz (Meteoblue, 2020)

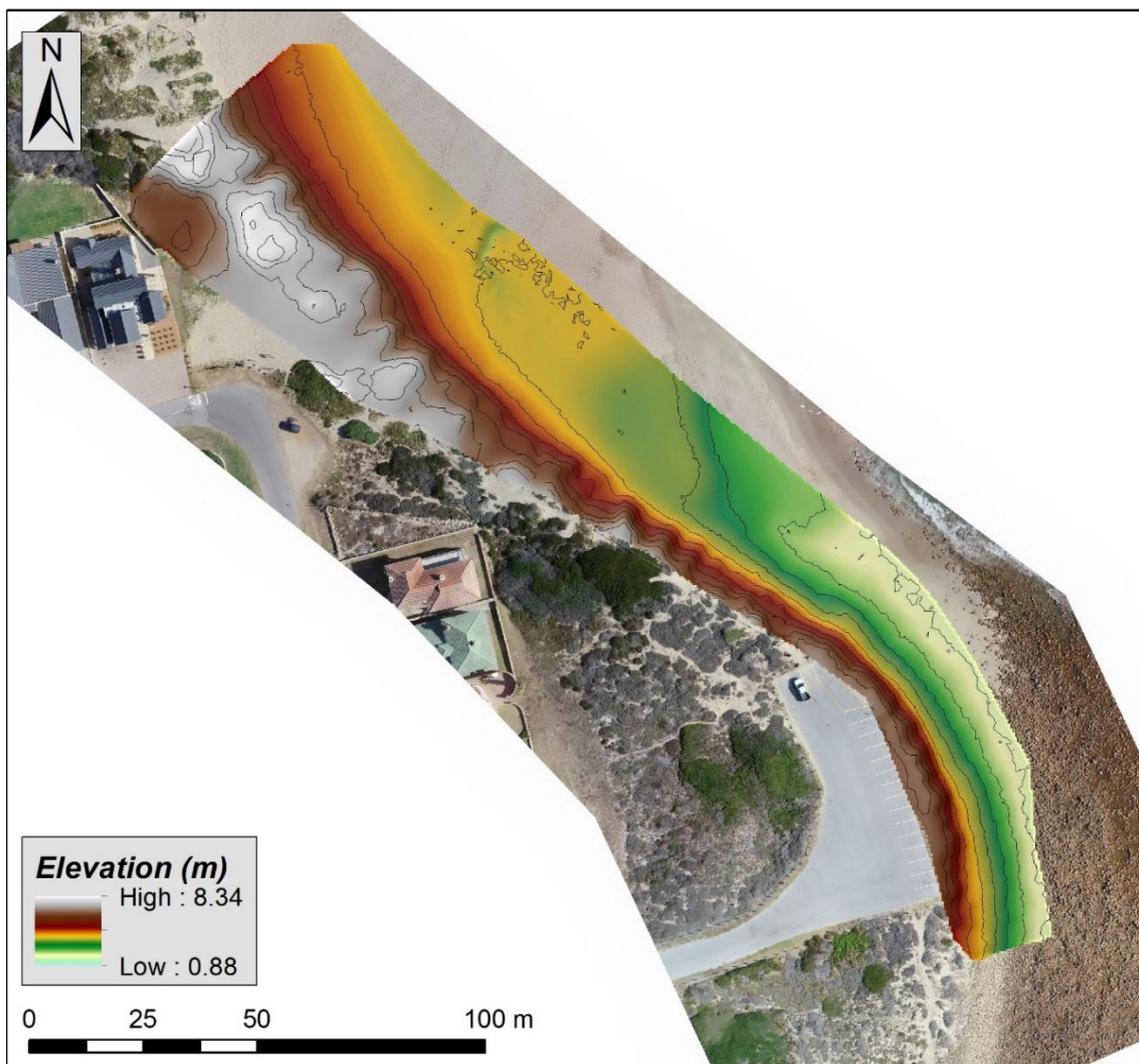
The parking lot in the south of the project area is located close to the HWM. There is a very narrow strip (6m) of vegetation to the west of the parking lot. In this area, the elevation rises quickly to approximately 5.5m above MSL. The area to the east of the parking lot has relatively uniform topography with a steep slope, which exceeds 30°, immediately adjacent to the parking lot.

Figure 4.1: Digital Elevation Model for the project area.

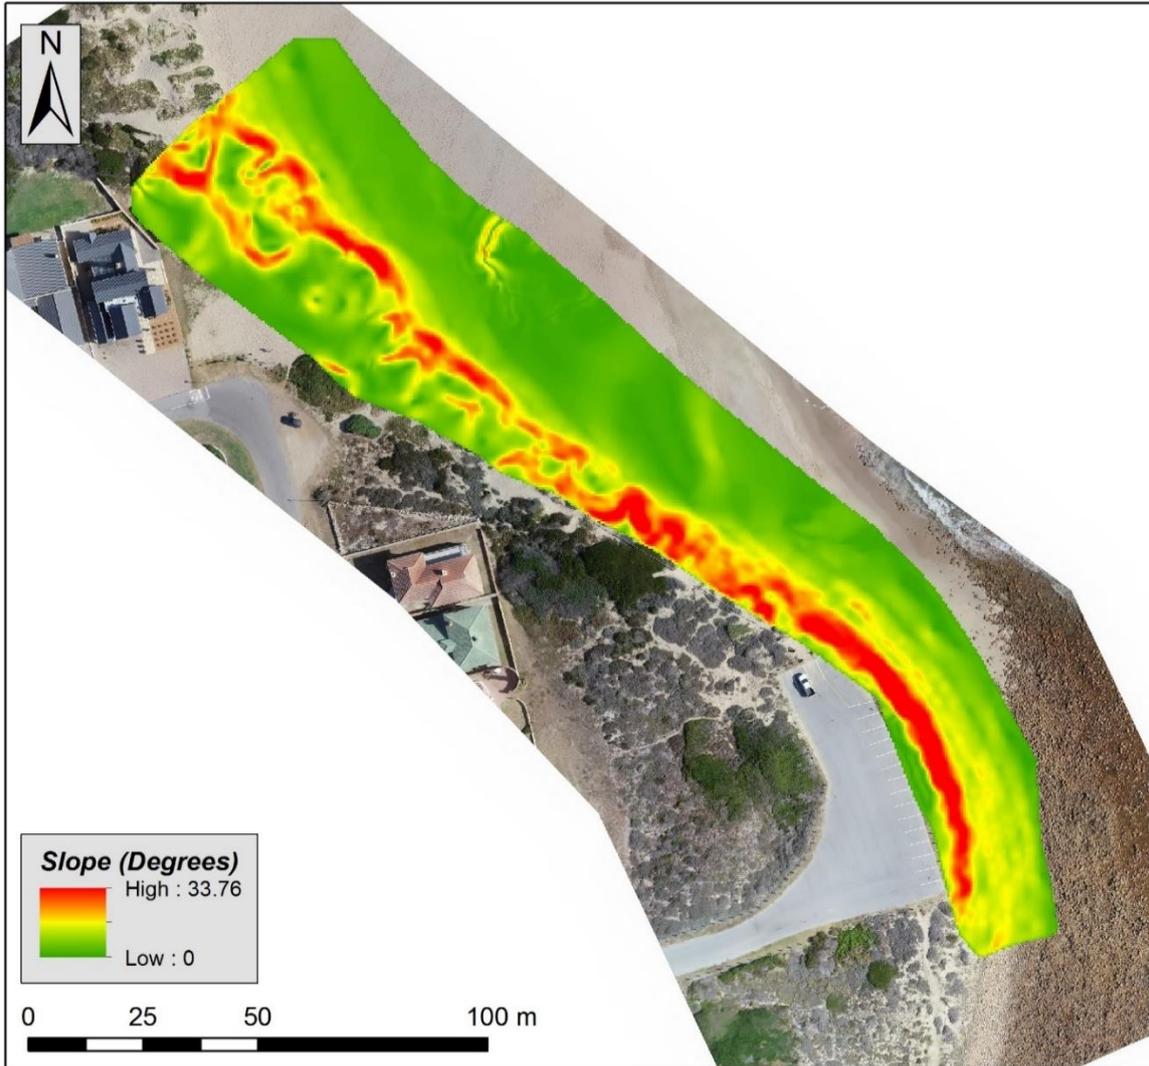
To the north-west of the parking lot, the dune system has been disturbed which has resulted in low vegetation cover, blowout dunes and active sand movement. As can be seen in Figures 4.1 and 4.2, the linear foredune system has been compromised as a result of wind erosion in areas where vegetation cover has been lost. This results in the development of hummock dunes that allow wind to blow between the hummocks, resulting in further erosion. The elevation in parts of this area exceeds 6.5m above MSL, however, between these high elevation areas, there are lower elevation blowout areas. This results in variable slopes along the foredune system, as seen in Figure 4.2.

Figure 4.2: Slope of the dunes within the project area.

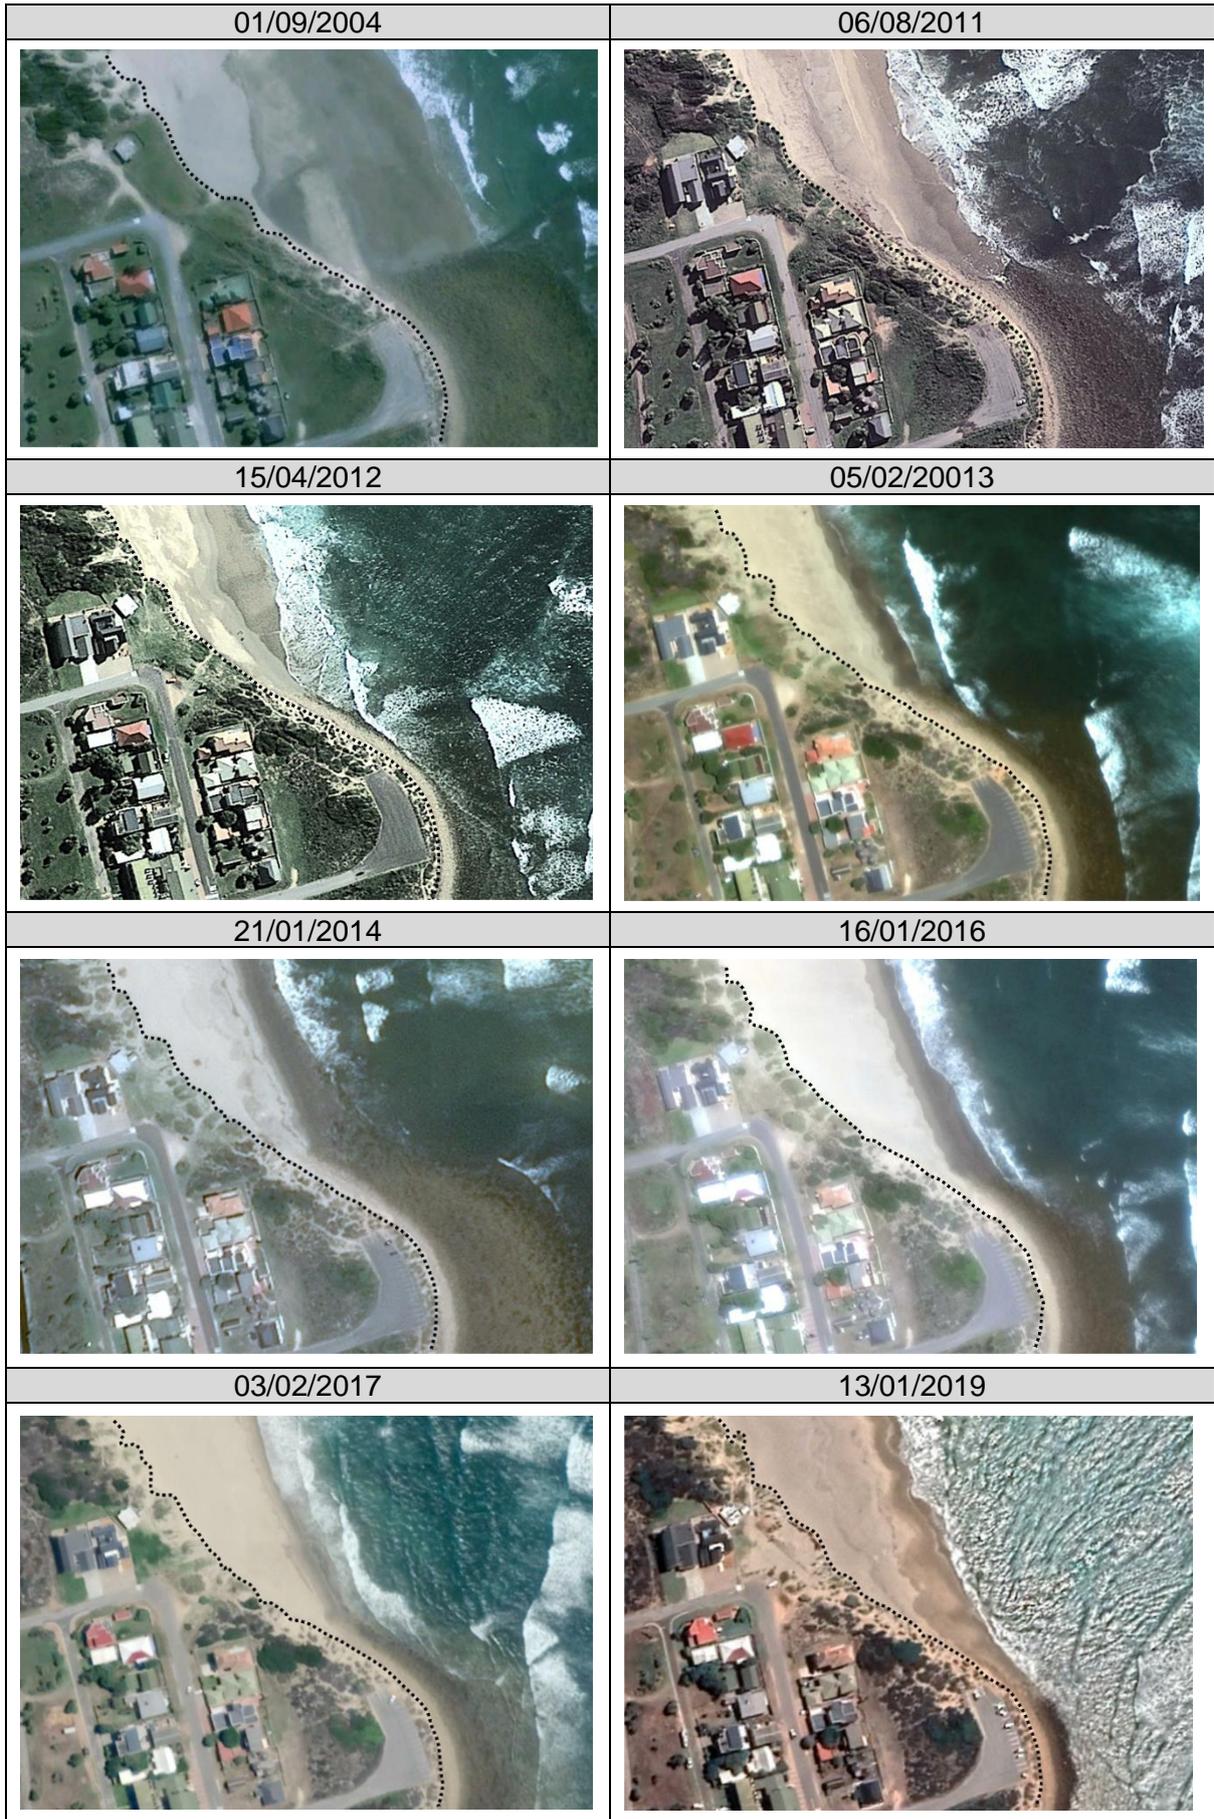
Based on analysis of aerial imagery over the last 16 years, the edge of vegetation line has remained relatively stable. However, it is evident that there has been a reduction in vegetation cover at existing beach access points. This includes the area just north of the formal parking lot and the dunes to the east of the smaller parking lot and ablution facilities (Figure 4.3).

Figure 4.3: Historical Edge-of-Vegetation.

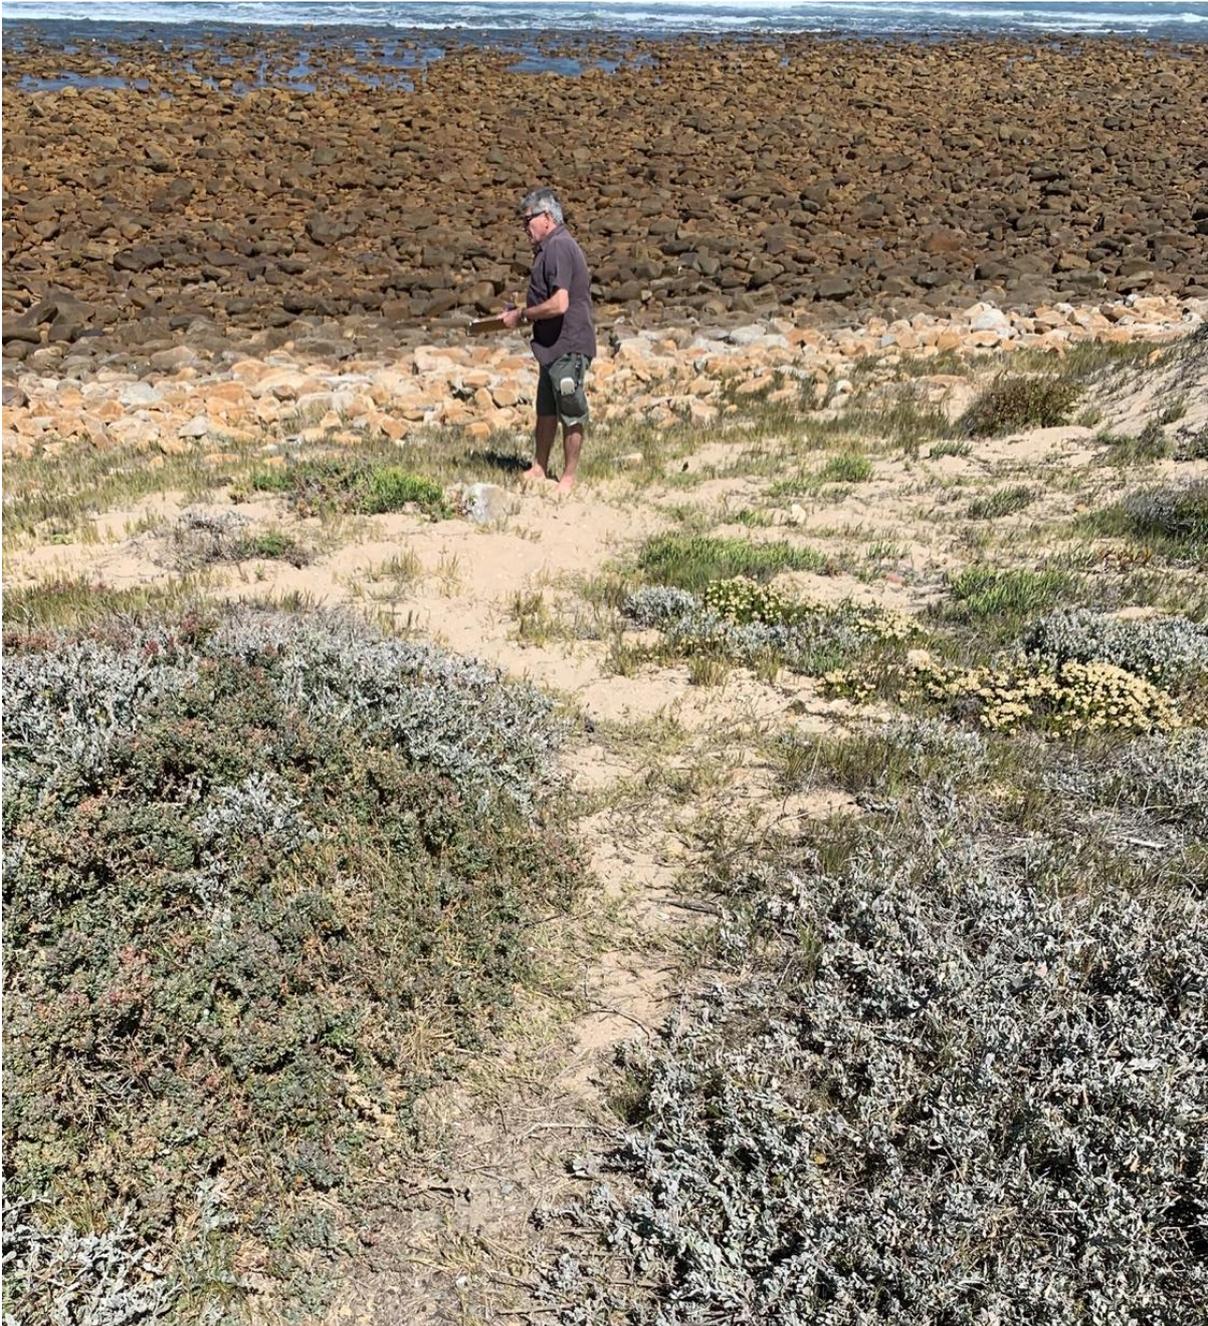
The vegetation in front of the parking area (Transects 30 and 31) differs slightly from the rest of the vegetation. Dominant species are *Tetragonia decumbens* and *Atriplex semibaccata*, with *Sporobolus virginicus* occurring on lower slopes close to the rocky area. A number of other species, some associated with salt marsh vegetation (such as *Chenolia diffusa*) as well as *Pelargonium* sp, *Helichrysum* sp. and *Artctotis* sp are found in lower numbers (Plate 5.1).

Plate 5.1: Typical vegetation in front of the parking area. In the foreground is *Atriplex semibaccata*, and the low growing grass species at the edge of the boulders is *Sporobolus virginicus*.

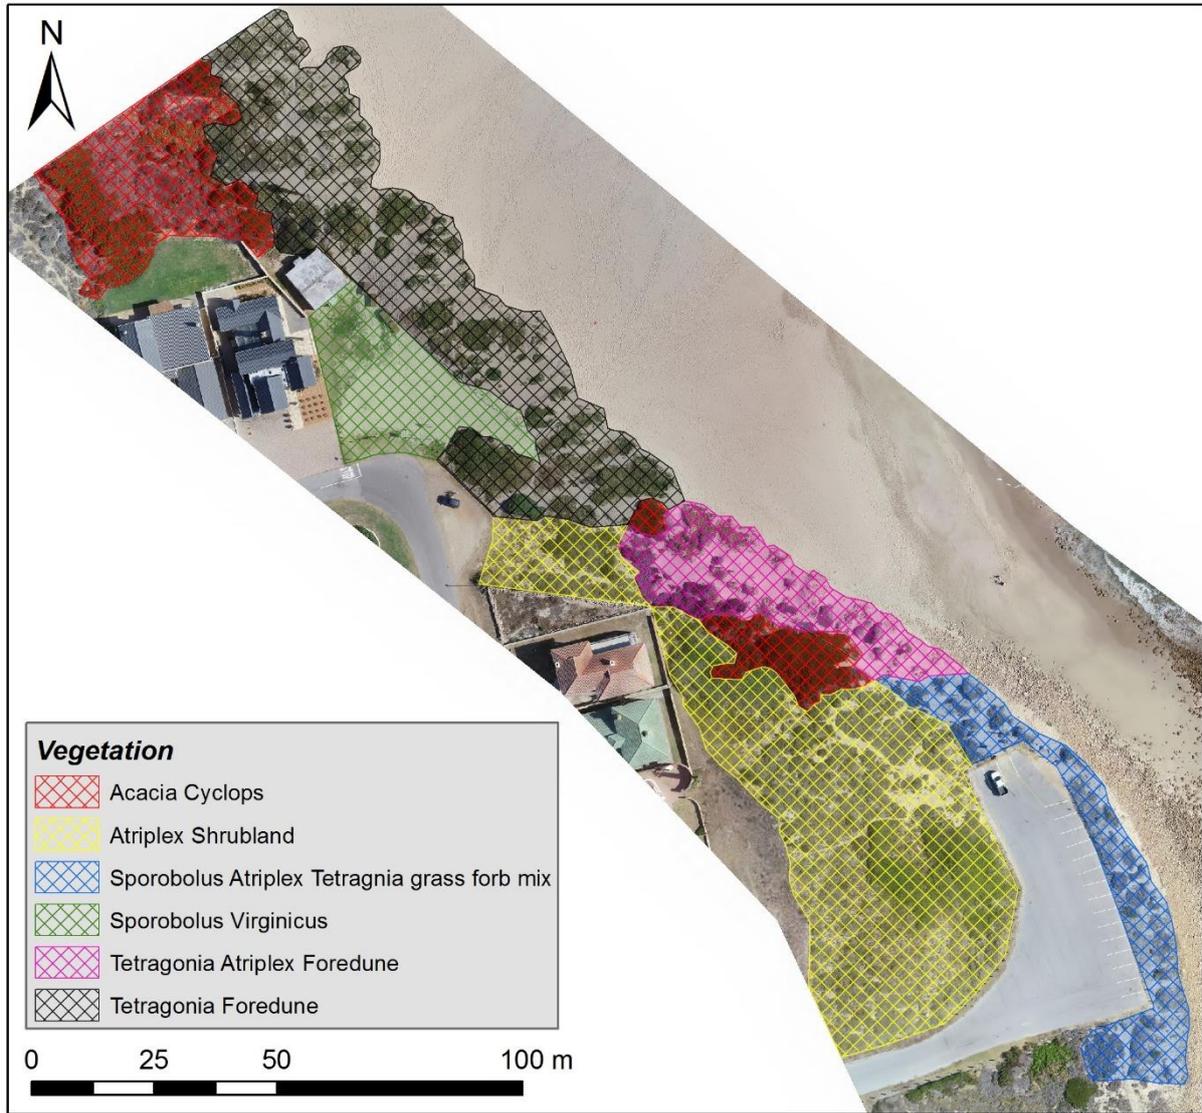
- vi. **Acacia cyclops.** There are three stands of the invasive Rooikrans at transects 25 and 28, as well as one smaller stand between transects 27 and 28. However, further to the north-east the dune behind the main beach is completely dominated by this invasive species (Figure 5.1; Plate 5.6).

Figure 5.1: Vegetation recorded on site

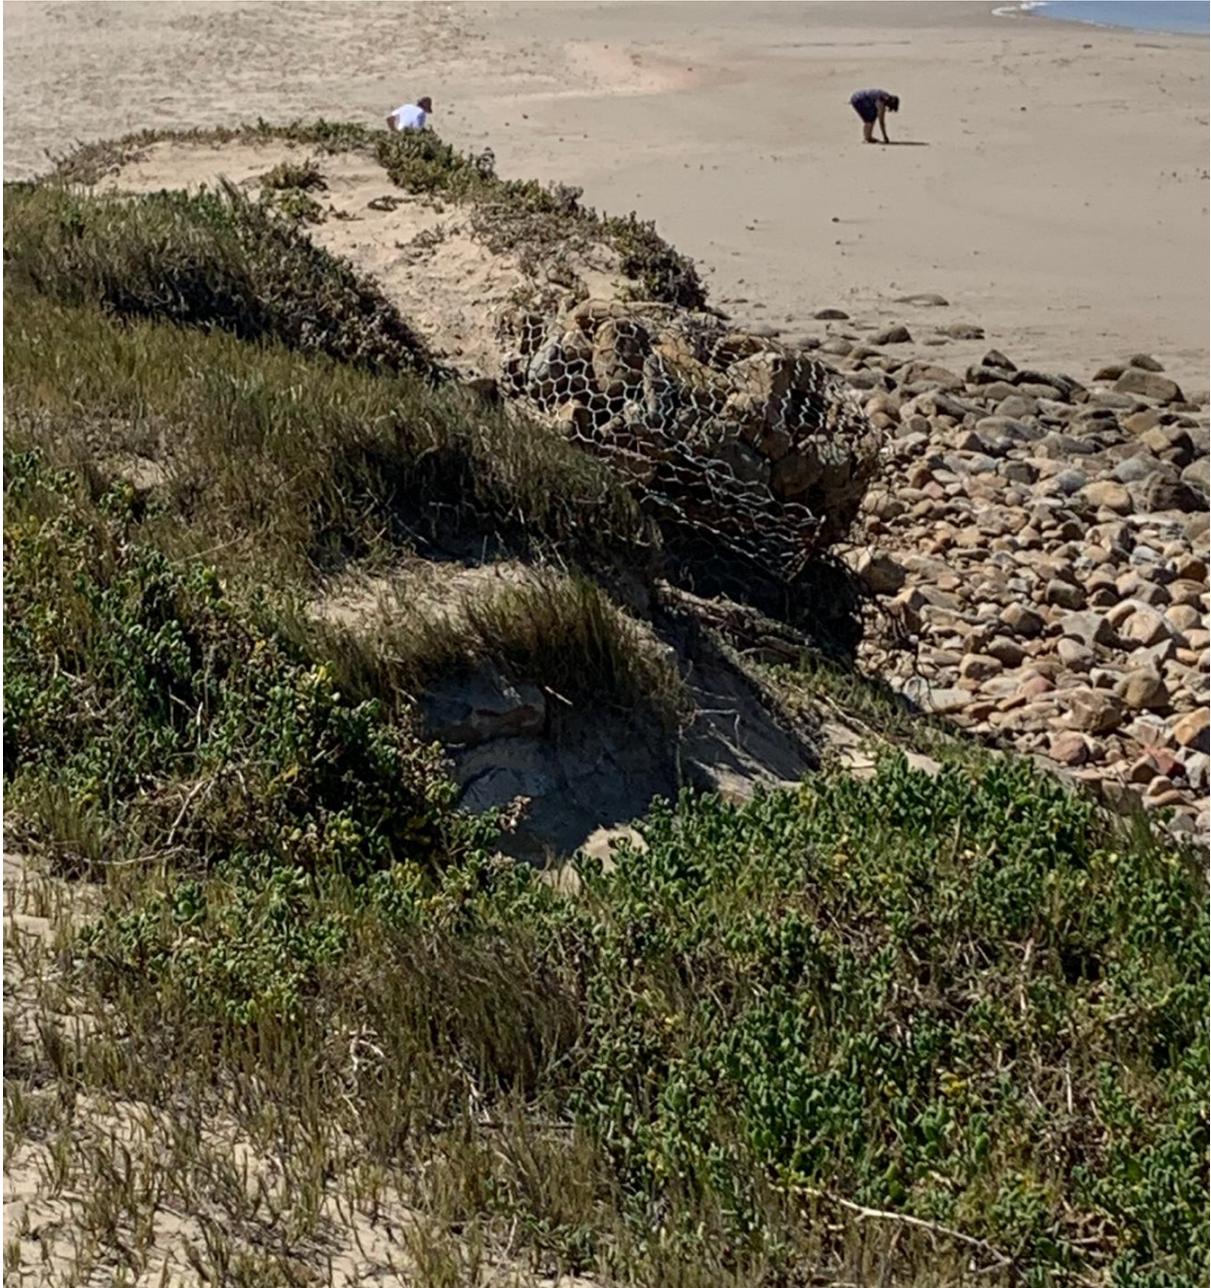
Plate 5.2: A *Sporobolus*, *Atriplex Tetragonia* grass forb mix dominates the eroded foredune ridge next to the parking area. Dominant species here *Tetragonia decumbens* (Foreground) and *Sporobolus virginicus* (background). Note erosion and Gabions placed to prevent further erosion but now dislodged from the slope.

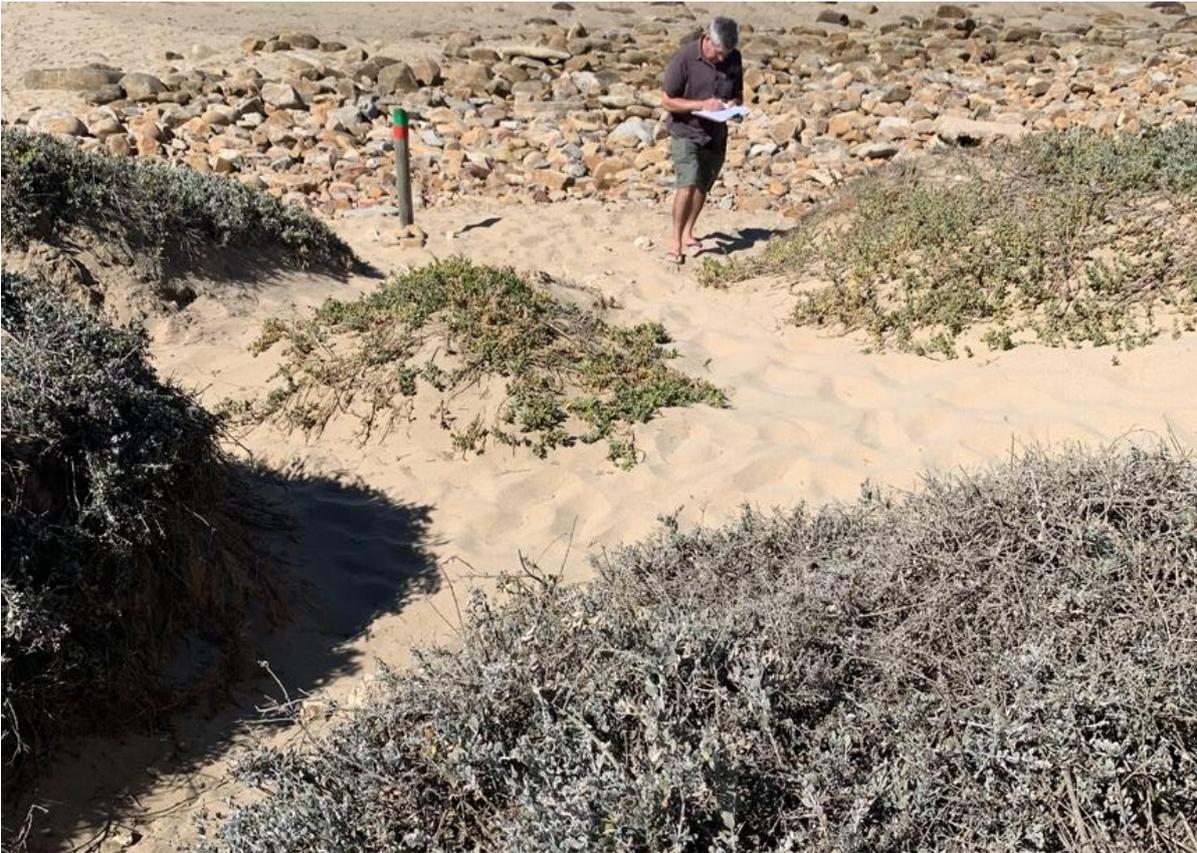
Plate 5.3: *Atriplex Tetragonia* dominated foredune habitat.

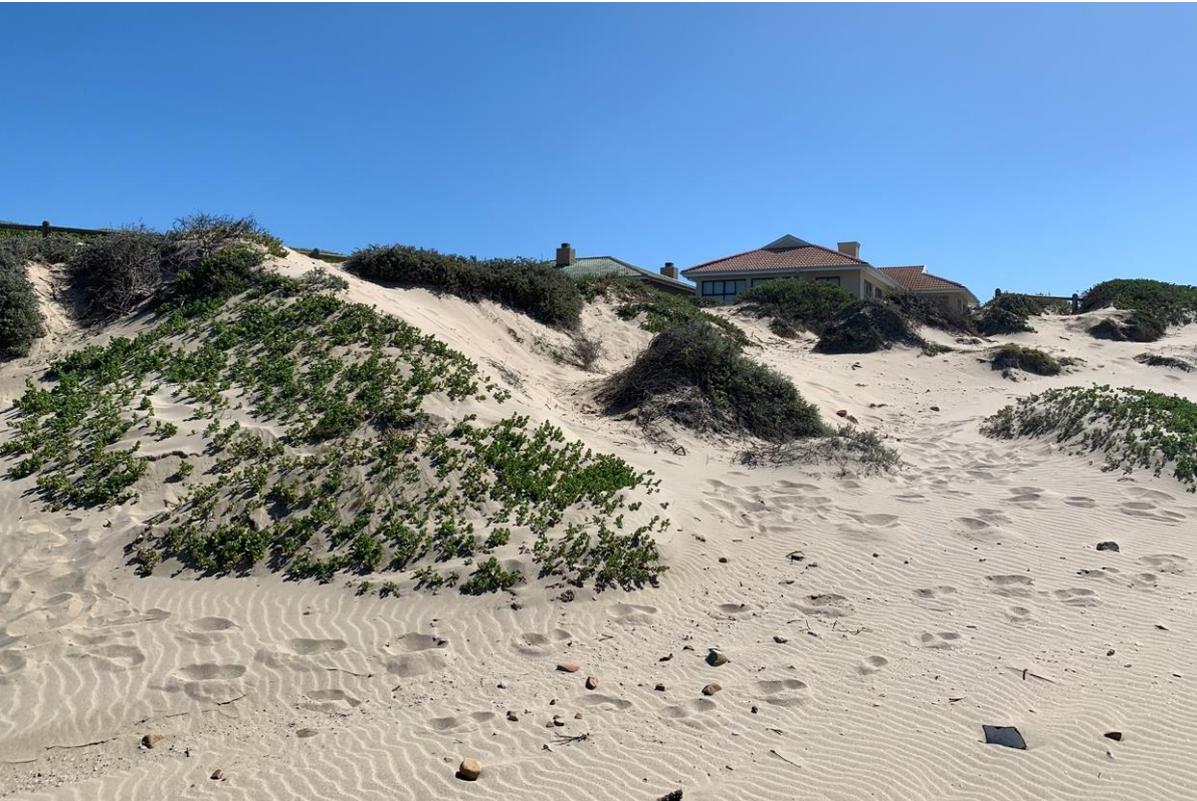
Plate 5.4: *Tetragonia* foredune. Note small blowouts and hummock dunes. The shrub in the middle foreground is *Chrysanthemoides monolifera*

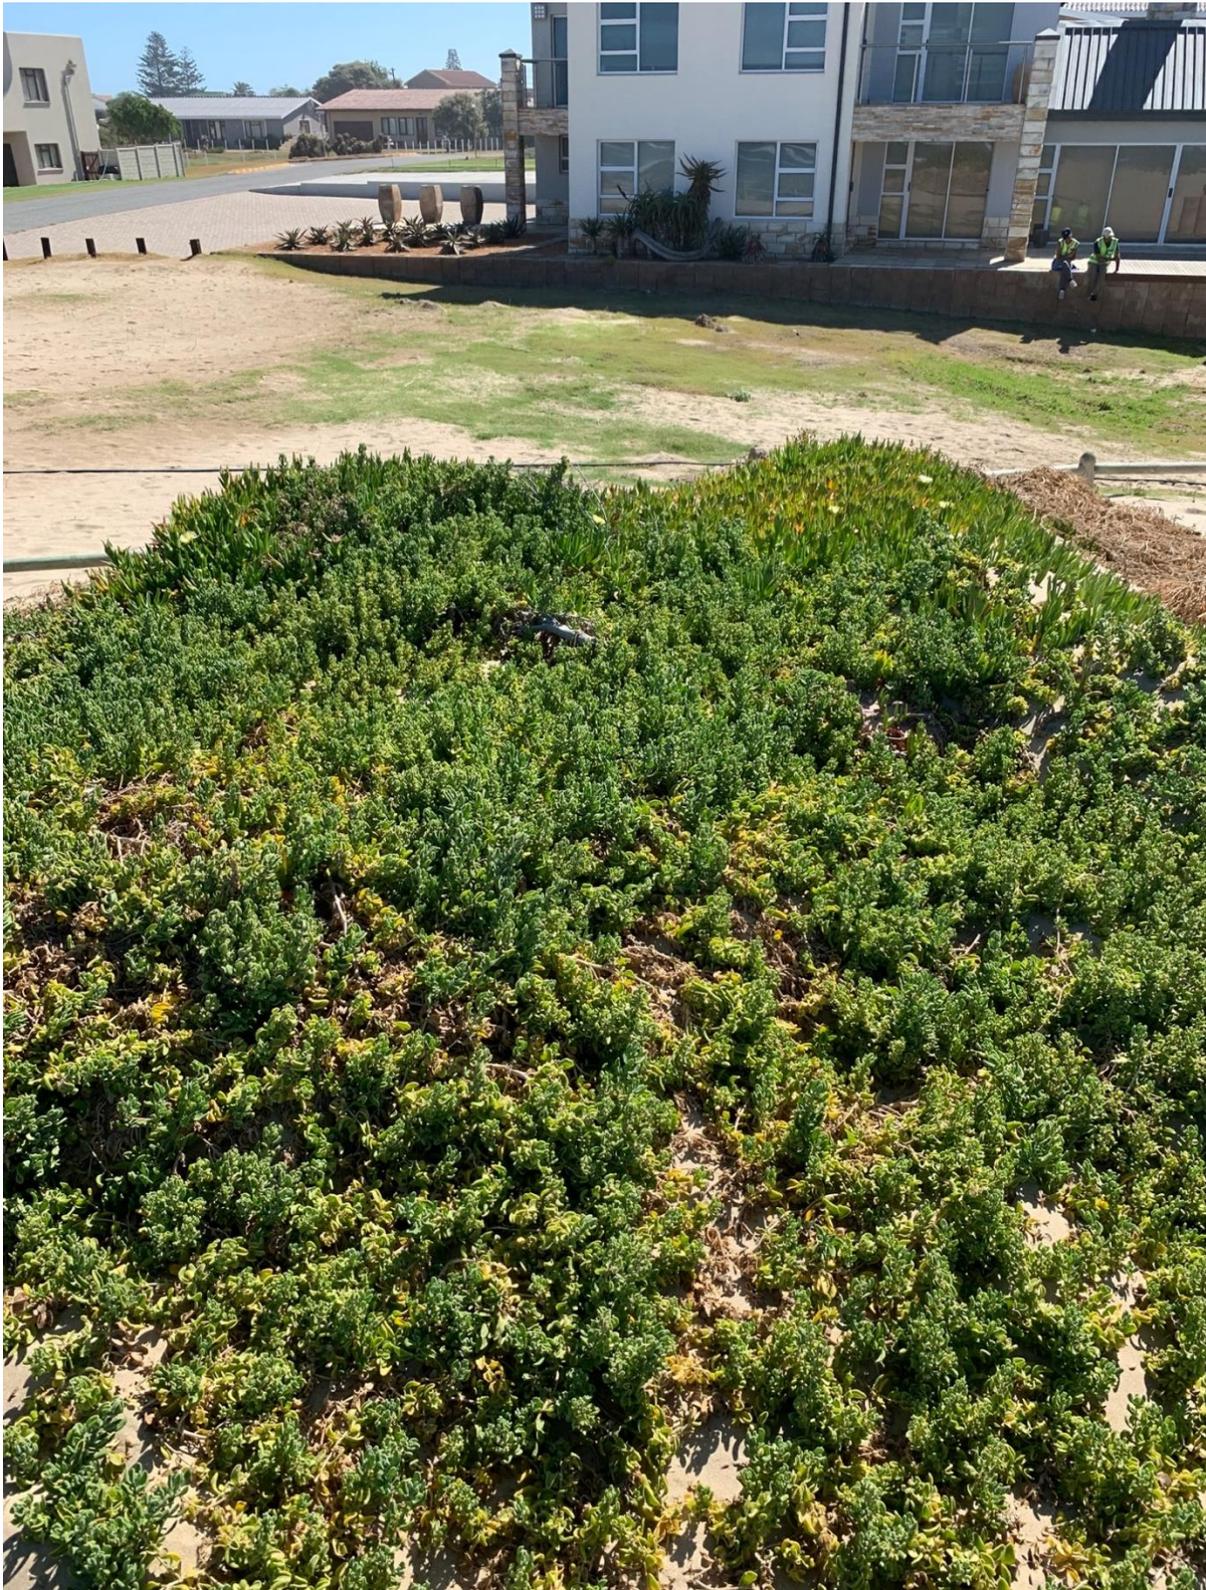
Plate 5.5: *Tetragonia decumbens* foredune in the foreground, and *Sporobolus virginicus* parking area in the background.

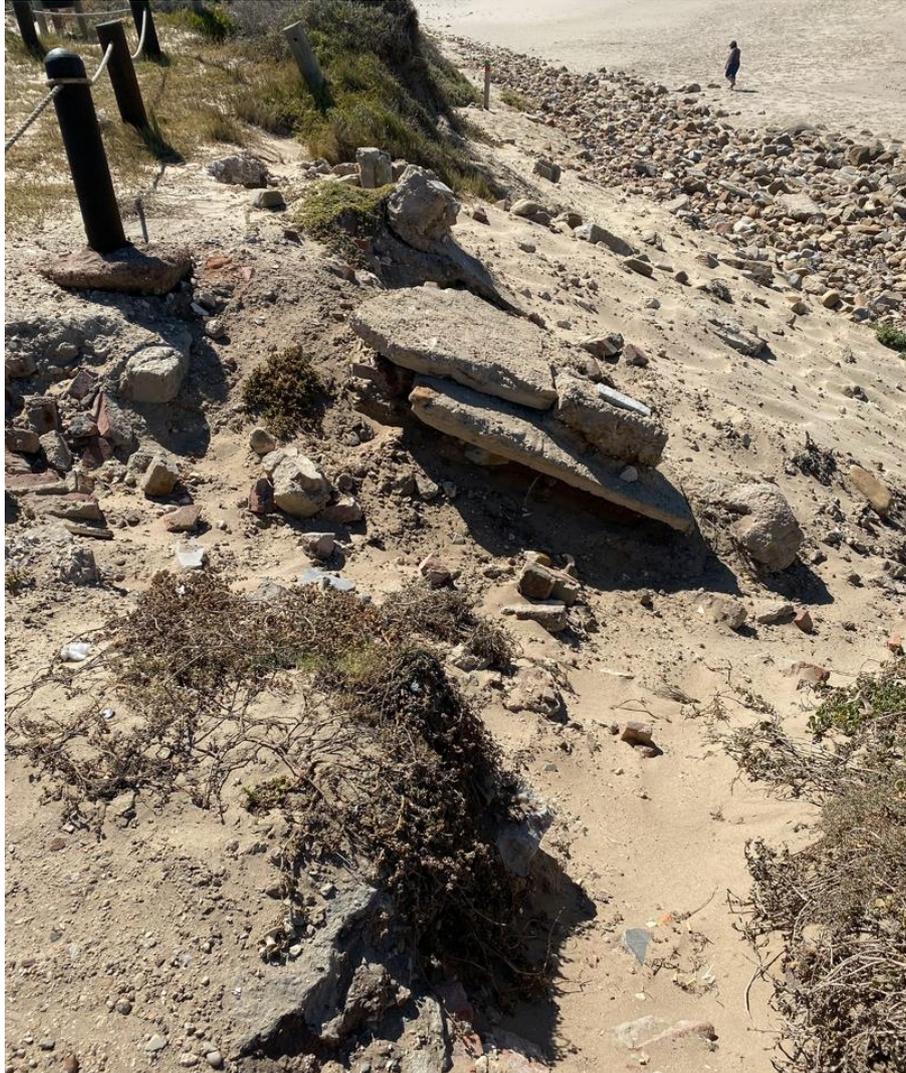
The dune slope below the parking area at Gouritz's is not stable. It is subject to wave attack during spring high tides, and this results in erosion at the base of the slope. Eventually the under-cutting results in the dune slumping (Plate 5.7). Attempts to stabilize the area using gabions has been partly successful, but ongoing maintenance is required (Plate 5.8).

Plate 5.7: The dune slope below the parking area is severely eroded due mainly to wave attack but also recreational impacts (trampling).

- i. **Slope re-enforcement, sand placement and revegetation** – the slope below the formal parking area has been subject to erosion from wave attack, and subsequent wind erosion (Plates 5.7 and 5.8). Sand will need to be brought in to fill the voids, and to establish a gentler slope that would be easier to revegetated. The slope should have a maximum slope angle of 18°. Thereafter the slope should be covered with mulch or brushwood, planted and the covered with Geojute matting. Geojute is commonly used as a biodegradable surface stabiliser or for pre-vegetated slopes. The product is manufactured from woven jute fibre to form a mesh of approximately 10mm x 10mm, which is staked at 1m² intervals. The jute will eventually degrade into an organic mulch after about two years, by which time the planted vegetation will have become established (see <http://www.geotextilesafrica.co.za/erosion-Geojute-data.html>). Alternatively, gabions could be constructed, but if required then engineering input is essential. Suitable species to plant include the grasses *Sporobolus virginicus* and *Elymus distichum*, and the herbs *Tetragonia decumbens* and *Gazania rigens var. uniflora*, as well as *Carpobrotus edulis*.

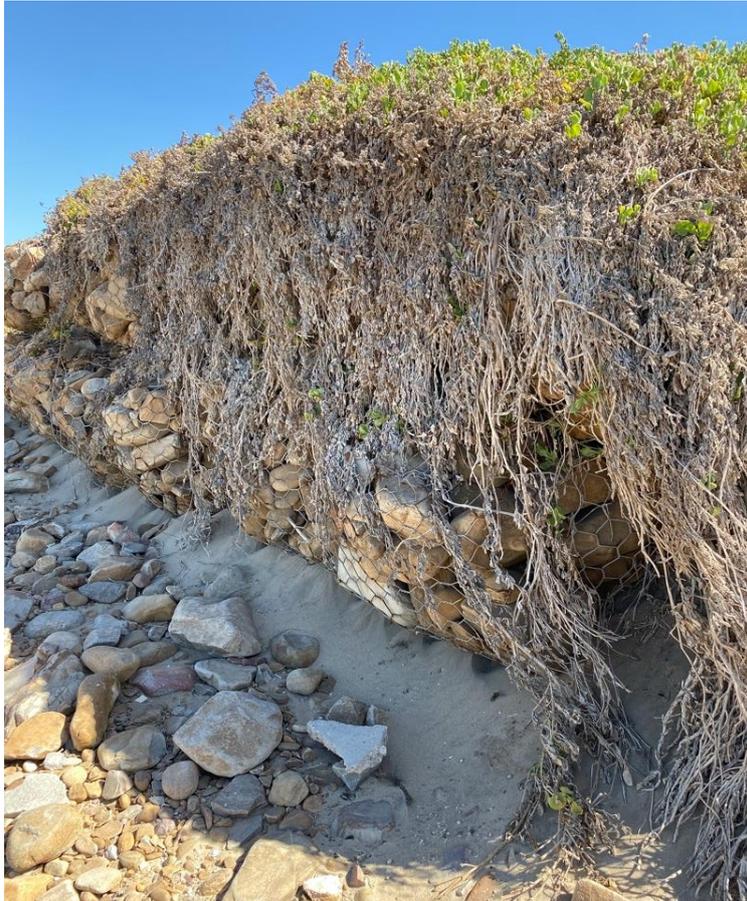
Plate 5.8: Gabions have been used to reinforce the slope but sand has eroded in front of them, and the undercutting eventually results in their collapse.
