Dune Maintenance and Management Plan – Gouritz

DUNE MAINTENANCE AND MANAGEMENT PLAN - GOURITZ

July 2020

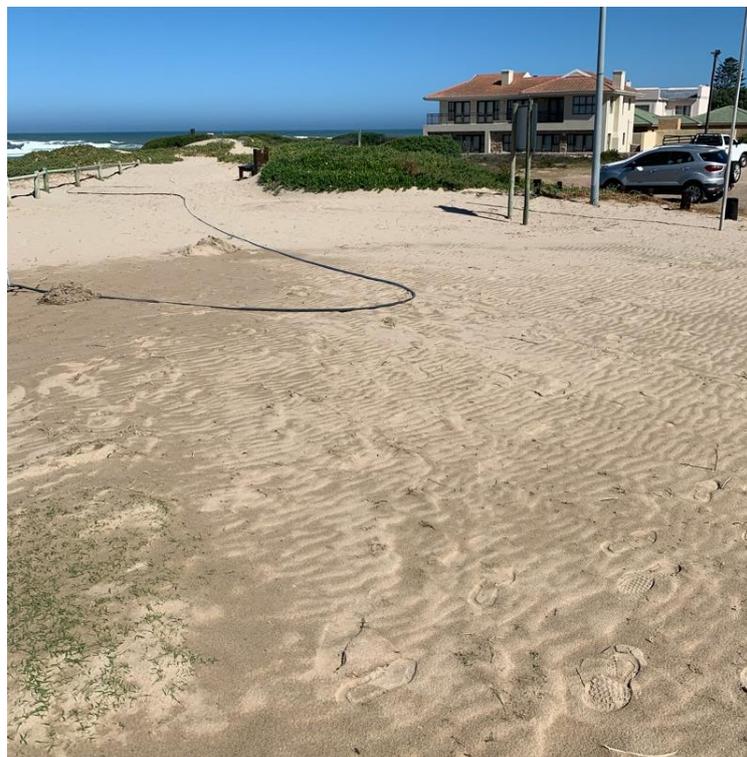
The grassy parking area at the corner of River Street and Kus Road has very low vegetation cover, and access from here to the beach is not well controlled. The grass cover (*Sporobolus virginicus*) cannot withstand the effects of vehicle traffic on the soft sand, and hence the surface is unstable.

Plate 5.9: Unstable and sandy parking area at River street.

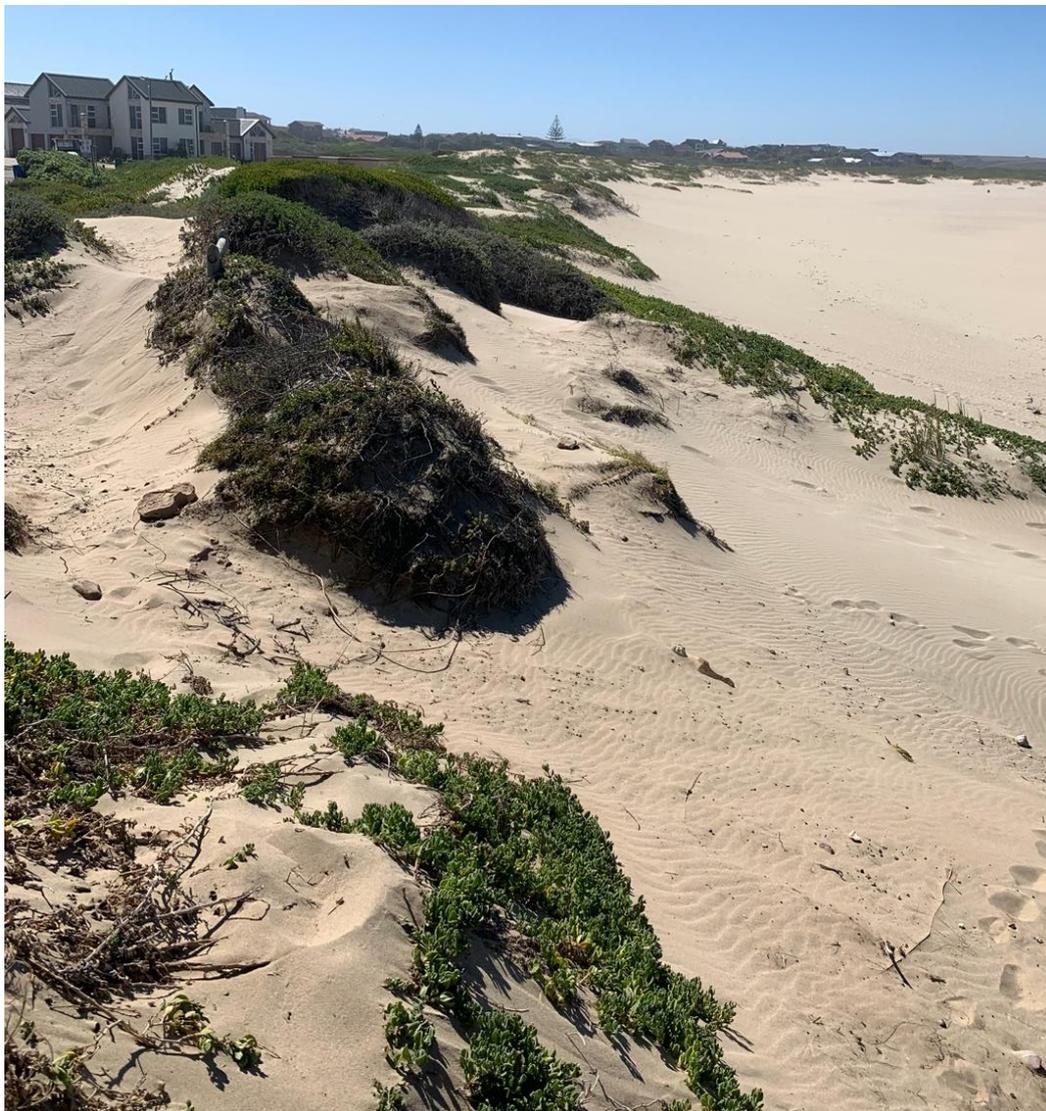
The reconstruction of dunes is sometimes necessary when the shape, size or topography has changed as a result of wind erosion and wave attack. This is the situation for the foredune ridge between transects 25 to 29, so ideally the dune system should be re-profiled with earthmoving equipment, but this will result in the loss of vegetation cover. Although the linear foredune ridge has been compromised, vegetation cover is still good (Plate 6.1). Therefore, it is recommended that the sand trapping techniques of installing wind-nets and spreading brushwood over the sand, followed by active revegetation be done instead. In this way the existing vegetation cover is not lost, and the approach will be more cost effective.

Plate 6.1: The vegetation along the foredune ridge has been impact from trampling, resulting in the loss of a linear ridge. However, cover is still relatively good and thus no re-contouring is recommended.

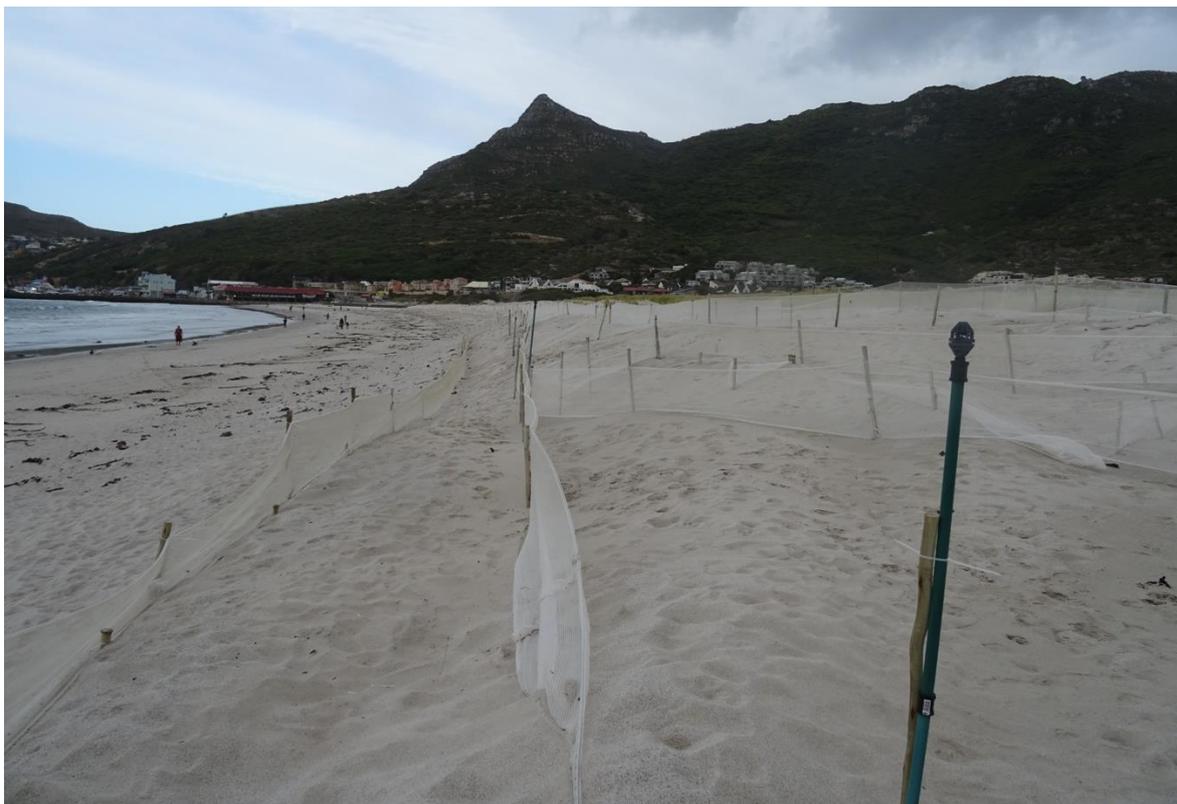
Plate 6.2: Bare sand and blowouts require wind-nets be established at 10m intervals prior to brushwood packing and planting, as done at Hout Bay, Cape Town (Photo R Rose).

- **Wind-nets in blowouts:** dune forming fences must mainly used on smaller isolated blowouts which are still surrounded by functional dunes and vegetation. They have the advantage of preventing people from walking through the blowouts, which is important since they are usually caused by trampling followed by natural wind erosion. The establishment of very short wind-nets at specific locations where erosion has taken place is required. These wind-nets should be constructed towards the back of the small blow-out dunes to trap wind-blown sand, and as it accumulates to fence height, a new wind-net fence must be placed approximately 15 to 20m in front of the wind-net, towards the mouth of the blowout. Once sand has accumulated to the required height behind the first wind-net, the area must be covered with brushwood or mulch and revegetated. Vegetation will become established as the sand surface is now stable. The wind-nets should ideally be constructed of natural materials such as branches obtained from alien invasive removal programs (with the seeds removed). If this is not possible then wind-nets can be constructed from porous materials such as shade cloth can be used (Plate 6.2). Wooden slats laced together, as well as hessian may also be used in addition to shade cloth.

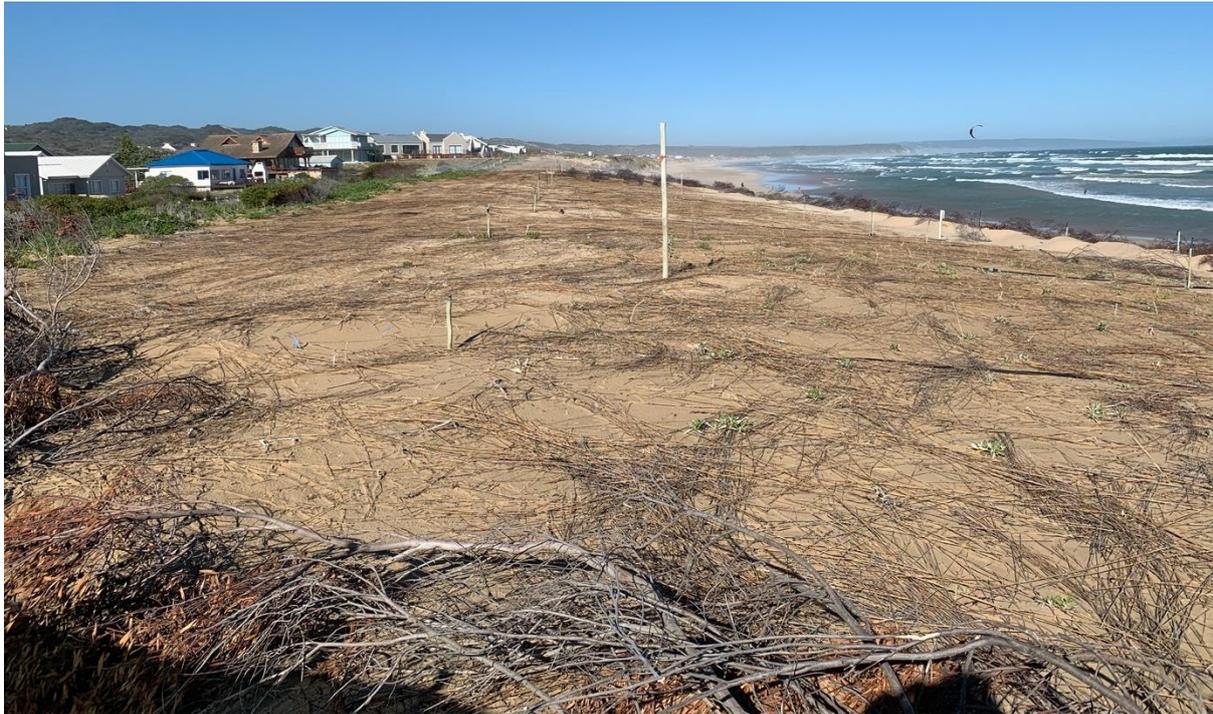
Plate 6.3: Brushwood is very suitable to place over there sand behind the foredune ridge prior to planting, as has been done at Lappiesbaai.

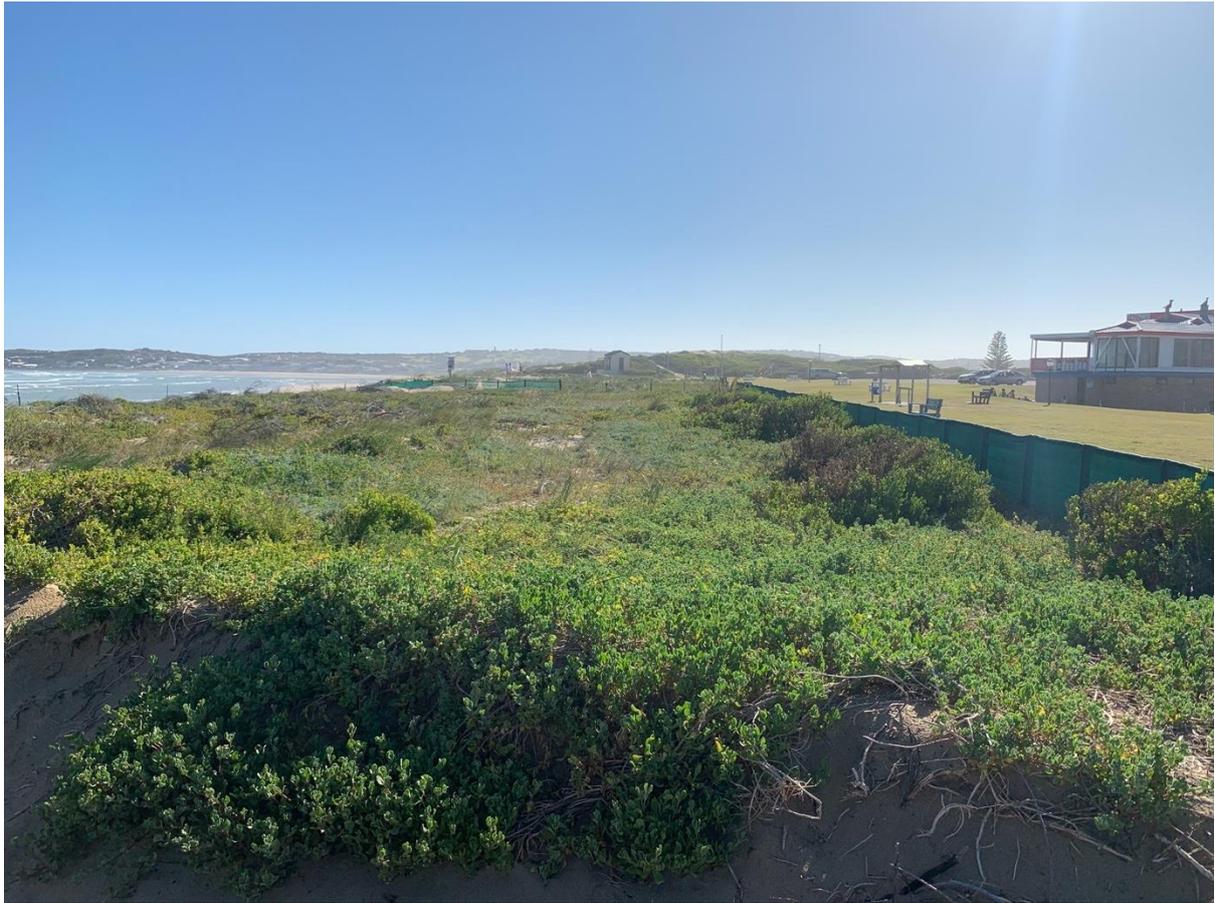
The most effective long-term method of dune stabilisation is through the planting of vegetation. It is the least expensive and most durable cover lens and blends into the natural setting. It is generally self-maintaining as coastal vegetation is adaptive to the harsh conditions it is exposed to, and plays a very important role in binding the sand, thus creating dune systems. Ultimately a self-sustaining ecosystem, with minimal maintenance requirements is created, and this should be the goal (Plate 6.4).

Plate 6.4: The area in front of the parking at lot at Lappiebaai has been successfully re-vegetated after the dune was recontoured, packed with brushwood and planted. The site was irrigated, and this played an important role in its successful revegetation.

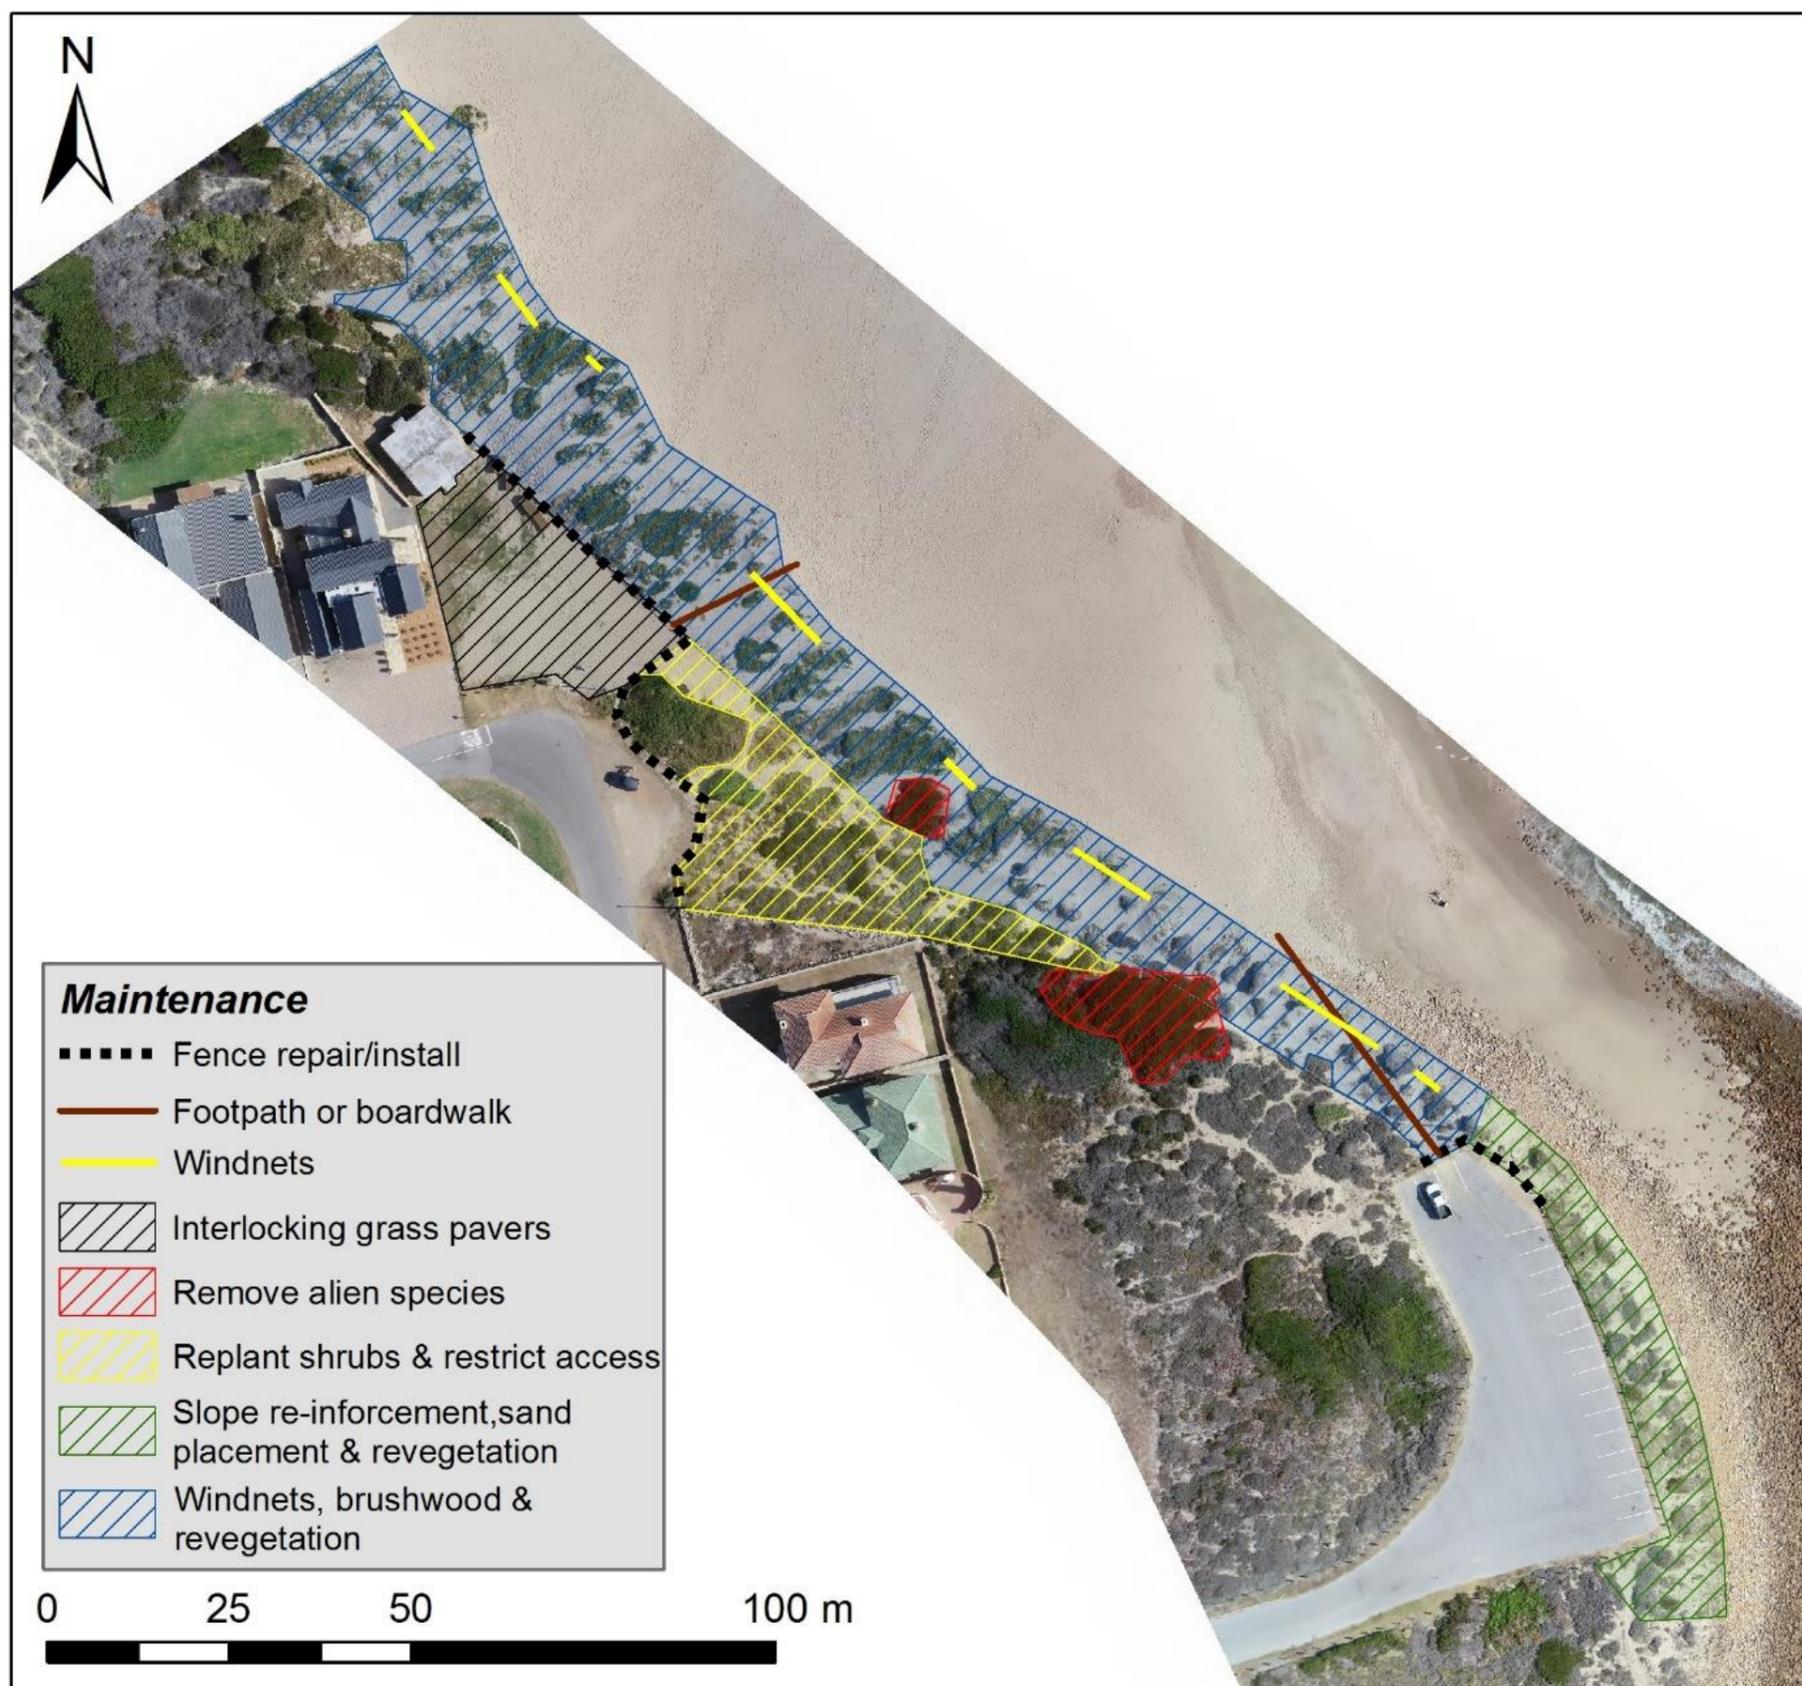
- i. **Slope re-enforcement, sand placement and revegetation** – the slope below the formal parking area has been subject to erosion from wave attack, and subsequent wind erosion (Plates 5.7 and 5.8). Sand will need to be brought in to fill the voids, and to establish a gentler slope that would be easier to revegetated. The slope should have a maximum slope angle of 18°. Thereafter the slope should be covered with mulch or brushwood, planted and the covered with Geojute matting. Geojute is commonly used as a biodegradable surface stabiliser or for pre-vegetated slopes. The product is manufactured from woven jute fibre to form a mesh of approximately 10mm x 10mm, which is staked at 1m² intervals. The jute will eventually degrade into an organic mulch after about two years, by which time the planted vegetation will have become established (see <http://www.geotextilesafrica.co.za/erosion-Geojute-data.html>). Alternatively, gabions could be constructed, but if required then engineering input is essential. Suitable species to plant include the grasses *Sporobolus virginicus* and *Elymus distichum*, and the herbs *Tetragonia decumbens* and *Gazania rigens var. uniflora*, as well as *Carpobrotus edulis*.

- viii. **Establish a lifeguard facility**. This MMP also covers activities associated with the establishment of a lifeguard facility, which will be a small (approximately 15m²) elevated wooden “Wendy house”. It is suggested that this be located just above the highwater mark where Seesig Road extends into the frontal dune system, to allow access for emergency vehicles. It is further suggested that an access control structure (boom) be installed just below the intersection of Seesig Road and River Street, to avoid illegal ORV access to the beach and river mouth.

Figure 6.1: Rehabilitation activities required.
