**CES: PROPOSED MBSA CLARKEBURY ROAD UPGRADE
PROJECT, CLARKEBURY AREA, OR TAMBO DISTRICT
MUNICIPALITY, EASTERN CAPE PROVINCE**

Archaeological Impact Assessment

ARCHAEOLOGICAL IMPACT ASSESSMENT (AIA) OF AREAS DEMARCTED FOR UPGRADING TO A SURFACE STANDARD MBSA CLARKEBURY ROAD UPGRADE PROJECT, CLARKEBURY AREA, OR TAMBO DISTRICT MUNICIPALITY, EASTERN CAPE PROVINCE

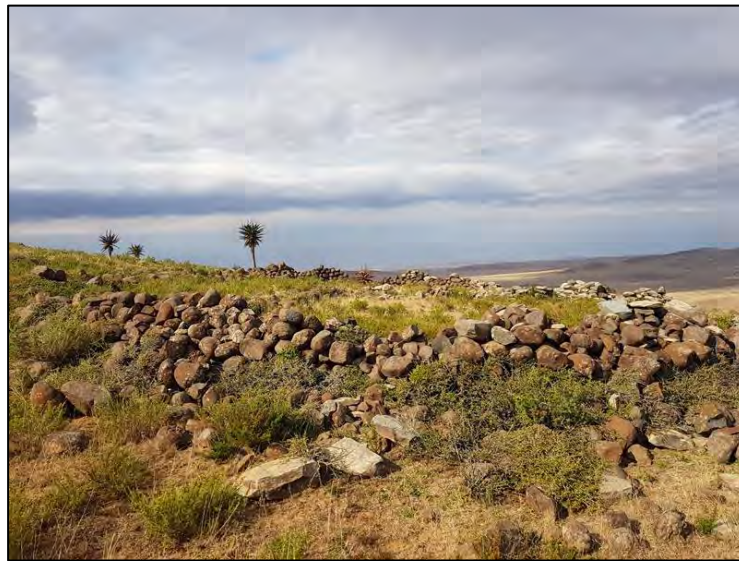
A frontier zone between the north and the south, the Eastern Cape landscape contains traces of precolonial Iron Age Farmer Period remnants. A large settlement area consisting out of elaborate stone walled enclosures was documented on the summit of a hill at Qulugu, at the site proposed for the road quarry. At the site, a series of circular stone wall enclosures of varying sizes occur across an area of approximately 4ha over much of the flat hilltop. The fairly well-preserved structures, which are in places overgrown with aloë and other shrubs, were built with round stones, in some instances to a height of more than 1.5m. Clear entrances are demarcated by monoliths at many of the enclosures, which were probably used as livestock “kraals”. Ashy soil occurs in a central part of the site in association of a number of stone cairns which might be the remains of gran bin stands. A small stone cairn occurs along the more secluded southern periphery of the site on a high rise which provides a look-out point to the surrounding landscape and the Tora River below. No material culture was observed at the site and a clear temporal context for the structures is not known but it is likely that the stone walls date to the terminal phases the Iron Age farmer period in the area. This inference is made based on the fact that the stone enclosures are exclusively circular in shape whereas squarely built enclosures, commonly found in the surrounding landscape, would occur on newer Historical or Contemporary period sites. In addition, the site is situated away from current and historical settlement areas and homesteads and its general appearance do not resemble Historical period livestock enclosures in the surrounding landscape. Finally, many of the stones in the walls are covered with rock lichens along exposed surfaces with no growth evident on obstructed sides. Lichens are known to grow at a slow rate, particularly on exposed soil surfaces which in this instance, suggests an older date range for the stone walls. The site is thus an archaeological site of medium significance which is protected under the National Heritage Resource Act (NHRA 1999). As it is situated in an area demarcated as a stone quarry, impact on the site might occur and mitigation measure will apply.

Figure 5-1: View of circular stone wall enclosure at Site EXIGO-MCRU-IA01.

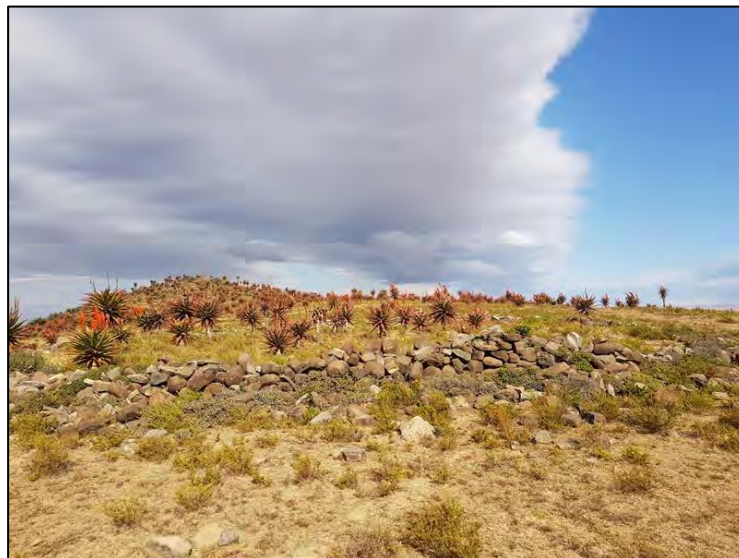
Figure 5-2: Stone walls on a high hill at Site EXIGO-MCRU-IA01.

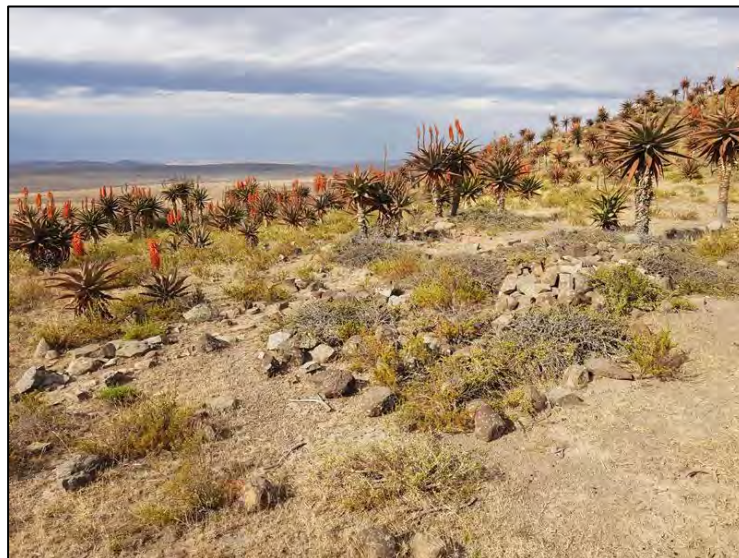
Figure 5-3: Ashy soil and possible grain bin stand foundations at Site EXIGO-MCRU-IA01.

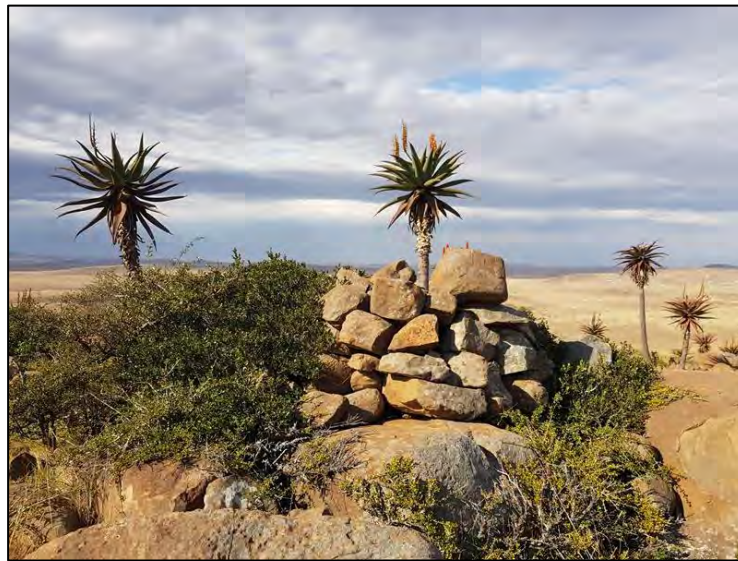
Figure 5-4: A small stone cairn at Site EXIGO-MCRU-IA01.

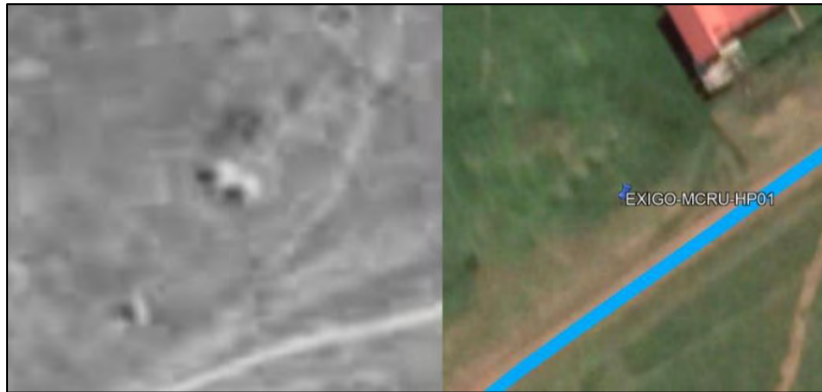
The dilapidated remains of a homestead, consisting out of the foundations of at least 3 huts as well as the partially intact walls of a stone wall enclosure were noted in the KuMbunga area along the road upgrade alignment. Material culture such as glass, metal and plastic occur at the site. An absolute age for the structures could not be ascertained but an analysis of historical aerial photographs indicates that the area

was relatively densely populated during the previous century. According to indications, the homesteads were in use by around 1938 and the structures are probably older than 60 years - and generally protected under the National Heritage Resource Act (NHRA 1999). However, the features are poorly preserved and they are of medium-low significance but a permit for the destruction of the structures is required subject to the NHRA should these sites be impacted on by the proposed road upgrade project.

Figure 5-6: Site EXIGO-MCRU-HP01 indicated on an archive aerial image (1938, left) and current aerial imagery (right).

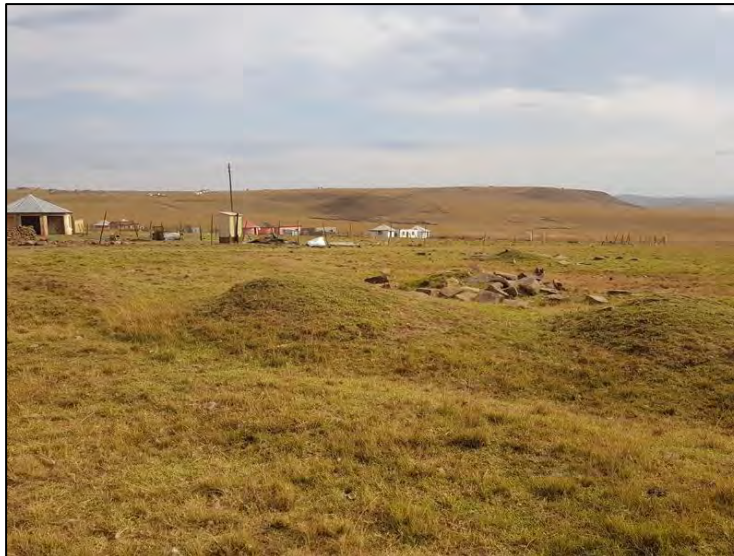
Figure 5-7: View of building foundation remains at Site EXIGO-MCRU-HP01.

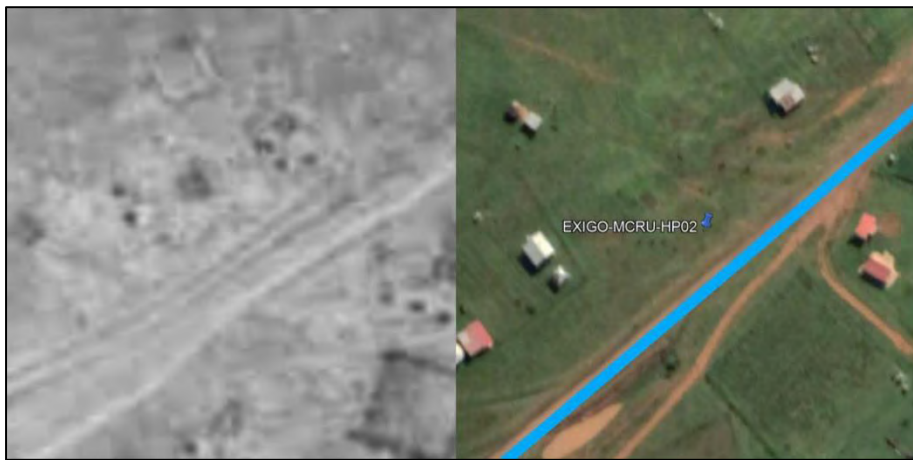
The remains of another homestead, consisting out of the foundations of at least 2 huts was noted in the KuMbanga area along the road upgrade alignment. Material culture such as glass, metal, plastic and a broken lower grindstone occur at the site. An absolute age for the site could not be ascertained but an analysis of historical aerial photographs indicates that the area was relatively densely populated during the previous century. According to indications, the homestead was in use by around 1938 and the structures are probably older than 60 years - and generally protected under the National Heritage Resource Act (NHRA 1999). However, the features are poorly preserved and they are of medium-low significance but a permit for the destruction of the structures is required subject to the NHRA should these sites be impacted on by the proposed road upgrade project.

Figure 5-9: Site EXIGO-MCRU-HP02 indicated on an archive aerial image (1938, left) and current aerial imagery (right).

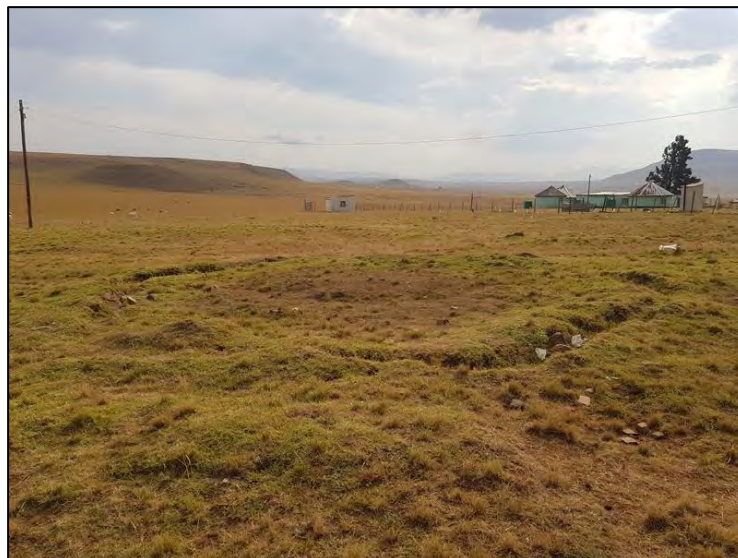
Figure 5-10: View of a hut foundation at Site EXIGO-MCRU-HP02.

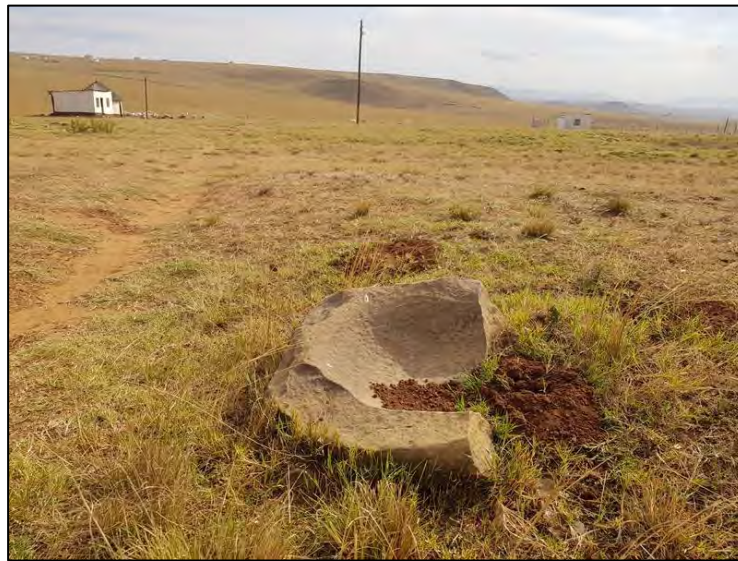
Figure 5-11: View of a broken upper grindstone at Site EXIGO-MCRU-HP02.

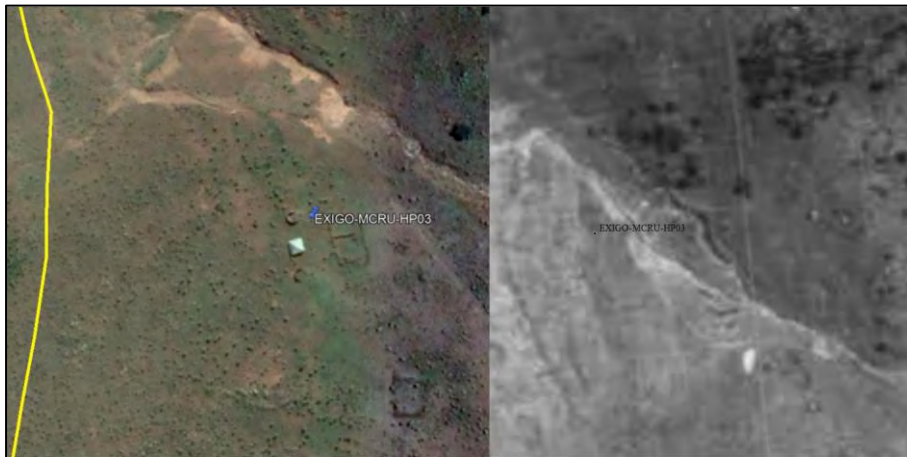
A Historical Period homestead complex consisting of a single room building, hut remains as well as elaborate livestock enclosures occur in the Qulugu area direct east of the proposed quarry site. The square building was constructed out of mud brick with a pitched corrugated iron roof. The building is typical of Historical Period architecture of the rural areas in the Eastern Cape. In addition, a number of square stone wall enclosures occur around the dwelling. The site is visible on archive aerial photographs and it is older than 60 years - and generally protected under the National Heritage Resource Act (NHRA 1999). However, the dwelling does not seem to hold any particular social or historical value and it is of medium-low heritage significance. A permit for the destruction of the structures is required subject to the NHRA should these sites be impacted on by the proposed road upgrade project.

Figure 5-13: Site EXIGO-MCRU-HP03 indicated on an archive aerial image (1938, right) and current aerial imagery (left).

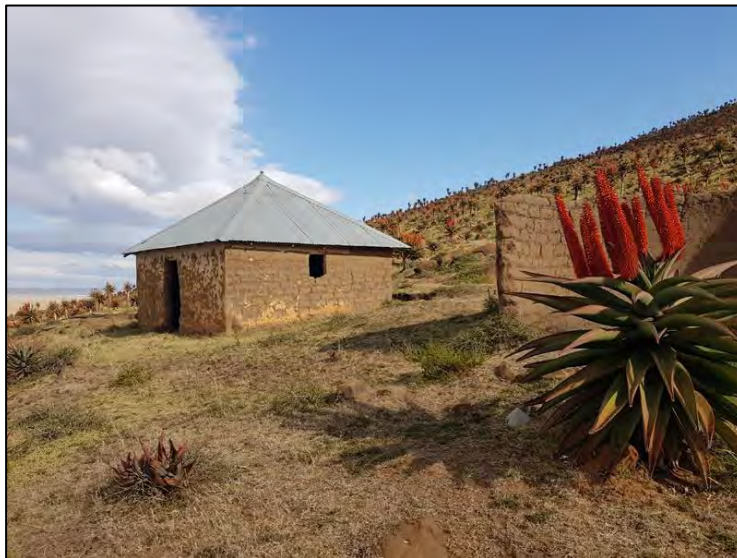
Figure 5-14: View of a mud brick dwelling and hut remains (right) at Site EXIGO-MCRU-HP03.

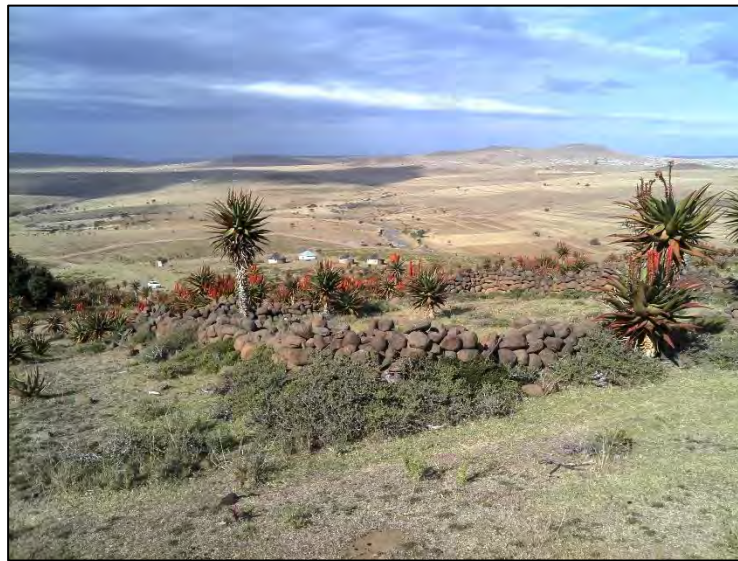
Figure 5-16: View of stone walled livestock enclosures at Site EXIGO-MCRU-HP03.

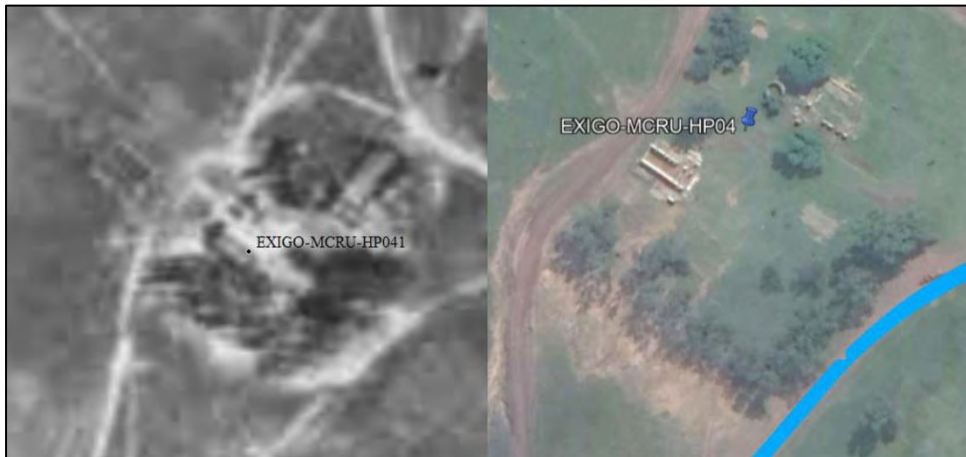
The remains of a compound of Historical Period multi room buildings occur along the road upgrade alignment in the Ntlakwevenkile area. Here, a large multi-room rectangular building once held the Phillipsdale Trading Store and the remains of a sandstone house and a mud brick building occur in its vicinity. An interesting feature at the site is the wall remains of a rondel structure, constructed out of skillfully shaped sandstone blocks. The building remains display typical Historical Period architectural features of the rural areas in the Eastern Cape. The site is visible on archive aerial photographs, it is older than 60 years and generally protected under the National Heritage Resource Act (NHRA 1999). Even though the buildings might afford a better understanding of architectural, settlement and social developments in the Clarkebury landscape, the site is dilapidated and poorly preserved, and it is rated as of medium-low heritage significance. A permit for the destruction of the structures is required subject to the NHRA should these sites be impacted on by the proposed road upgrade.

Figure 5-18: Site EXIGO-MCRU-HP04 indicated on an archive aerial image (1938, left) and current aerial imagery (right).

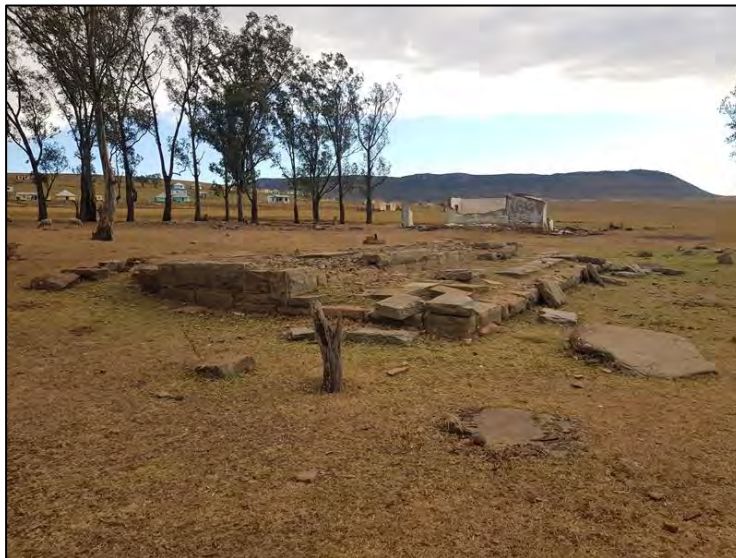
Figure 5-19: View of a sandstone building foundation at Site EXIGO-MCRU-HP04.

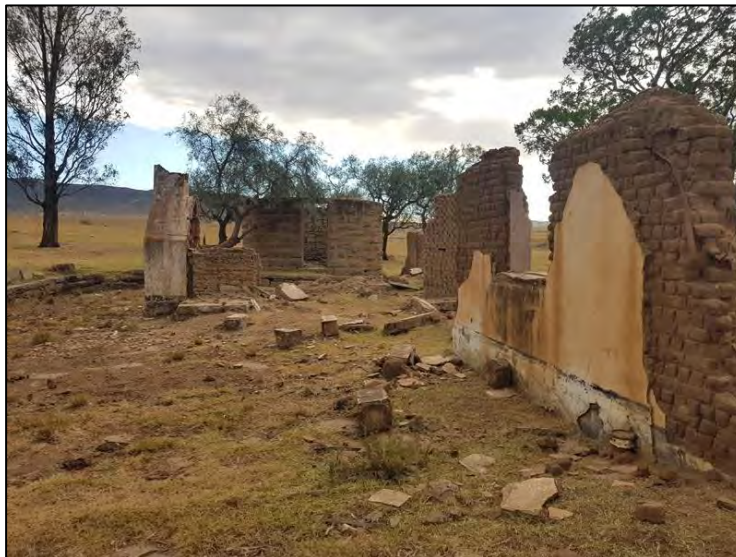
Figure 5-20: View of building remains remains at Site EXIGO-MCRU-HP04. Note the stone rondel in the middle background.

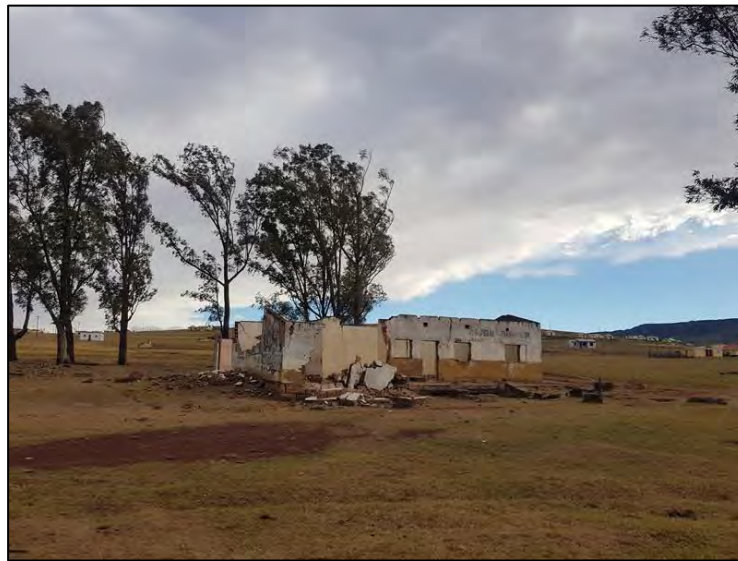
Figure 5-21: View of the remains of the Phillipsdale Trading Store at Site EXIGO-MCRU-HP04.

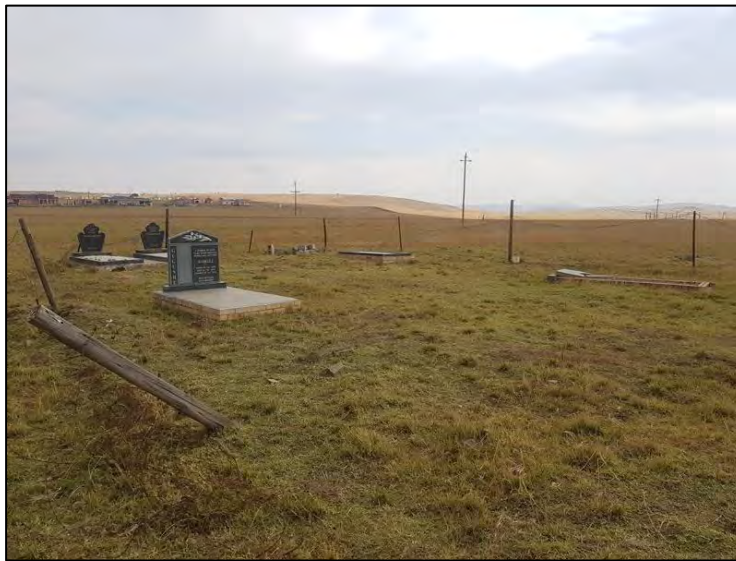
A small cemetery containing at least 7 graves occurs in the KuMbunga area directly east of the DR08034-N2 road. The majority of burials are indicated by concrete and marble stone bases and marked marble headstones. Single graves are indicated by elongated soil mounds which are covered in surface grass and stones. Material culture such as glass and enamel containers were noted in associated with some of the graves. The cemetery is fenced off and the general condition of the graves is good. The burial site is of high heritage significance, it is situated in the general vicinity of the proposed road upgrade route and a conservation buffer of 50m should be observed. Alternatively, the burials should be relocated according to the applicable social and statutory requirements, should impact prove inevitable.

Figure 5-33: View of the burial site at Site EXIGO-MCRU-BP01.

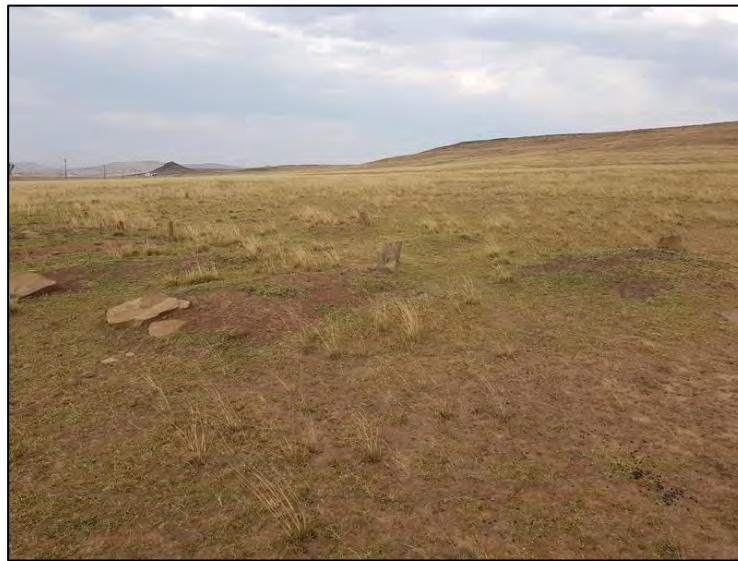
At least 8 graves occur in an open field in the Mtshayelweni area directly south of the existing Clarkebury Road. The burials are indicated by soil mounds and some graves bear unmarked rocks headstones. The site is not fenced and the graves are in a poor state of preservation. The burial site is of high heritage significance, it is situated in close proximity of proposed road upgrade route and a conservation buffer of 50m should be observed. Alternatively, the burials should be relocated according to the applicable social and statutory requirements, should impact prove inevitable.

Figure 5-35: View of the burial site at Site EXIGO-MCRU-BP02.

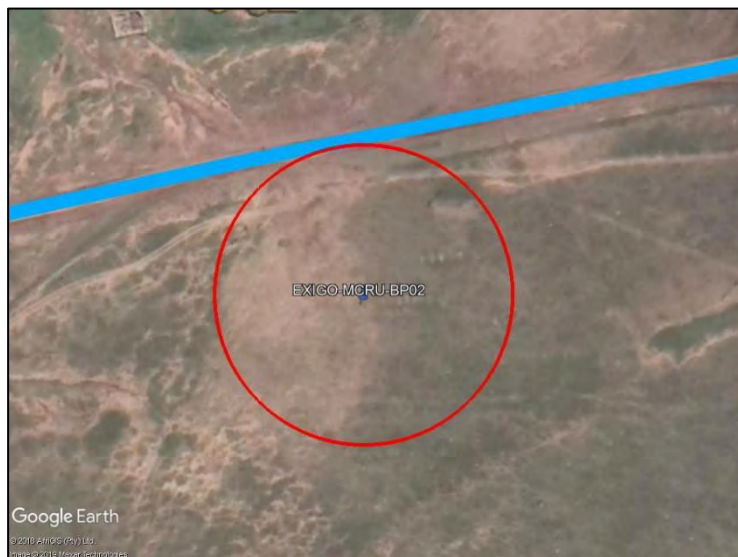
Figure 5-36: Site EXIGO-MCRU-BP02 and a required 50m conservation buffer (red line) in relation to the road alignment (blue line).

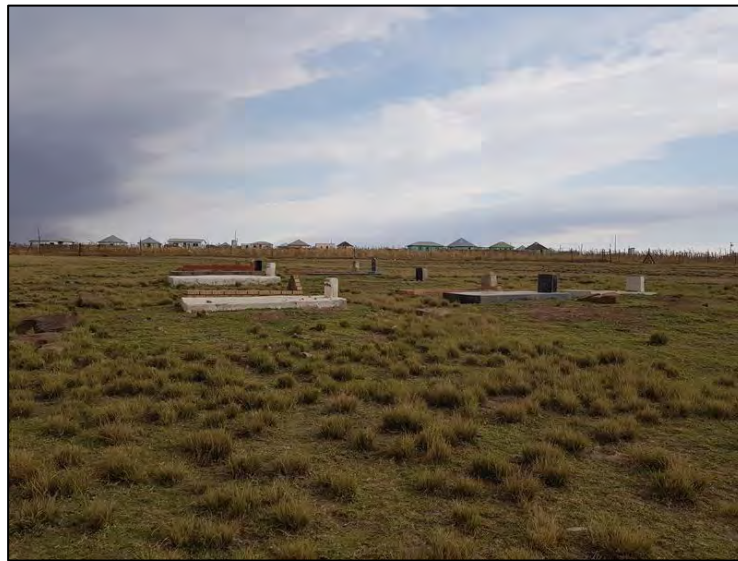
A small cemetery containing at least 7 graves occurs in the Ngqubusini area south of the existing Clarkebury Road. The majority of burials are indicated by concrete slabs and cement headstones. Single graves are indicated by elongated soil mounds which are covered in surface grass and stones. Material culture such as glass and enamel containers were noted in associated with some of the graves. The cemetery is not fenced off but the general condition of the graves is good. The burial site is of high heritage significance, it is situated in the general vicinity of the proposed road upgrade route and a conservation buffer of 50m should be observed. Alternatively, the burials should be relocated according to the applicable social and statutory requirements, should impact prove inevitable.

Figure 5-37: View of the burial site at Site EXIGO-MCRU-BP03.

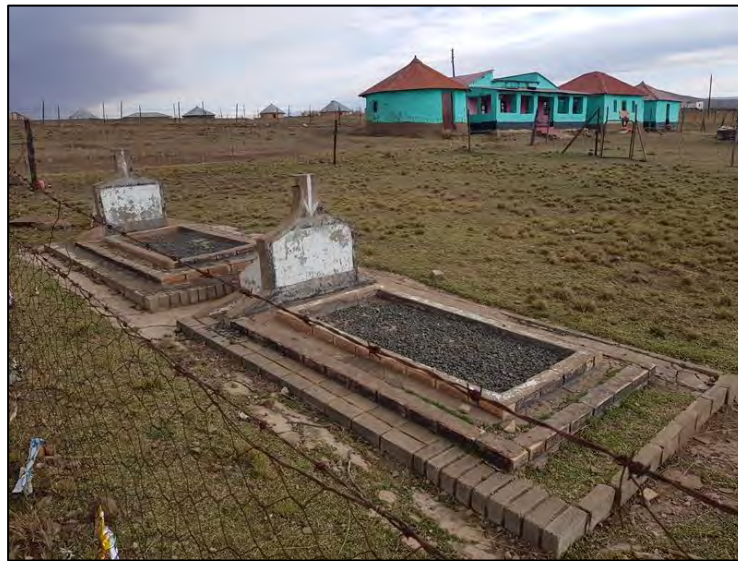
Two graves occur within a homestead complex in the Ngqubusini area south of the existing Clarkebury Road. The burials are covered with brick and filled-in gravel grave dressings bearing cement headstones. The cemetery are fenced off but the general condition of the graves is good. The burial site is of high heritage significance, it is situated in the general vicinity of the proposed road upgrade route and a conservation buffer of 50m should be observed. Alternatively, the burials should be relocated according to the applicable social and statutory requirements, should impact prove inevitable.

Figure 5-39: View of the burial site at Site EXIGO-MCRU-BP04.

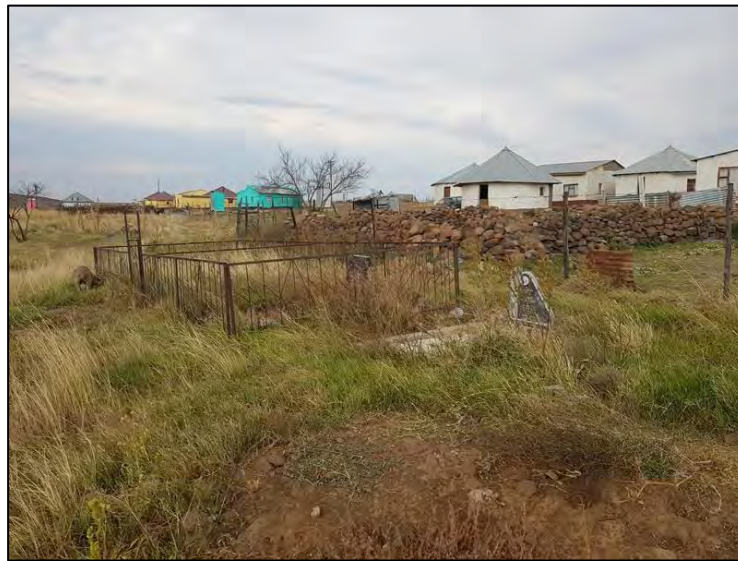
A small cemetery containing at least 5 graves occurs next to a homestead in the Ngqubusini area south of the existing Clarkebury Road. The majority of burials are indicated by concrete slabs and marked marble headstones. Single graves are indicated by elongated soil mounds which are covered in surface grass and stones. Some of the graves are individually fenced off with cast iron fences and the general condition of the graves, which are partially obstructed by surface vegetation, is good. The burial site is of high heritage significance, it is situated in the general vicinity of the proposed road upgrade route and a conservation buffer of 50m should be observed. Alternatively, the burials should be relocated according to the applicable social and statutory requirements, should impact prove inevitable.

Figure 5-41: View of the burial site at Site EXIGO-MCRU-BP05.

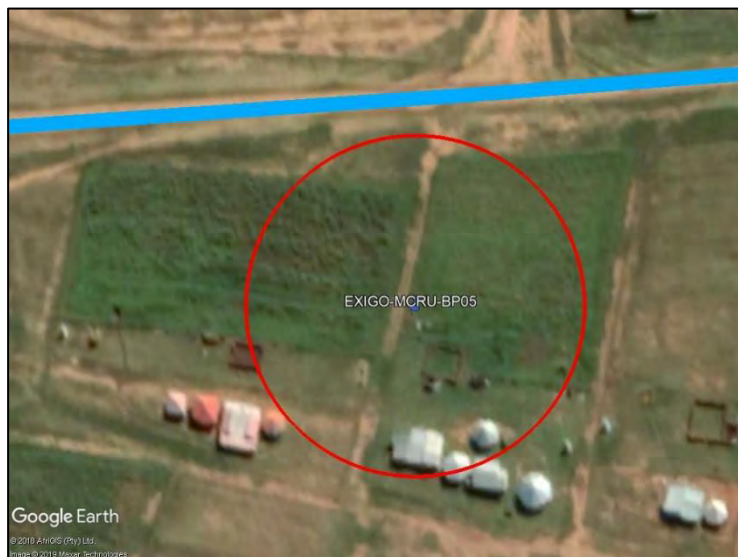
Figure 5-42: Site EXIGO-MCRU-BP05 and a required 50m conservation buffer (red line) in relation to the road alignment (blue line).

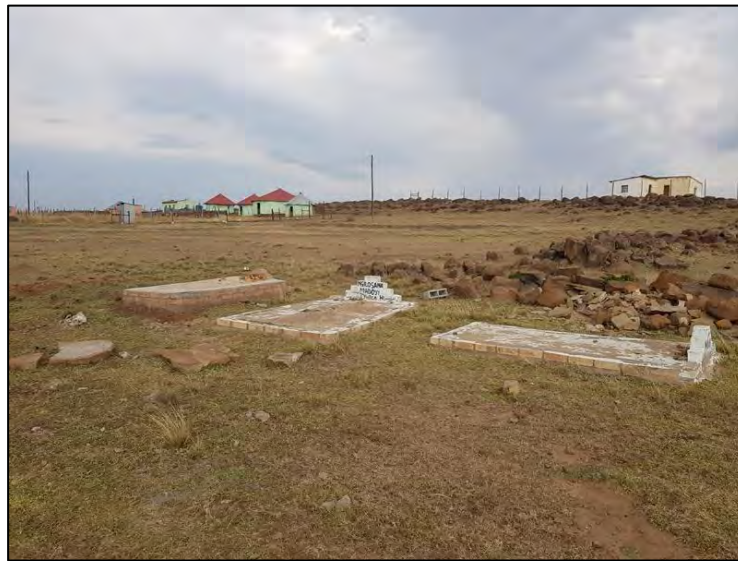
Three graves occur in an open field in the Ngqubusini area directly south of the existing Clarkebury Road. The burials are indicated by concrete and brick slabs and brick headstones. The graves are not fenced off but they are generally well preserved. The burial site is of high heritage significance, it is situated in the close proximity of the proposed road upgrade route and a conservation buffer of 50m should be observed. Alternatively, the burials should be relocated according to the applicable social and statutory requirements, should impact prove inevitable.

Figure 5-43: View of the burial site at Site EXIGO-MCRU-BP06.

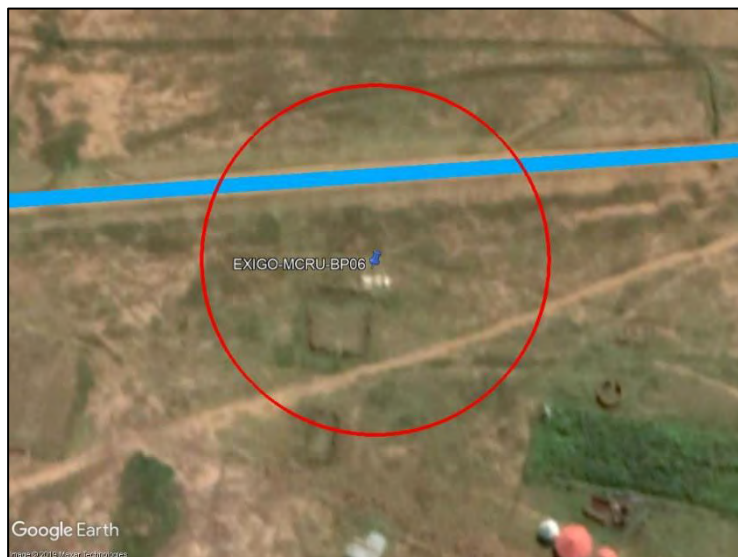
Figure 5-44: Site EXIGO-MCRU-BP06 and a required 50m conservation buffer (red line) in relation to the road alignment (blue line).

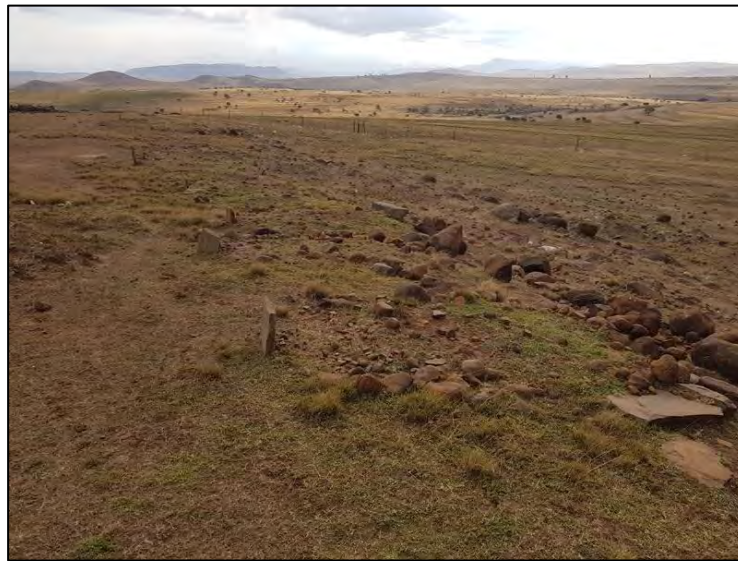
A large community cemetery containing an unknown number of graves occurs in the Ngqubusini area directly north of the existing Clarkebury Road. The majority of burials are indicated by elongated soil mounds and stone cairns which are covered in surface grass and stones. Some burials bear hand-carved headstones and a date of “1898” (?) were noted on one of the headstones. As such, it might be assumed that many of the burials in the cemetery date to the Historical Period. Material culture such as glass and enamel containers were noted in associated with some of the graves. The cemetery is not fenced off but the general condition of the graves is poor. The burial site is of high heritage significance, it is situated in close proximity vicinity of the proposed road upgrade route and a conservation buffer of 50m should be observed. Alternatively, the burials should be relocated according to the applicable social and statutory requirements, should impact prove inevitable.

Figure 5-45: View of the burial site at Site EXIGO-MCRU-BP07.

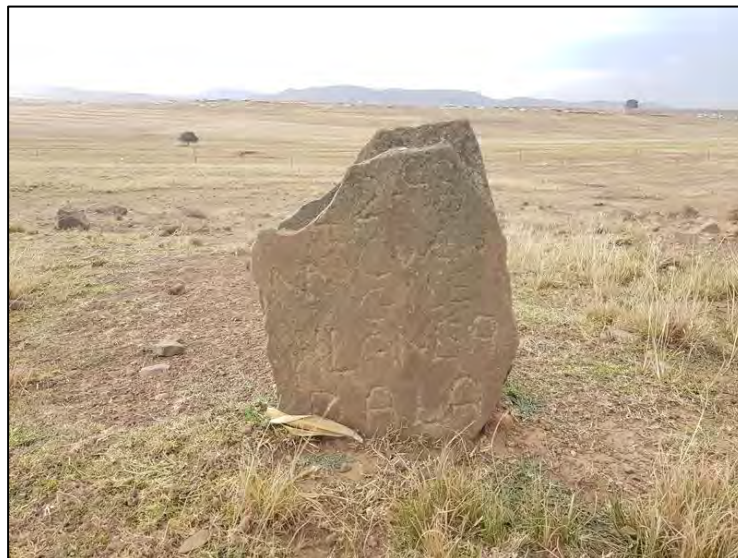
Figure 5-46: View of a hand-carved headstone at Site EXIGO-MCRU-BP07.

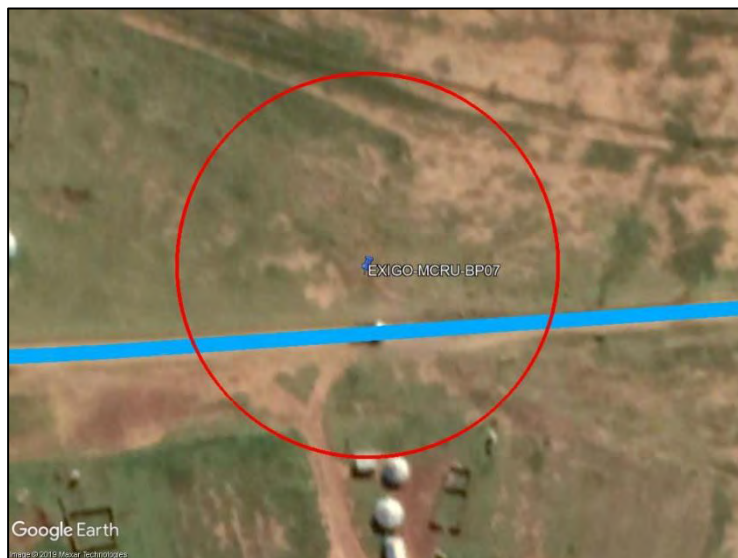
Figure 5-47: Site EXIGO-MCRU-BP07 and a required 50m conservation buffer (red line) in relation to the road alignment (blue line).

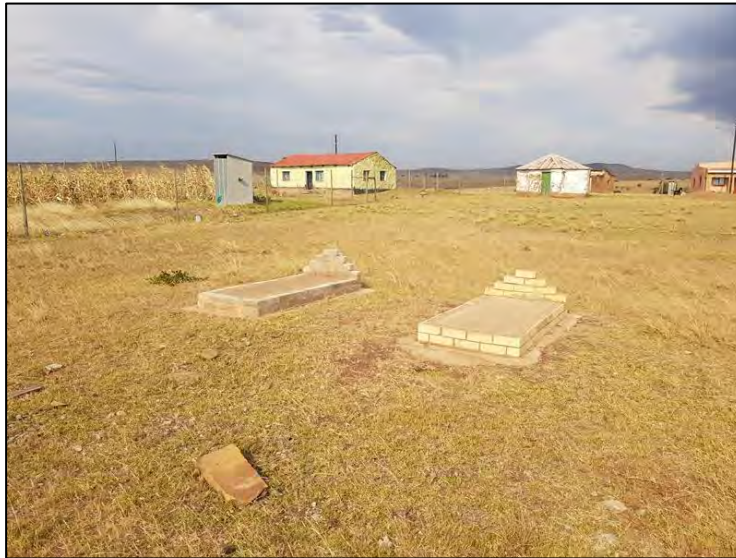
Two graves occur in an open field in the Luqolweni area south of the existing Clarkebury Road. The burials are indicated by concrete and brick slabs and brick headstones. The graves are not fenced off but they are generally well preserved. The burial site is of high heritage significance, it is situated in the close proximity of the proposed road upgrade route and a conservation buffer of 50m should be observed. Alternatively, the burials should be relocated according to the applicable social and statutory requirements, should impact prove inevitable.

Figure 5-48: View of the burial site at Site EXIGO-MCRU-BP08.
