**CES: PROPOSED MBSA CLARKEBURY ROAD UPGRADE  
PROJECT, CLARKEBURY AREA, OR TAMBO DISTRICT  
MUNICIPALITY, EASTERN CAPE PROVINCE**

**Archaeological Impact Assessment**

## ARCHAEOLOGICAL IMPACT ASSESSMENT (AIA) OF AREAS DEMARCTED FOR UPGRADING TO A SURFACE STANDARD MBSA CLARKEBURY ROAD UPGRADE PROJECT, CLARKEBURY AREA, OR TAMBO DISTRICT MUNICIPALITY, EASTERN CAPE PROVINCE

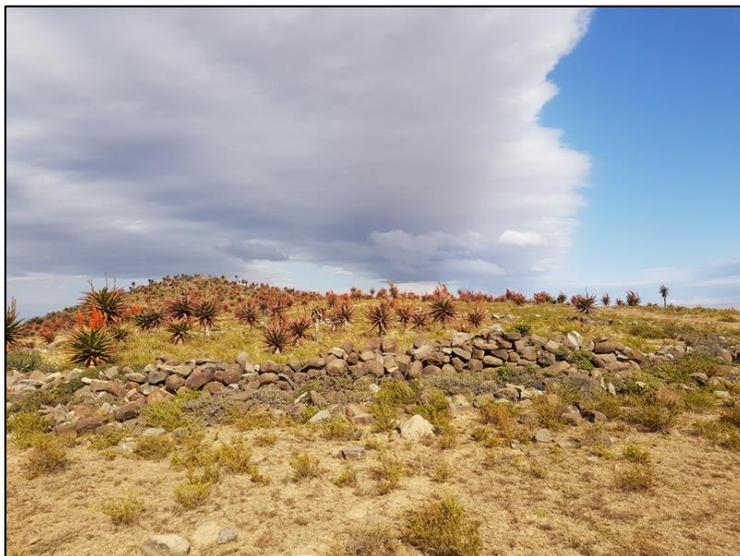
Figure 5-2: Stone walls on a high hill at Site EXIGO-MCRU-IA01.

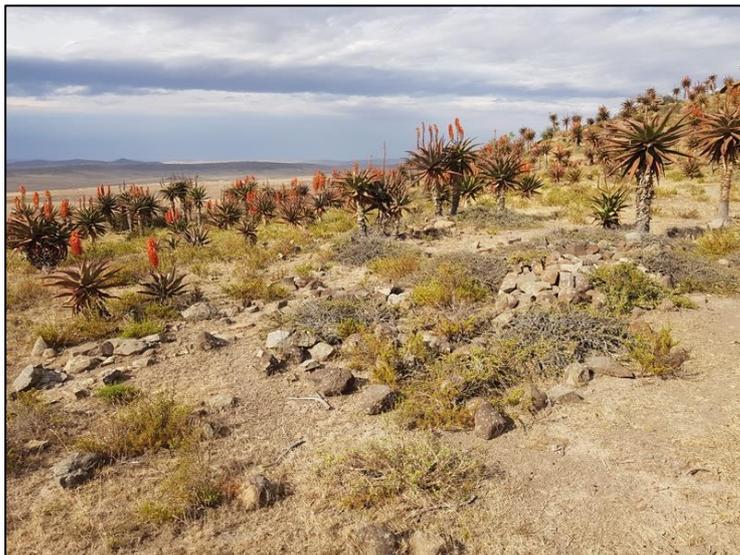
Figure 5-3: Ashy soil and possible grain bin stand foundations at Site EXIGO-MCRU-IA01.

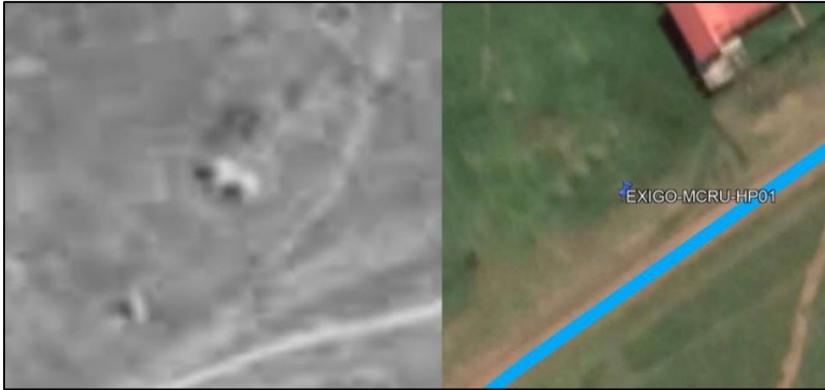
The dilapidated remains of a homestead, consisting out of the foundations of at least 3 huts as well as the partially intact walls of a stone wall enclosure were noted in the KuMbunga area along the road upgrade alignment. Material culture such as glass, metal and plastic occur at the site. An absolute age for the structures could not be ascertained but an analysis of historical aerial photographs indicates that the area

was relatively densely populated during the previous century. According to indications, the homesteads were in use by around 1938 and the structures are probably older than 60 years - and generally protected under the National Heritage Resource Act (NHRA 1999). However, the features are poorly preserved and they are of medium-low significance but a permit for the destruction of the structures is required subject to the NHRA should these sites be impacted on by the proposed road upgrade project.

Figure 5-6: Site EXIGO-MCRU-HP01 indicated on an archive aerial image (1938, left) and current aerial imagery (right).

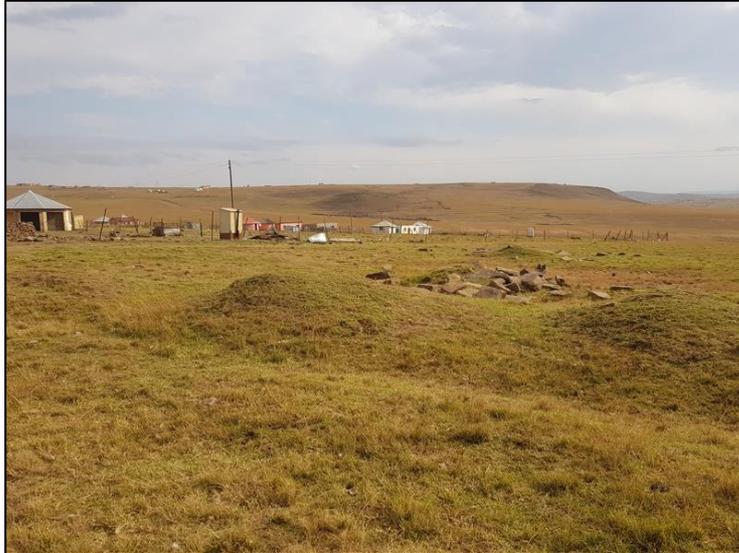
Figure 5-7: View of building foundation remains at Site EXIGO-MCRU-HP01.

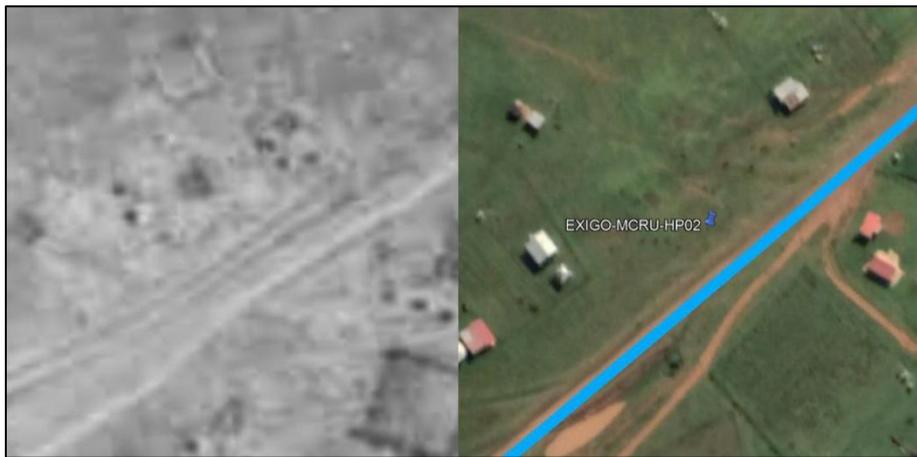
The remains of another homestead, consisting out of the foundations of at least 2 huts was noted in the KuMbanga area along the road upgrade alignment. Material culture such as glass, metal, plastic and a broken lower grindstone occur at the site. An absolute age for the site could not be ascertained but an analysis of historical aerial photographs indicates that the area was relatively densely populated during the previous century. According to indications, the homestead was in use by around 1938 and the structures are probably older than 60 years - and generally protected under the National Heritage Resource Act (NHRA 1999). However, the features are poorly preserved and they are of medium-low significance but a permit for the destruction of the structures is required subject to the NHRA should these sites be impacted on by the proposed road upgrade project.

Figure 5-9: Site EXIGO-MCRU-HP02 indicated on an archive aerial image (1938, left) and current aerial imagery (right).

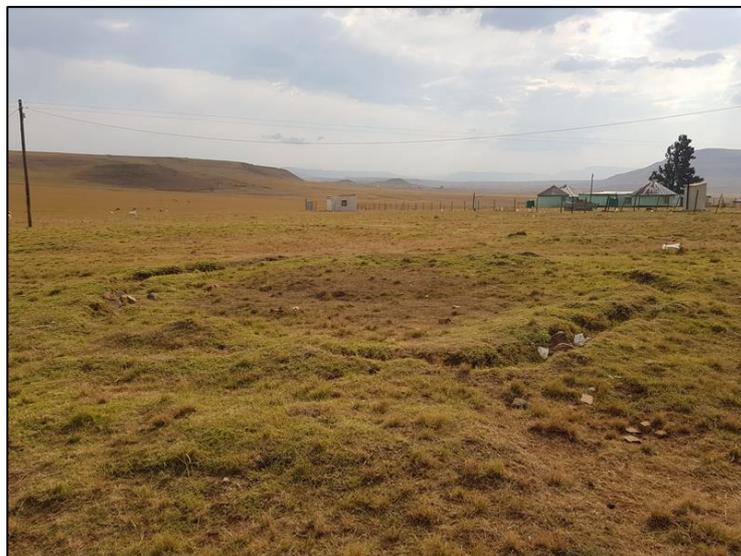
Figure 5-10: View of a hut foundation at Site EXIGO-MCRU-HP02.

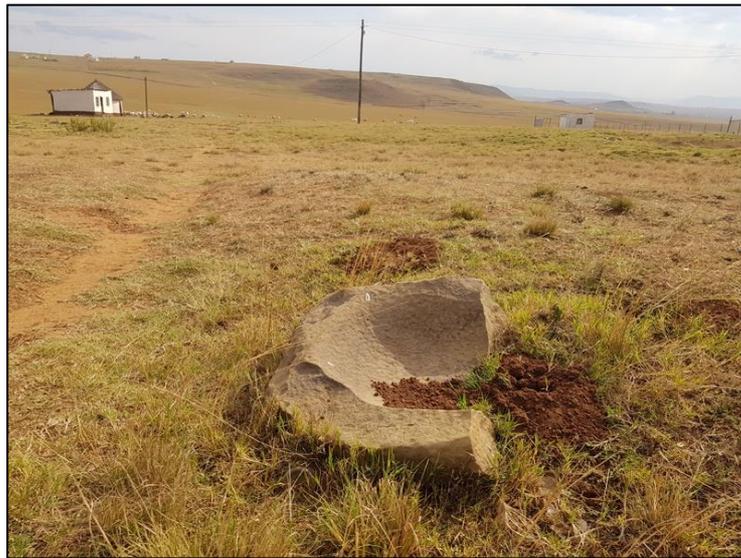
Figure 5-11: View of a broken upper grindstone at Site EXIGO-MCRU-HP02.

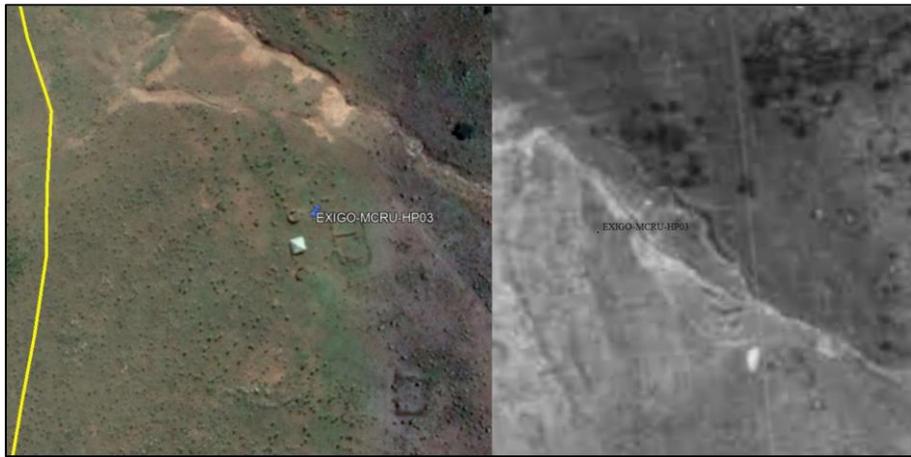
A Historical Period homestead complex consisting of a single room building, hut remains as well as elaborate livestock enclosures occur in the Qulugu area direct east of the proposed quarry site. The square building was constructed out of mud brick with a pitched corrugated iron roof. The building is typical of Historical Period architecture of the rural areas in the Eastern Cape. In addition, a number of square stone wall enclosures occur around the dwelling. The site is visible on archive aerial photographs and it is older than 60 years - and generally protected under the National Heritage Resource Act (NHRA 1999). However, the dwelling does not seem to hold any particular social or historical value and it is of medium-low heritage significance. A permit for the destruction of the structures is required subject to the NHRA should these sites be impacted on by the proposed road upgrade project.

Figure 5-13: Site EXIGO-MCRU-HP03 indicated on an archive aerial image (1938, right) and current aerial imagery (left).

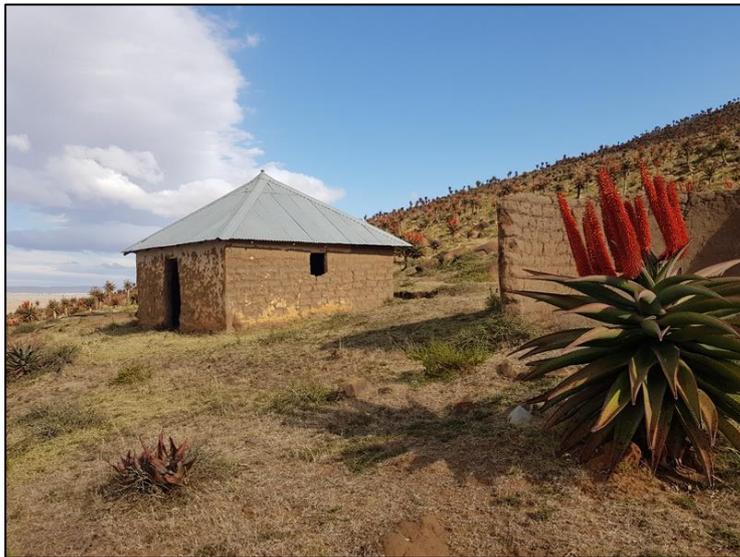
Figure 5-14: View of a mud brick dwelling and hut remains (right) at Site EXIGO-MCRU-HP03.

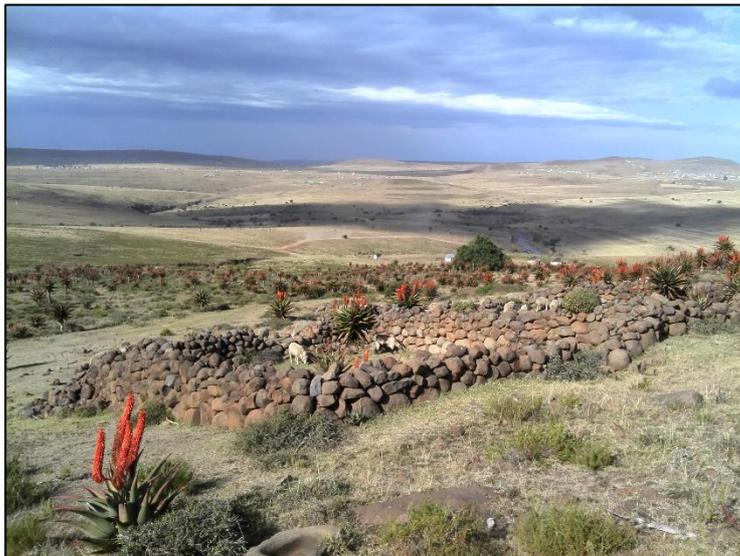
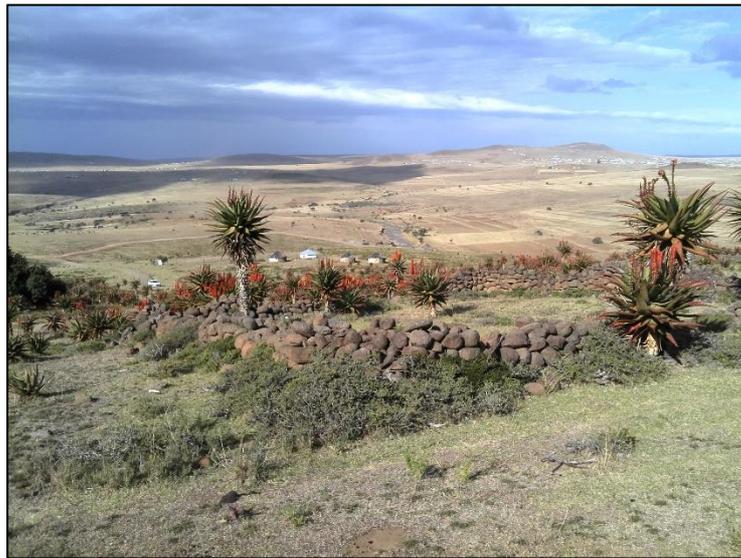
Figure 5-15: View of stone walled livestock enclosures at Site EXIGO-MCRU-HP03.

Figure 5-16: View of stone walled livestock enclosures at Site EXIGO-MCRU-HP03.

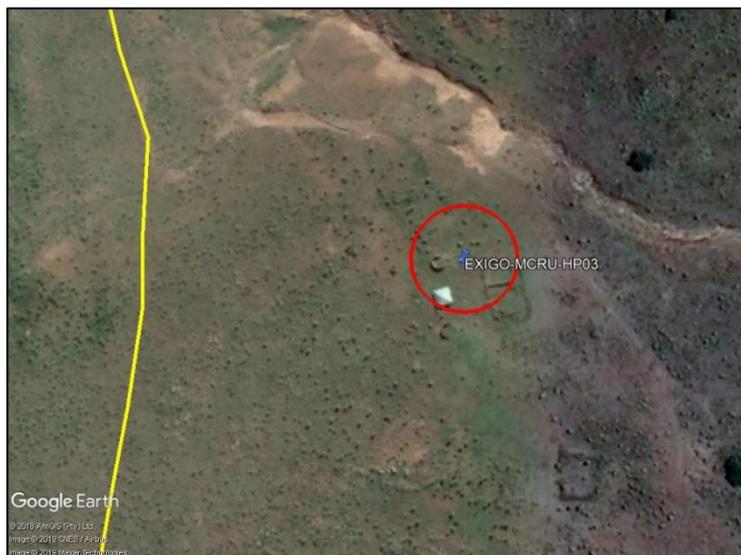
Figure 5-17: Site EXIGO-MCRU- HP03 and a required 20m conservation buffer (red line) in relation to the site proposed for the quarry (yellow line).

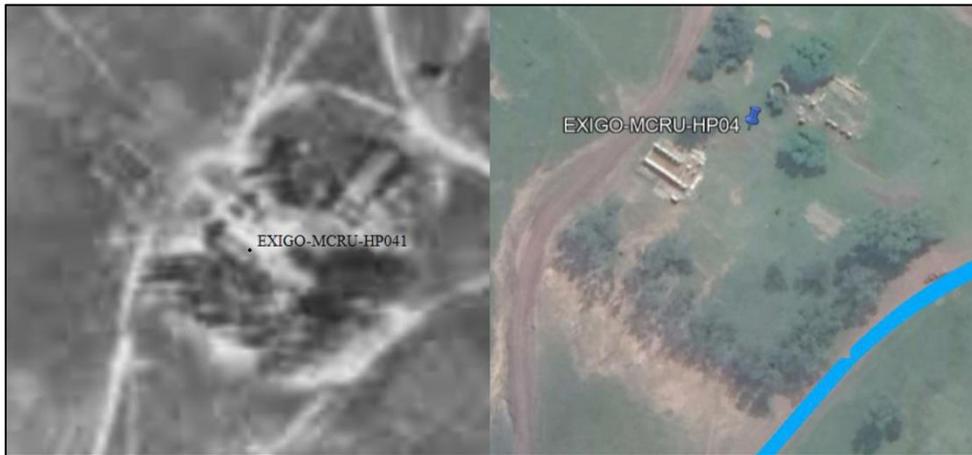
The remains of a compound of Historical Period multi room buildings occur along the road upgrade alignment in the Ntlakwevenkile area. Here, a large multi-room rectangular building once held the Phillipsdale Trading Store and the remains of a sandstone house and a mud brick building occur in its vicinity. An interesting feature at the site is the wall remains of a rondel structure, constructed out of skillfully shaped sandstone blocks. The building remains display typical Historical Period architectural features of the rural areas in the Eastern Cape. The site is visible on archive aerial photographs, it is older than 60 years and generally protected under the National Heritage Resource Act (NHRA 1999). Even though the buildings might afford a better understanding of architectural, settlement and social developments in the Clarkebury landscape, the site is dilapidated and poorly preserved, and it is rated as of medium-low heritage significance. A permit for the destruction of the structures is required subject to the NHRA should these sites be impacted on by the proposed road upgrade.

Figure 5-18: Site EXIGO-MCRU-HP04 indicated on an archive aerial image (1938, left) and current aerial imagery (right).

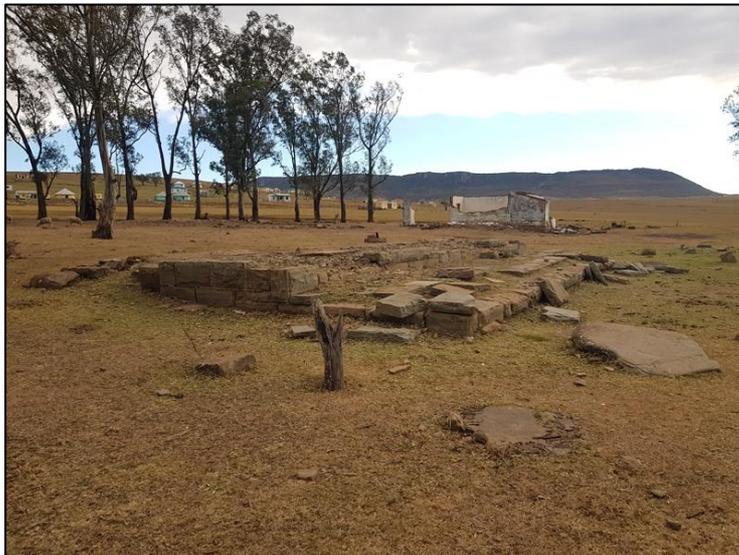
Figure 5-19: View of a sandstone building foundation at Site EXIGO-MCRU-HP04.

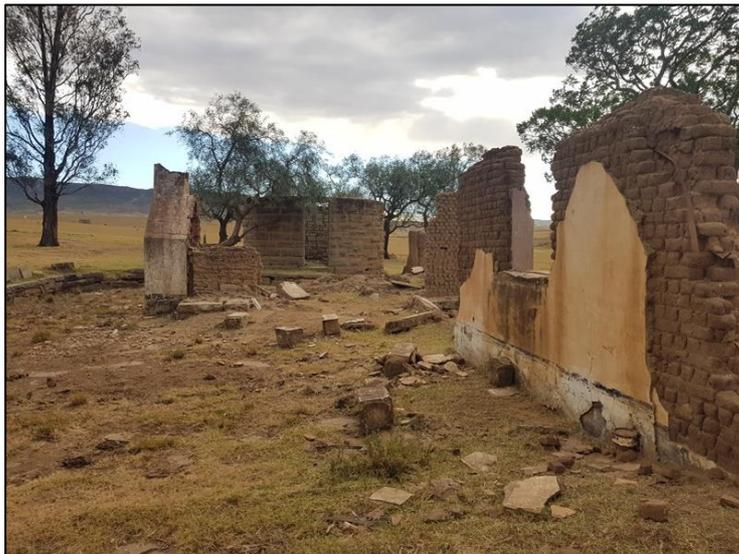
Figure 5-20: View of building remains remains at Site EXIGO-MCRU-HP04. Note the stone rondel in the middle background.

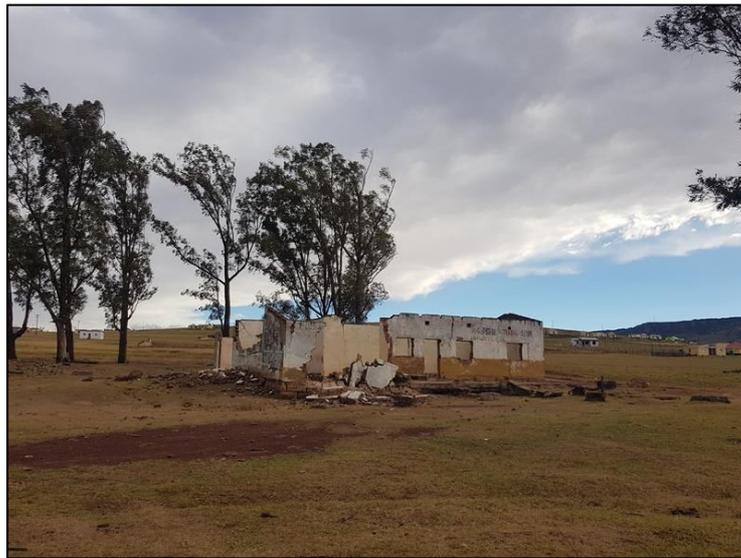
Figure 5-21: View of the remains of the Phillipsdale Trading Store at Site EXIGO-MCRU-HP04.

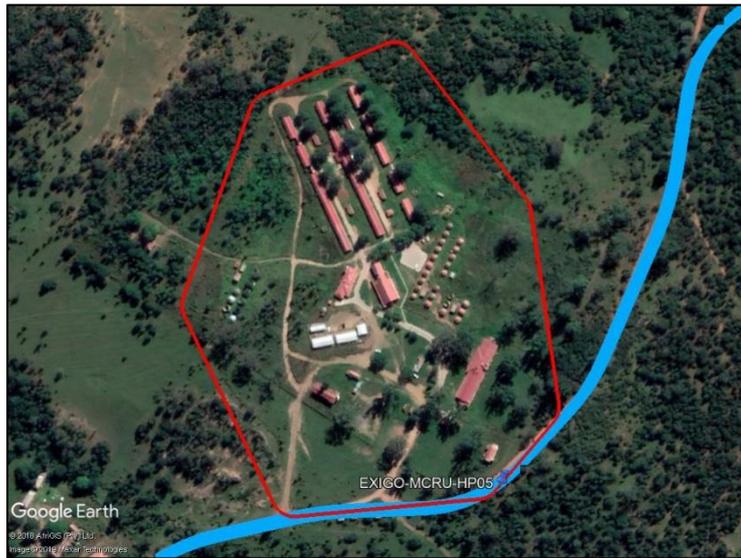
Figure 5-29: Site EXIGO-MCRU-HP05 (Mjanyana Hospital complex) and a required 20m conservation buffer (red line) in relation to the road alignment (blue line).

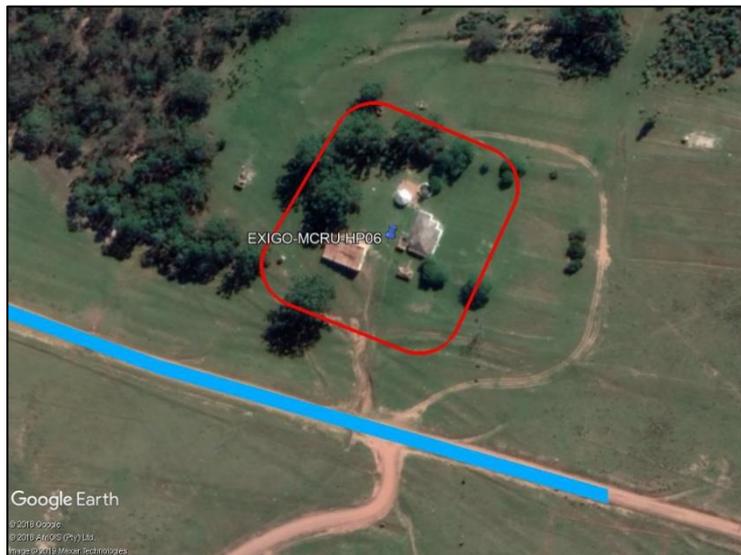
Figure 5-32: The Lookout Trading Store complex and a required 20m conservation buffer (red line) in relation to the road alignment (blue line).

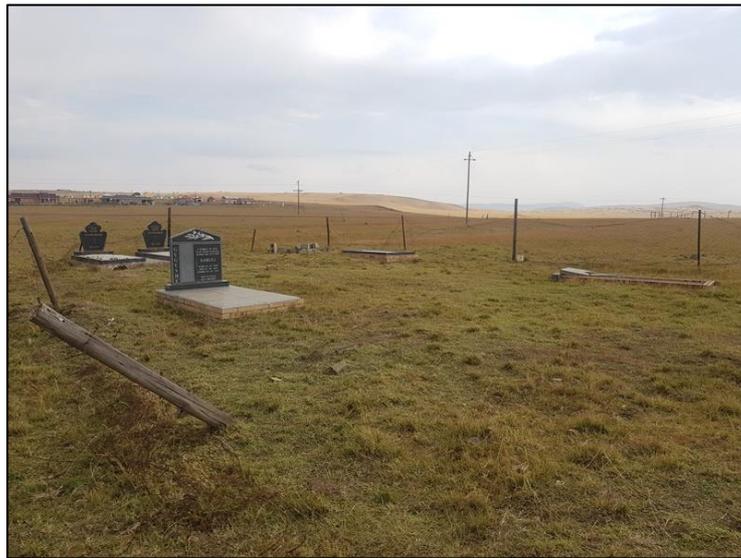
A small cemetery containing at least 7 graves occurs in the KuMbunga area directly east of the DR08034-N2 road. The majority of burials are indicated by concrete and marble stone bases and marked marble headstones. Single graves are indicated by elongated soil mounds which are covered in surface grass and stones. Material culture such as glass and enamel containers were noted in associated with some of the graves. The cemetery is fenced off and the general condition of the graves is good. The burial site is of high heritage significance, it is situated in the general vicinity of the proposed road upgrade route and a conservation buffer of 50m should be observed. Alternatively, the burials should be relocated according to the applicable social and statutory requirements, should impact prove inevitable.

Figure 5-33: View of the burial site at Site EXIGO-MCRU-BP01.

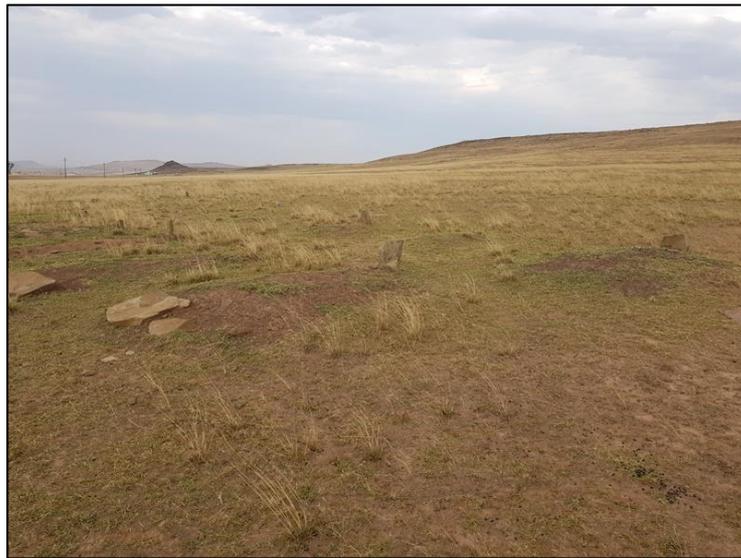
At least 8 graves occur in an open field in the Mtshayelweni area directly south of the existing Clarkebury Road. The burials are indicated by soil mounds and some graves bear unmarked rocks headstones. The site is not fenced and the graves are in a poor state of preservation. The burial site is of high heritage significance, it is situated in close proximity of proposed road upgrade route and a conservation buffer of 50m should be observed. Alternatively, the burials should be relocated according to the applicable social and statutory requirements, should impact prove inevitable.

Figure 5-35: View of the burial site at Site EXIGO-MCRU-BP02.

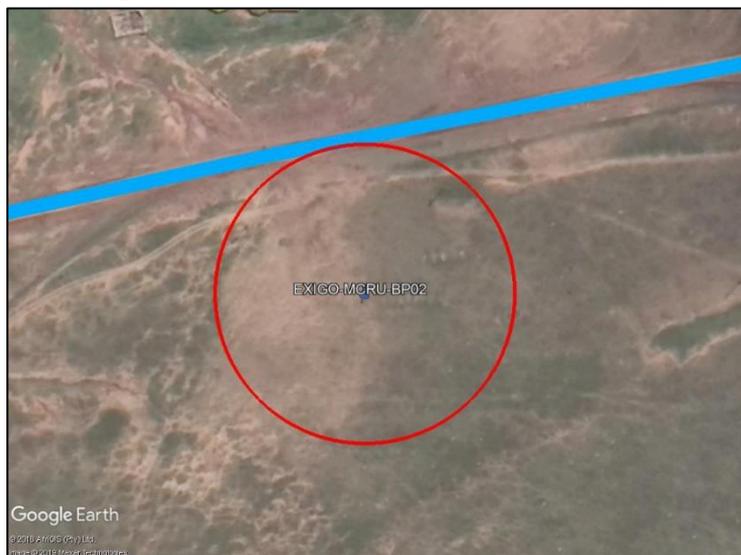
Figure 5-36: Site EXIGO-MCRU-BP02 and a required 50m conservation buffer (red line) in relation to the road alignment (blue line).

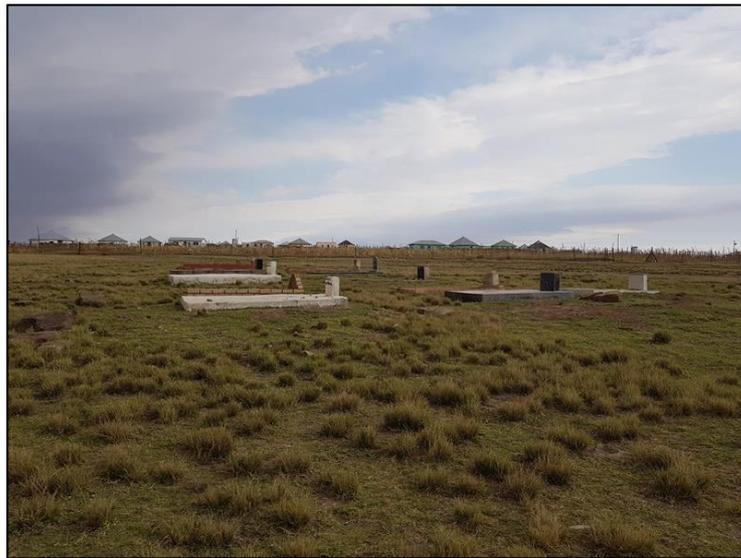
A small cemetery containing at least 7 graves occurs in the Ngqubusini area south of the existing Clarkebury Road. The majority of burials are indicated by concrete slabs and cement headstones. Single graves are indicated by elongated soil mounds which are covered in surface grass and stones. Material culture such as glass and enamel containers were noted in associated with some of the graves. The cemetery is not fenced off but the general condition of the graves is good. The burial site is of high heritage significance, it is situated in the general vicinity of the proposed road upgrade route and a conservation buffer of 50m should be observed. Alternatively, the burials should be relocated according to the applicable social and statutory requirements, should impact prove inevitable.

Figure 5-37: View of the burial site at Site EXIGO-MCRU-BP03.

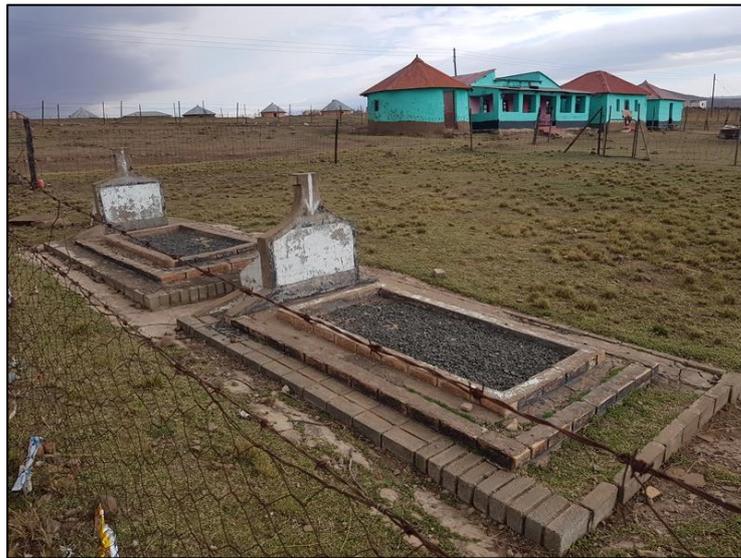
Two graves occur within a homestead complex in the Ngqubusini area south of the existing Clarkebury Road. The burials are covered with brick and filled-in gravel grave dressings bearing cement headstones. The cemetery are fenced off but the general condition of the graves is good. The burial site is of high heritage significance, it is situated in the general vicinity of the proposed road upgrade route and a conservation buffer of 50m should be observed. Alternatively, the burials should be relocated according to the applicable social and statutory requirements, should impact prove inevitable.

Figure 5-39: View of the burial site at Site EXIGO-MCRU-BP04.

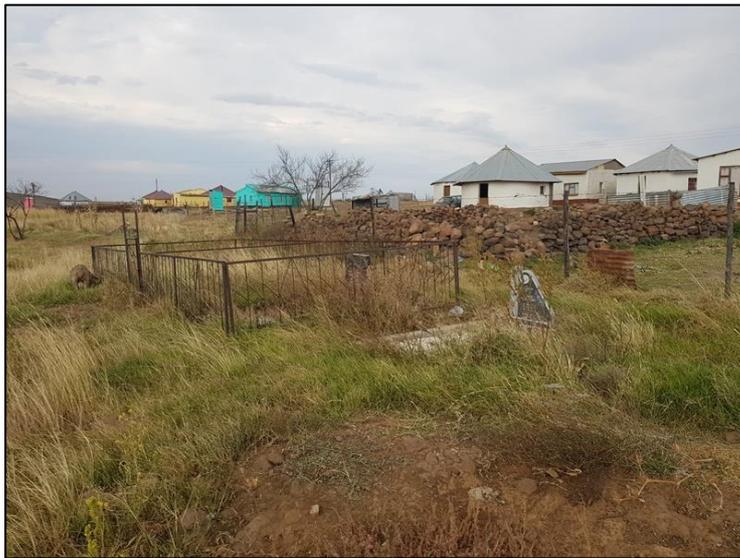
A small cemetery containing at least 5 graves occurs next to a homestead in the Ngqubusini area south of the existing Clarkebury Road. The majority of burials are indicated by concrete slabs and marked marble headstones. Single graves are indicated by elongated soil mounds which are covered in surface grass and stones. Some of the graves are individually fenced off with cast iron fences and the general condition of the graves, which are partially obstructed by surface vegetation, is good. The burial site is of high heritage significance, it is situated in the general vicinity of the proposed road upgrade route and a conservation buffer of 50m should be observed. Alternatively, the burials should be relocated according to the applicable social and statutory requirements, should impact prove inevitable.

Figure 5-41: View of the burial site at Site EXIGO-MCRU-BP05.

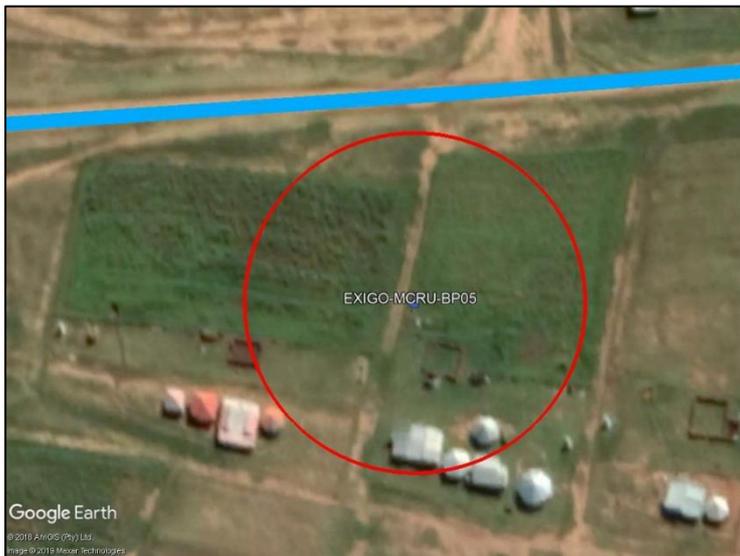
Figure 5-42: Site EXIGO-MCRU-BP05 and a required 50m conservation buffer (red line) in relation to the road alignment (blue line).

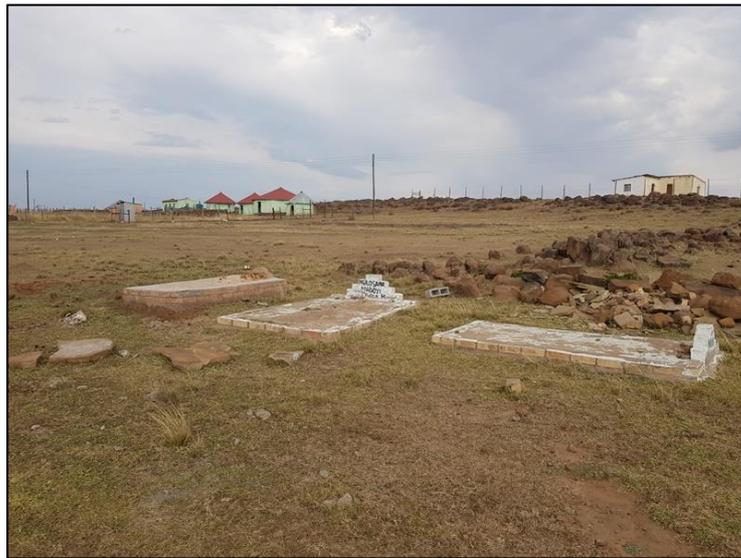
Three graves occur in an open field in the Ngqubusini area directly south of the existing Clarkebury Road. The burials are indicated by concrete and brick slabs and brick headstones. The graves are not fenced off but they are generally well preserved. The burial site is of high heritage significance, it is situated in the close proximity of the proposed road upgrade route and a conservation buffer of 50m should be observed. Alternatively, the burials should be relocated according to the applicable social and statutory requirements, should impact prove inevitable.

Figure 5-43: View of the burial site at Site EXIGO-MCRU-BP06.

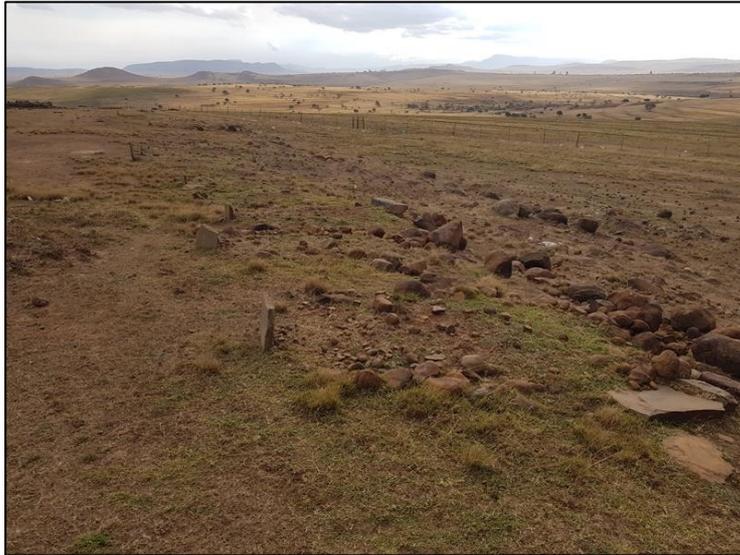
A large community cemetery containing an unknown number of graves occurs in the Ngqubusini area directly north of the existing Clarkebury Road. The majority of burials are indicated by elongated soil mounds and stone cairns which are covered in surface grass and stones. Some burials bear hand-carved headstones and a date of “1898” (?) were noted on one of the headstones. As such, it might be assumed that many of the burials in the cemetery date to the Historical Period. Material culture such as glass and enamel containers were noted in associated with some of the graves. The cemetery is not fenced off but the general condition of the graves is poor. The burial site is of high heritage significance, it is situated in close proximity vicinity of the proposed road upgrade route and a conservation buffer of 50m should be observed. Alternatively, the burials should be relocated according to the applicable social and statutory requirements, should impact prove inevitable.

Figure 5-45: View of the burial site at Site EXIGO-MCRU-BP07.

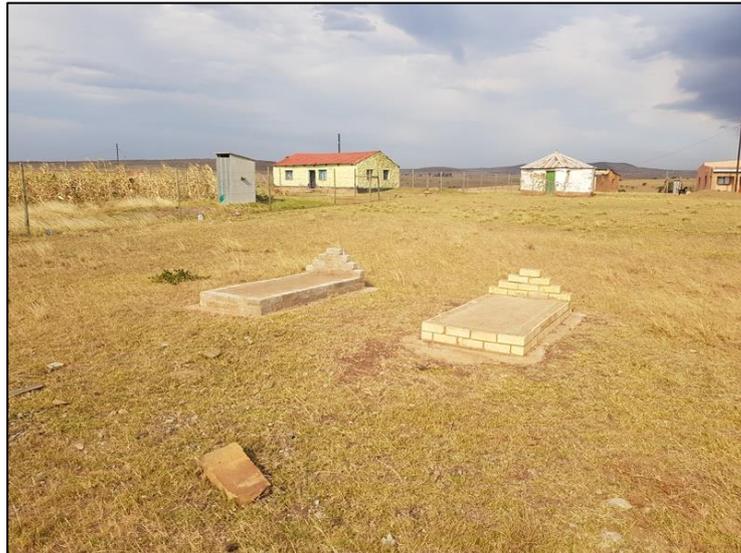
Two graves occur in an open field in the Luqolweni area south of the existing Clarkebury Road. The burials are indicated by concrete and brick slabs and brick headstones. The graves are not fenced off but they are generally well preserved. The burial site is of high heritage significance, it is situated in the close proximity of the proposed road upgrade route and a conservation buffer of 50m should be observed. Alternatively, the burials should be relocated according to the applicable social and statutory requirements, should impact prove inevitable.

Figure 5-48: View of the burial site at Site EXIGO-MCRU-BP08.

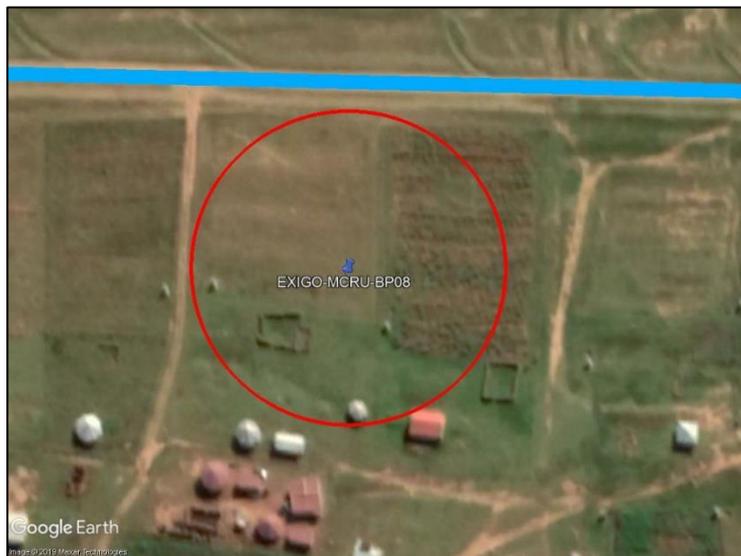
Figure 5-49: Site EXIGO-MCRU-BP08 and a required 50m conservation buffer (red line) in relation to the road alignment (blue line).
