**APPENDIX C1 -
AQUATIC IMPACT ASSESSMENT**

**N1 Section 16 Zandkraal (km33.8) to Winburg South (km78.0) upgrade in the
Free State Province**

AQUATIC IMPACT ASSESSMENT

16 November 2020

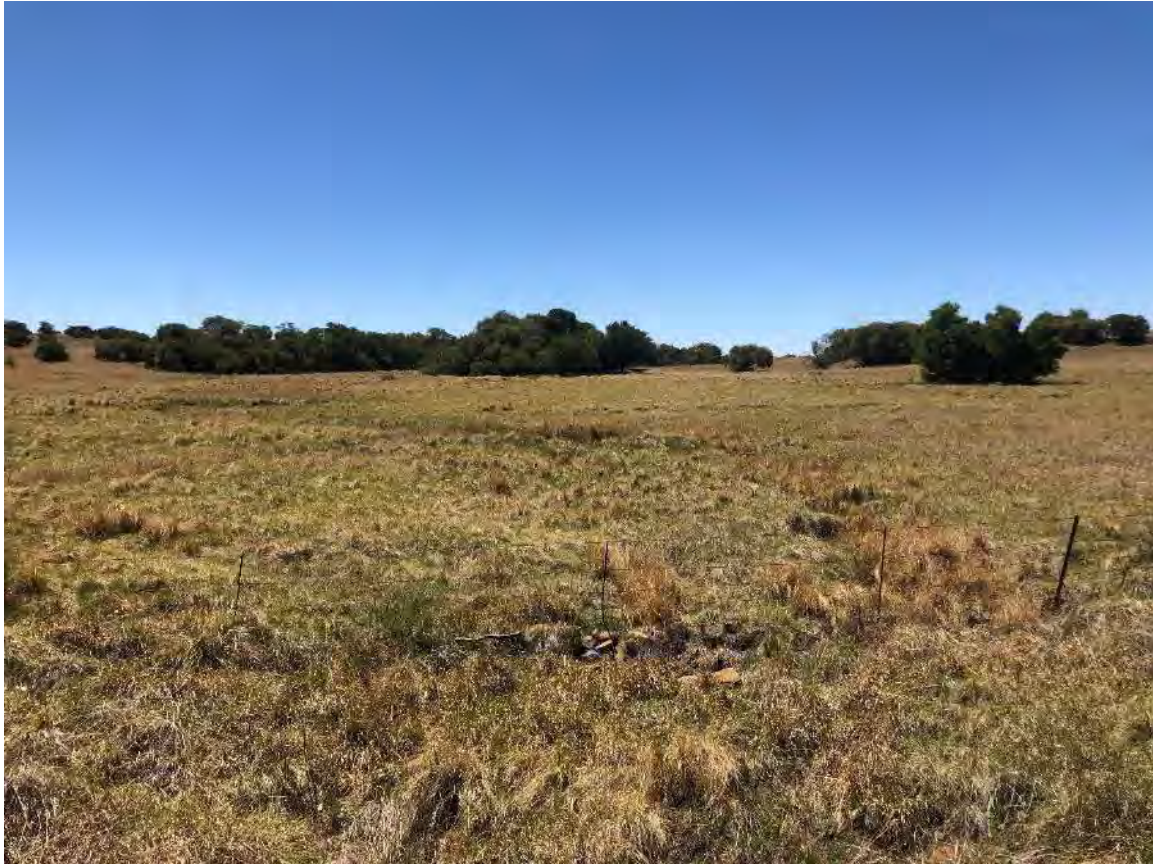
Plate 1: A view of a drainage line near BP77.7 showing no real aquatic features but will contain flow during high rainfall periods

1. Small drainage lines and water courses with no obligate wetland or riparian elements (Plate 1)
2. Mainstem streams and rivers with riverine wetland (*Typha capensis* / *Phragmites australis* reedbeds) (Plate 2). Some of the larger systems also contained relic channels similar to oxbow areas that also contained wetland elements (*Phragmites australis*, *Isolepis spp*, *Juncus spp*) (Plate 3)
3. Mainstem stream and rivers with no wetland elements thus containing riparian elements only. The riparian systems were dominated by various *Searsia* or Karee species, which included *Searsia erosa*, *S. lancea*, *S. pyroides*, *Salix babylonica* (Plate 4)
4. Small endorheic pans / depression wetlands (Plate 5) associated with the eastern edge of the Free State Panfield Complex (Holmes, 2015).

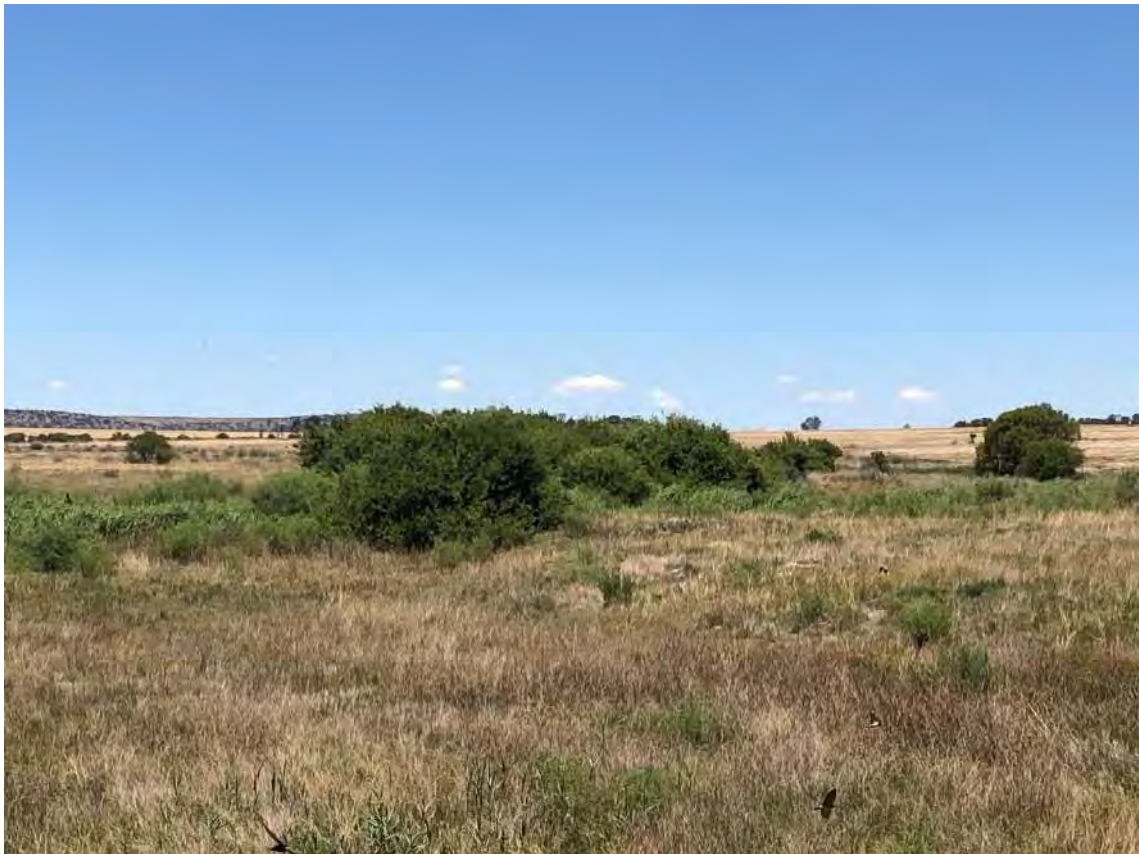
Plate 2: A watercourse with Reedbed (*Phragmites australis*) wetland, however none of these are located within 500m of any of the proposed sites

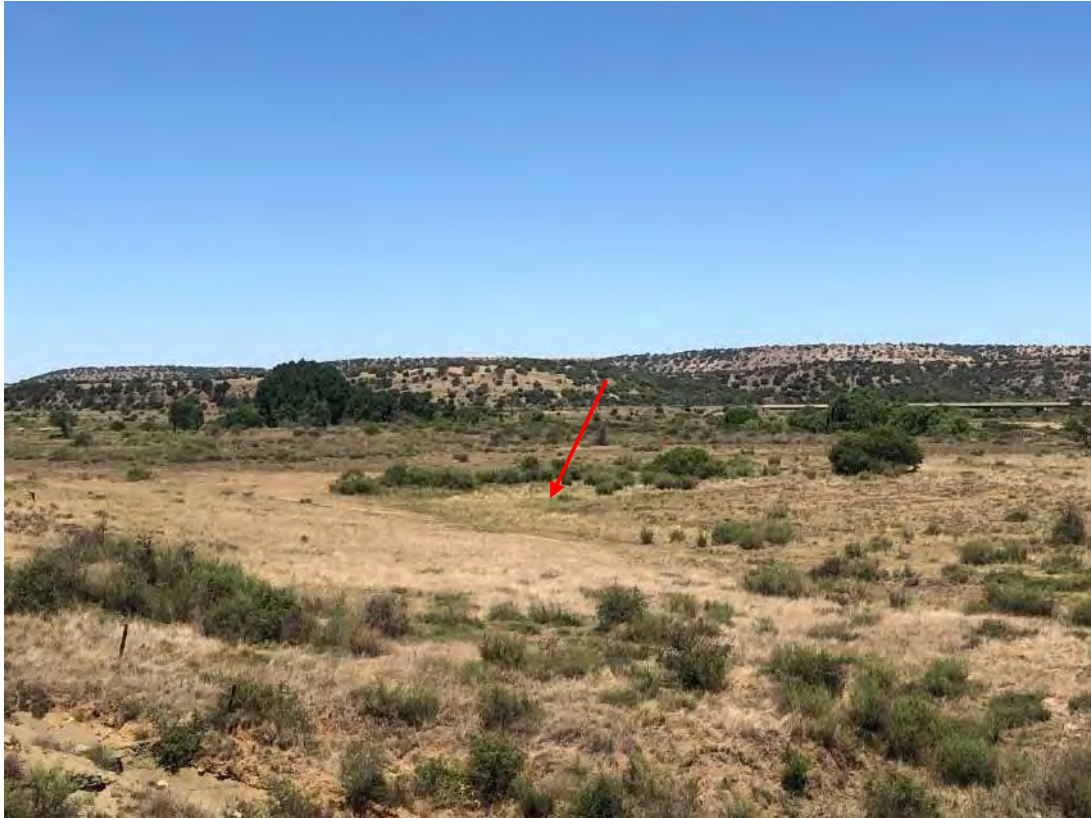
Plate 3: The oxbow channel (arrow) associated with the Groot Vet River

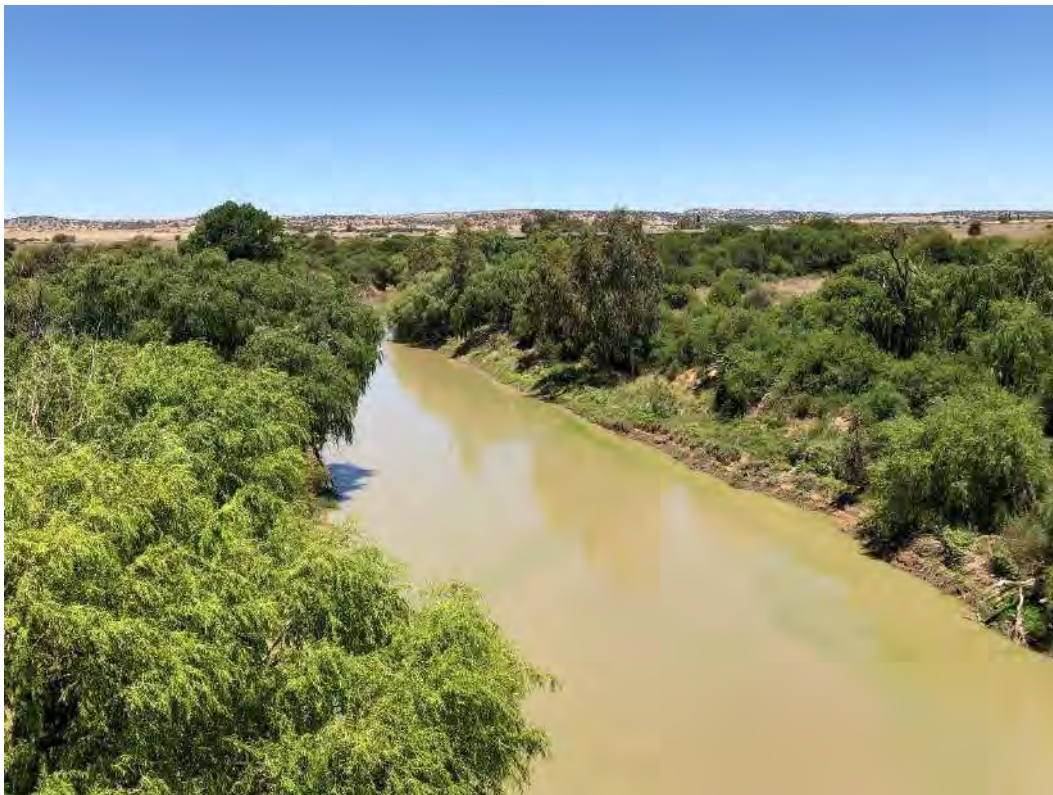
Plate 4: The Groot Vet River, - riparian system dominated by invasive Willows, with no wetland elements

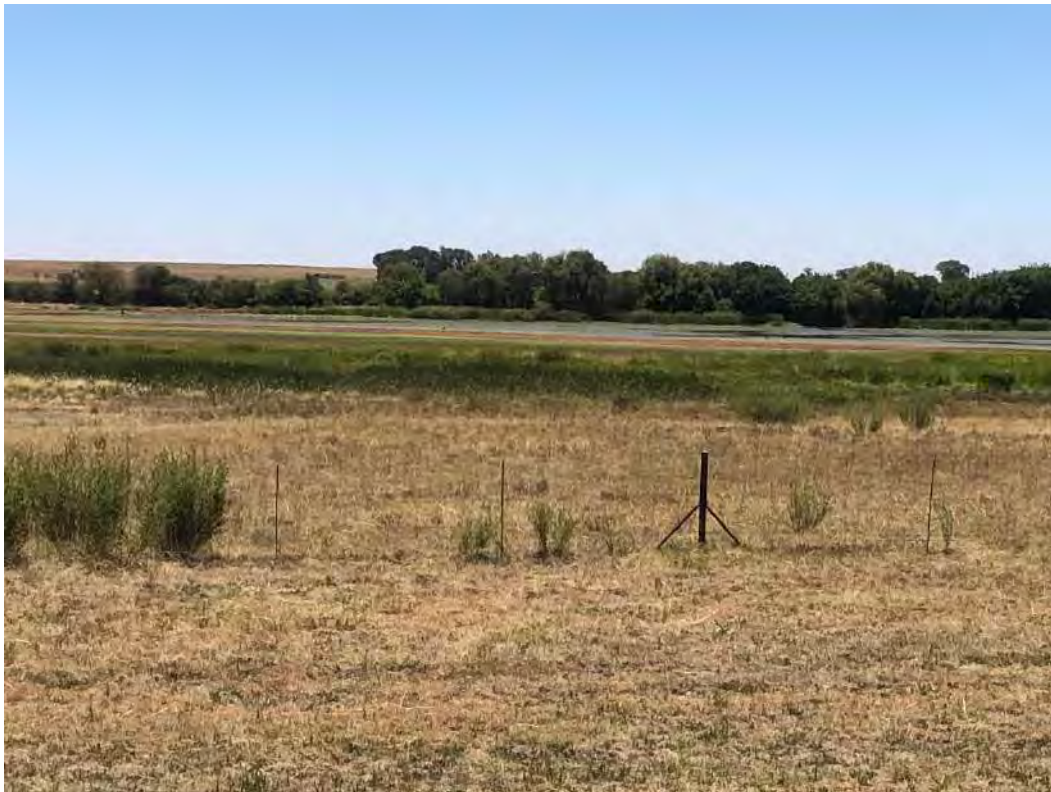
Plate 5: One of the larger pans in the region that has been transformed into a dam 800m from BP44.6

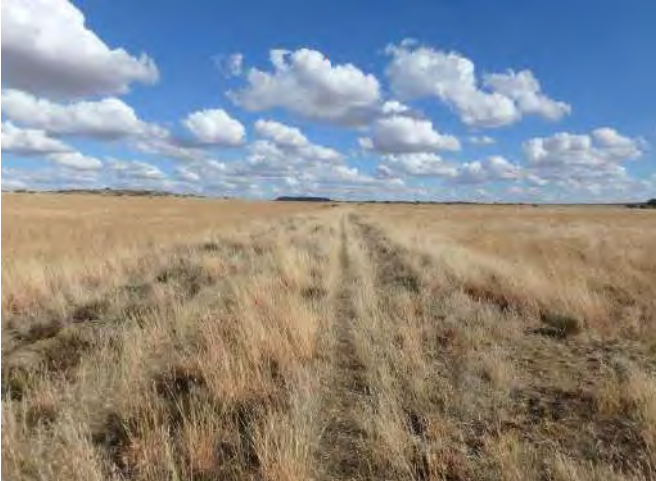
BORROW PIT/QUARRY NAME	DESCRIPTION	PHOTOGRAPH
<p>BP 39.6</p>	<p>The site occurs on a flat area consisting of natural grassland dominated by <i>Themeda triandra</i>. No SCC were observed.</p> <p>An artificial wetland/dam is located 500m to the south of the site boundary.</p>

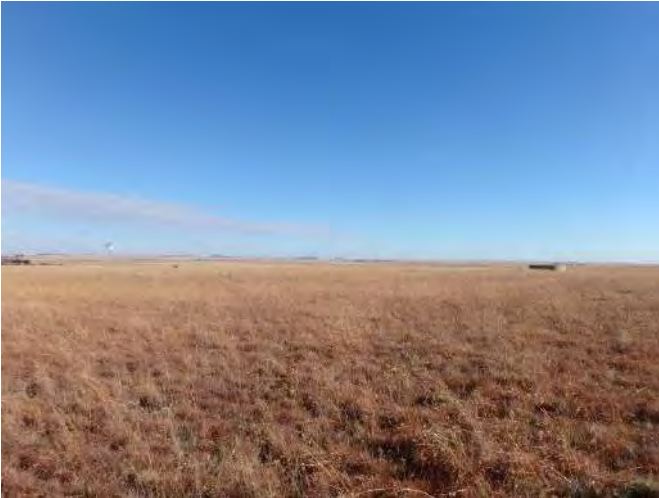
BORROW PIT/QUARRY NAME	DESCRIPTION	PHOTOGRAPH
BP42.2	<p>The site occurs on a flat area consisting of natural grassland dominated by <i>Themeda triandra</i>. No SCC were observed.</p> <p>Grasses appeared to be short and may imply recent grazing. This is the only mining site that occurs within 500m of a natural wetland. The wetland is located 240m to the east of the site boundary.</p>

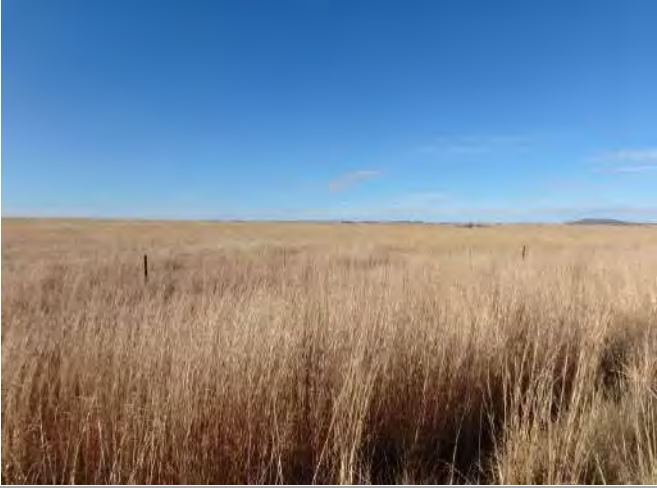
BORROW PIT/QUARRY NAME	DESCRIPTION	PHOTOGRAPH
BP 42.7	<p>The site occurs on a flat area consisting of natural grassland dominated by <i>Themeda triandra</i>. No SCC were observed.</p> <p>The site appears to be completely unimpacted by grazing and contains fully grown grasses.</p>

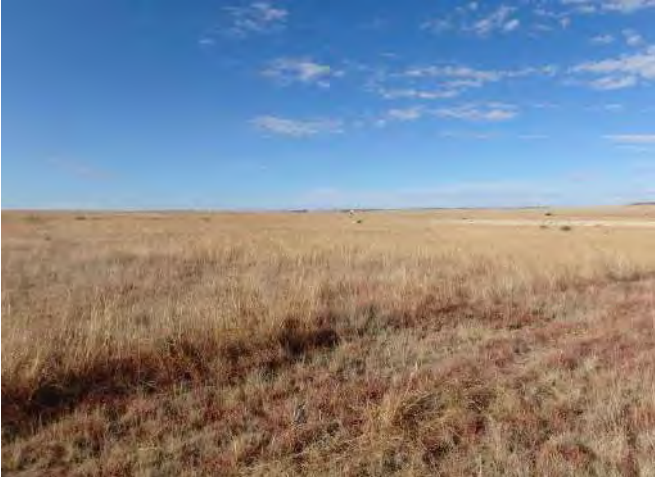
BORROW PIT/QUARRY NAME	DESCRIPTION	PHOTOGRAPH
<p>BP 44.5</p>	<p>The site occurs on a flat area consisting of natural grassland dominated by <i>Themeda triandra</i>. No SCC were observed.</p> <p>An artificial dam is located approx. 216m to the northwest of the site boundary. The N1 forms the northern boundary of the site and is also located between the noted artificial dam and the mining site.</p>

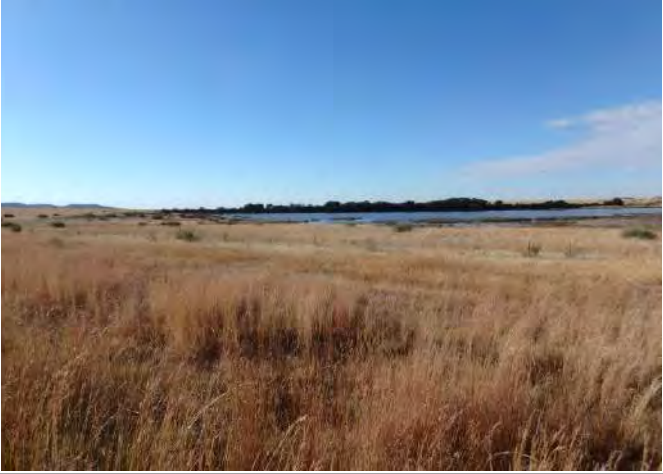
<p>BP 44.6</p>	<p>The site occurs on a flat area consisting of natural grassland dominated by <i>Themeda triandra</i>. No SCC were observed.</p> <p>An artificial dam is located approx. 40m to the west of the site boundary. Small <i>Acacia karroo</i> shrubs are scattered near the dam.</p>

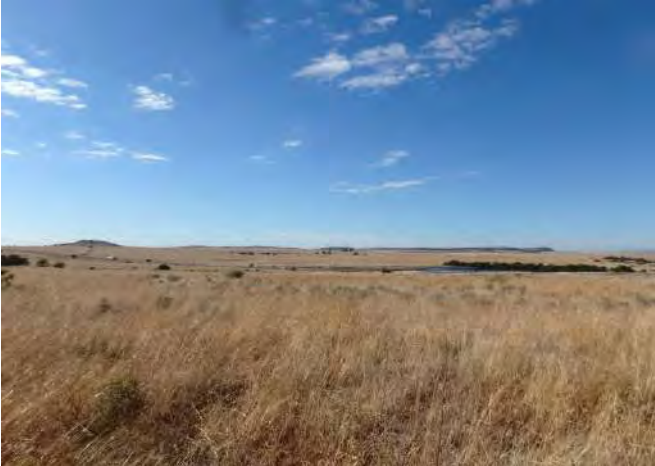
BORROW PIT/QUARRY NAME	DESCRIPTION	PHOTOGRAPH
<p>Q 50.6</p>	<p>The site is an existing quarry and will be expanded to more than double its existing size.</p> <p>The site occurs on a flat area consisting of natural grassland dominated by <i>Themeda triandra</i>. No SCC were observed.</p> <p>Small <i>Acacia karroo</i> shrubs and trees are scattered near the proposed stockpile area.</p>

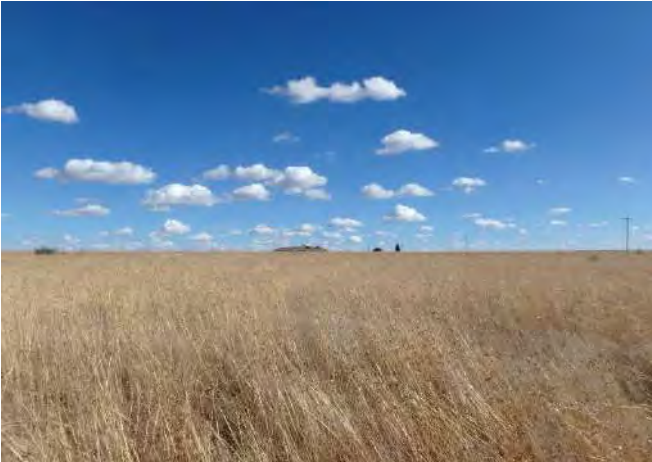
BORROW PIT/QUARRY NAME	DESCRIPTION	PHOTOGRAPH
BP 51.0	<p>The site occurs on a flat area consisting of natural grassland dominated by <i>Themeda triandra</i>. No SCC were observed.</p> <p>An artificial wetland/dam is located 450m to the west of the site boundary.</p>

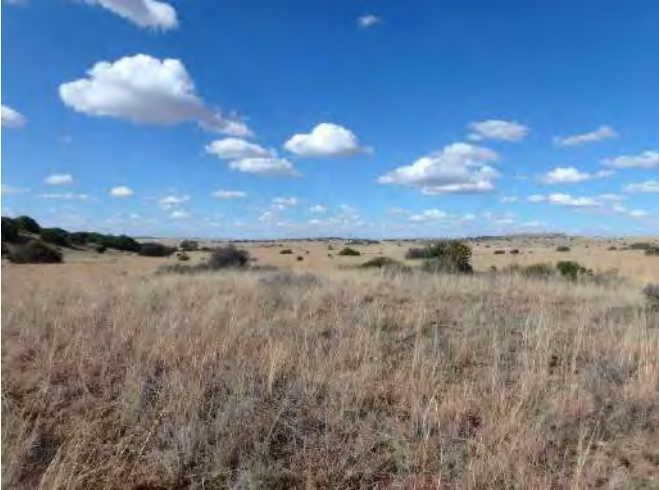
BORROW PIT/QUARRY NAME	DESCRIPTION	PHOTOGRAPH
<p>BP 52.8</p>	<p>The site consists of 2 portions which are located near a rocky outcrop containing scattered <i>Acacia karroo</i> trees and shrubs interspersed with <i>Themeda triandra</i> grasses. A large portion of the site is located on a flat plan surrounding the outcrop.</p> <p>A drainage system is located 170m to the east of the site boundary but no surface water were observed. a small artificial wetland/dam is also located 270m to the west of the site boundary. No SCC were observed on site.</p>

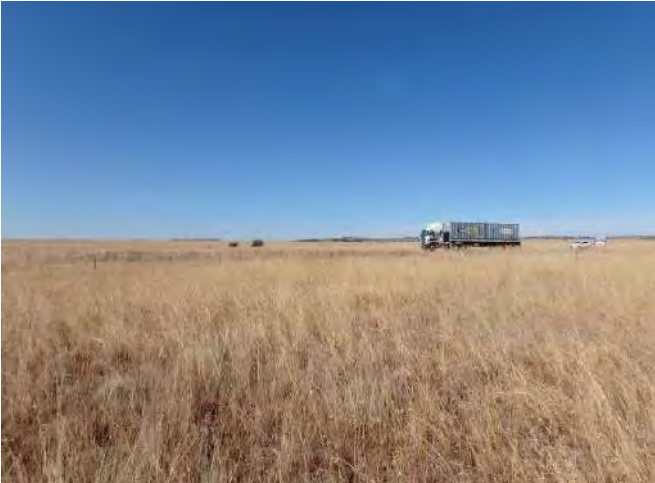
BORROW PIT/QUARRY NAME	DESCRIPTION	PHOTOGRAPH
<p>BP 56.3</p>	<p>The site occurs on a flat area consisting of natural grassland dominated by <i>Themeda triandra</i>. No SCC were observed.</p> <p>An artificial wetland/dam is located 150m to the west of the site boundary.</p>

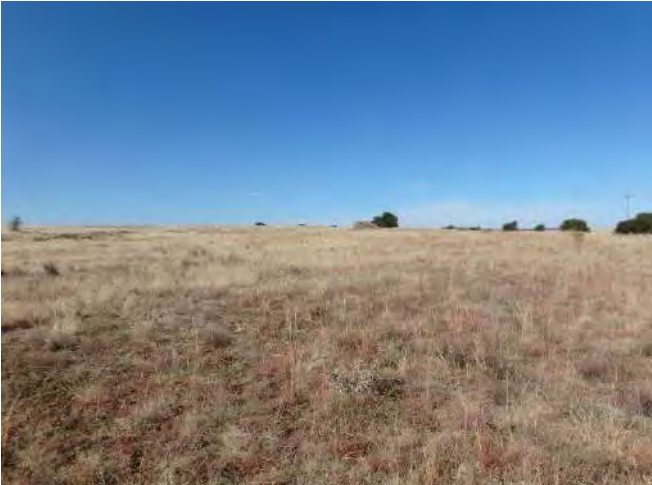
BORROW PIT/QUARRY NAME	DESCRIPTION	PHOTOGRAPH
<p>BP 57.9</p>	<p>The site occurs on a flat area consisting of natural grassland dominated by <i>Themeda triandra</i> and scattered <i>Acacia karroo</i> trees. No SCC were observed.</p> <p>An artificial wetland/dam is located 100m to north of the site boundary. A gravel road forms the western boundary of the site.</p>

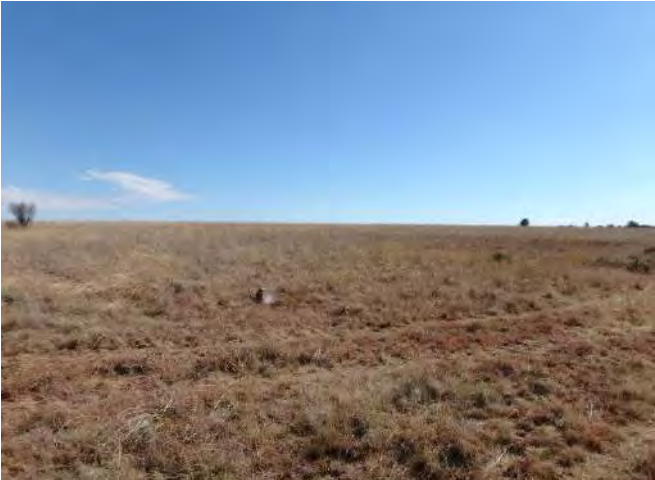
BORROW PIT/QUARRY NAME	DESCRIPTION	PHOTOGRAPH
<p>BP 64.2</p>	<p>The site occurs on a flat area consisting of natural grassland dominated by <i>Themeda triandra</i> and scattered <i>Acacia karroo</i> trees. No SCC were observed.</p> <p>A small farm dam is located in the centre of the site. the dam was dry during the site visit. The Groot-Vet River lays a 100m to the east of the site boundary.</p>

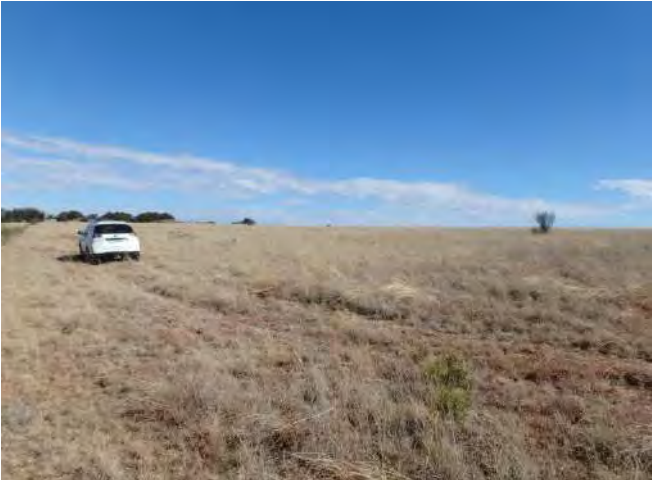
BORROW PIT/QUARRY NAME	DESCRIPTION	PHOTOGRAPH
<p>BP 67.3</p>	<p>The site consists of 2 portions that occur on a flat area consisting of natural grassland dominated by <i>Themeda triandra</i> and scattered <i>Acacia karroo</i> trees. No SCC were observed.</p> <p>No water features will be impacted.</p>

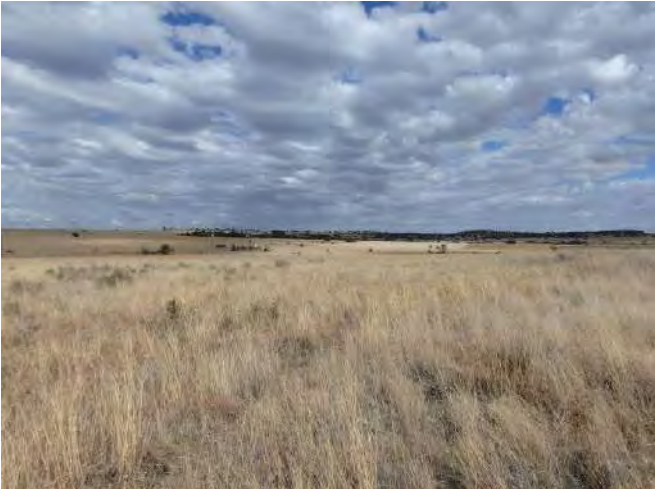
BORROW PIT/QUARRY NAME	DESCRIPTION	PHOTOGRAPH
<p>BP 72.4</p>	<p>The site occurs on a flat area consisting of natural grassland dominated by <i>Themeda triandra</i>. No SCC were observed.</p> <p>An artificial wetland/dam is located about 250m to the southwest of the site boundary.</p>

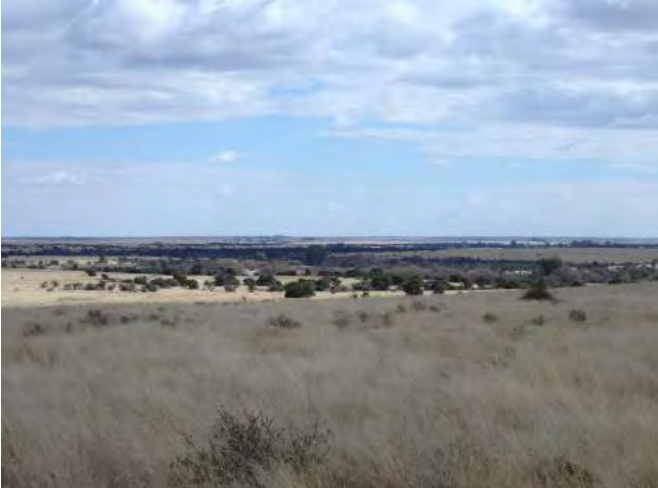
BORROW PIT/QUARRY NAME	DESCRIPTION	PHOTOGRAPH
<p>BP 72.7</p>	<p>The site occurs on a flat area consisting of natural grassland dominated by <i>Themeda triandra</i> and scattered <i>Acacia karroo</i> trees. No SCC were observed.</p> <p>An artificial wetland/dam is located 320m to the southwest of the site boundary.</p>

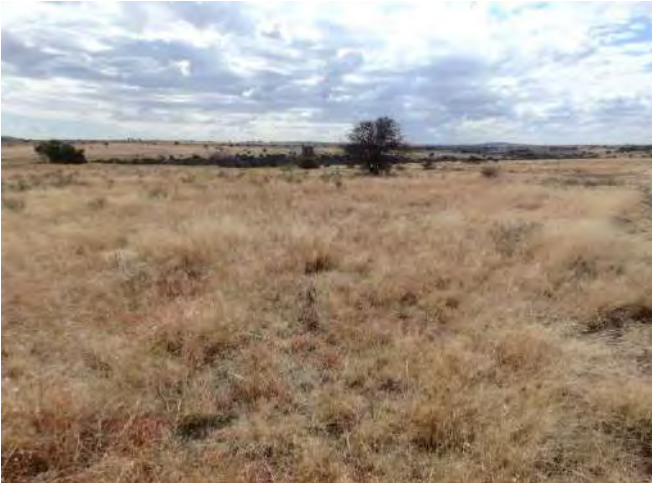
BORROW PIT/QUARRY NAME	DESCRIPTION	PHOTOGRAPH
BP 73.8	<p>The site consist of 2 portions that occur on a flat area consisting of natural grassland dominated by <i>Themeda triandra</i> and scattered <i>Acacia karroo</i> trees. No SCC were observed.</p> <p>No water features will be impacted.</p>

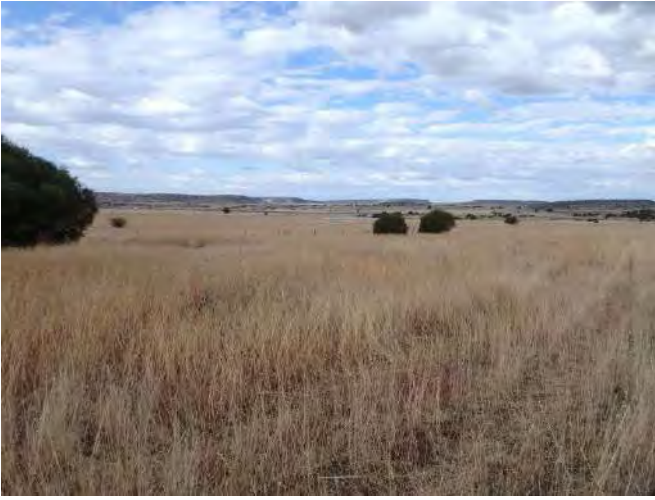
BORROW PIT/QUARRY NAME	DESCRIPTION	PHOTOGRAPH
<p>BP 77.7</p>	<p>The site occurs on a flat area consisting of natural grassland consisting of predominantly <i>Themeda triandra</i>. Other species like <i>Eragrostis curvula</i> were also observed. Scattered trees occur ranging between <i>Acacia karroo</i>, <i>Olea eoropaea</i> and <i>Gymnosporia buxifolia</i> species. No SCC were observed.</p> <p>An artificial wetland/dam is located 370m to the east of the site boundary.</p>

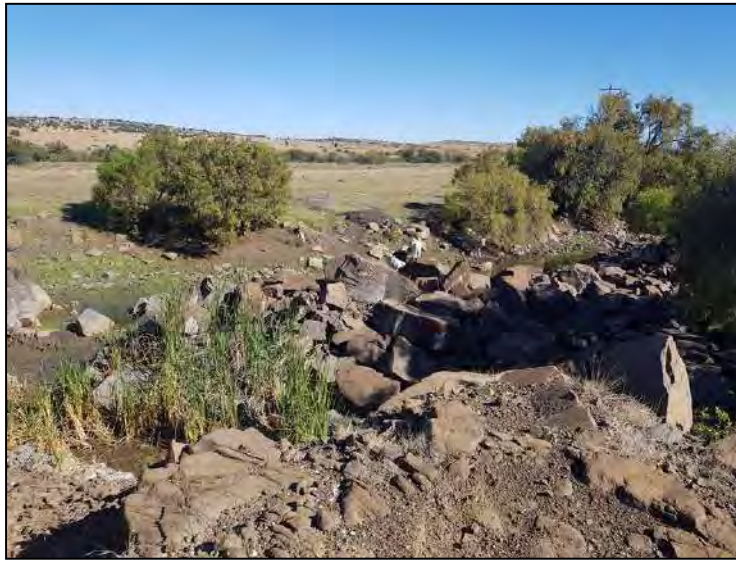
Figure 2-3: View of an existing quarry at Q1 on the farm Rietfontein.

The farm is situated just south of the Winburg/Brandfort interchange approximately 200m east of km 77.7. The farm is situated east of the R703 and approximately 1.9 km perpendicular from km 72.6 of the N1-16. An existing quarry was un-rehabilitated and left approximately 3m deep. The area is sparsely grassed and can be described as typical Free State grasslands with regular outcrops of. Shrubs and bushes and scattered trees are also visible. The quarry was previously used for a previous road construction project.

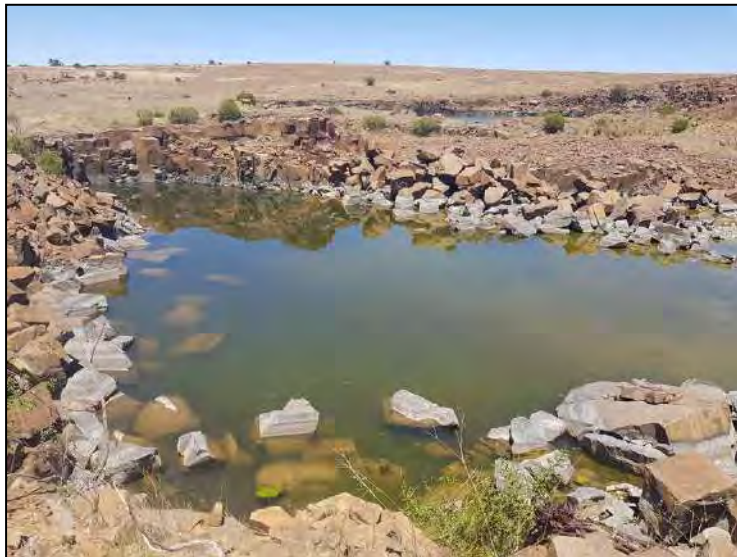
Figure 2-6: View of an existing quarry at Q2 on the farm Grisella.

The farm is located north of the Monte Video/Kromdraai intersection. The proposed quarry is approximately 500m west of the N1. A large quarry area was partially rehabilitated and a vast and deep digging site had been fenced off previously. The area inclines to the west where rock surfaces and faces occur along the area of the proposed quarry. To the east the area is grassed and can be described as typical Free State grasslands with regular outcrops of dolerite on the ridge side of the borrow pit. Shrubs and bushes and scattered trees are also visible. The quarry was previously used for a previous road construction project.

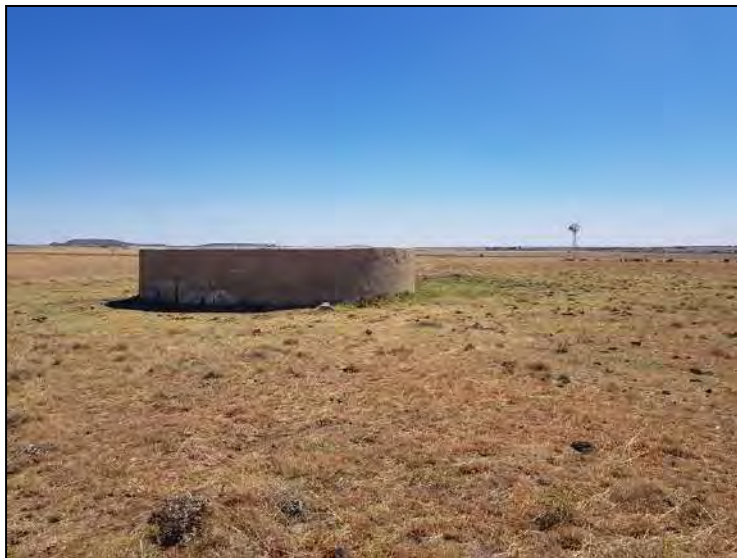
Figure 2-12: View of a concrete dam at BP 42.7 on the farm Die Pan.

The farm is located just north of the Verkeerdevlei/Brandfort intersection. The borrow pit borders the N1 road reserve on the eastern side. The portion of the farm is untouched and lies in its natural state. The area is grassed and can be described as typical Free State grasslands. The portion of the farm is currently used as a grazing camp for cattle with a concrete dam present. There is no established or previously used borrow pit on the portion of the farm.

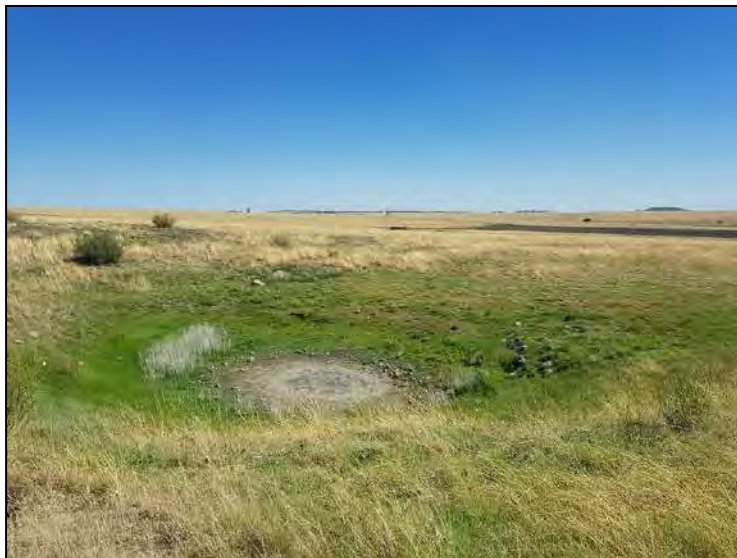
Figure 2-14: View of an existing burrow pit at BP 44.5 on Graspan.

The farm is located north of the Verkeerdevlei/Brandfort intersection. The proposed borrow pit borders the N1 road reserve on the western side. The portion of the farm is currently used as a grazing camp for cattle. A small overgrown borrow pit is present on this part of the farm. The existing borrow pit was last utilized in the 1970's and have been fully rehabilitated. The area is grassed and can be described as typical Free State grasslands.

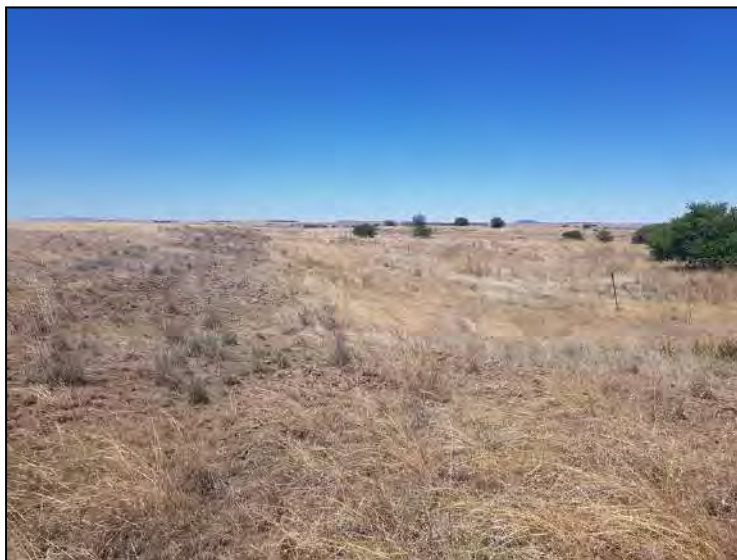
Figure 2-18: View of an old burrow pit on Tweefontein.

The farm is located north of the Monte Video/Kromdraai intersection. The proposed borrow pit is approximately 1 km south-east from the N1. The portion of the farm is currently used as a grazing camp for cattle. A previously used borrow pit is visible on the south-western side of the area. The majority of the area is untouched and lies in its natural state. Previous excavations were visible on the western side of the source. The area is grassed and can be described as typical Free State grasslands with regular outcrops of dolerite on the ridge side of the borrow pit.

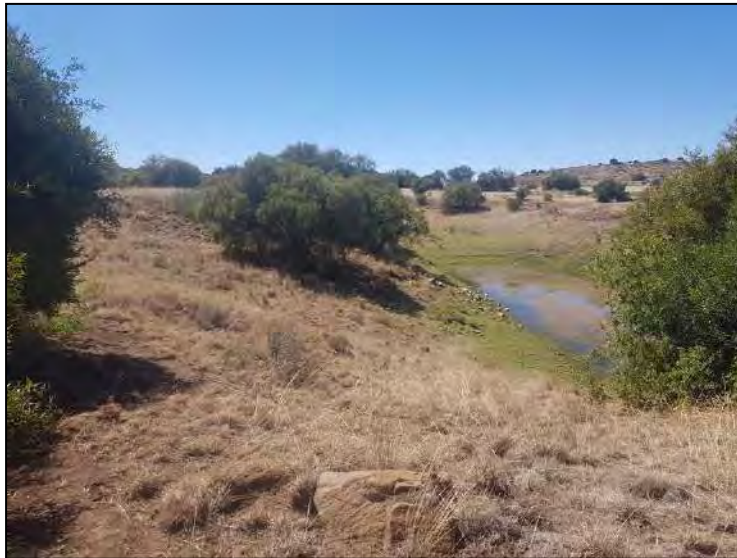
Figure 2-19: View of an old burrow pit at BP 52.8 on the farm Helpman.

The farm is located south of the Candy/Joséphinesdal intersection. The existing borrow pit borders the N1 on the western side. The portion of land is not currently utilised by the owner. A large portion is presently covered densely with typical Free State red grass. A large area of the proposed borrow pit still remains untouched and in its natural state. The existing borrow pit was not rehabilitated and construction waste like concrete and old pipes were spoiled in the borrow pit. The western portion of the borrow pit is moderately covered with Karee trees and the remaining area can be described as typical Free State grasslands.

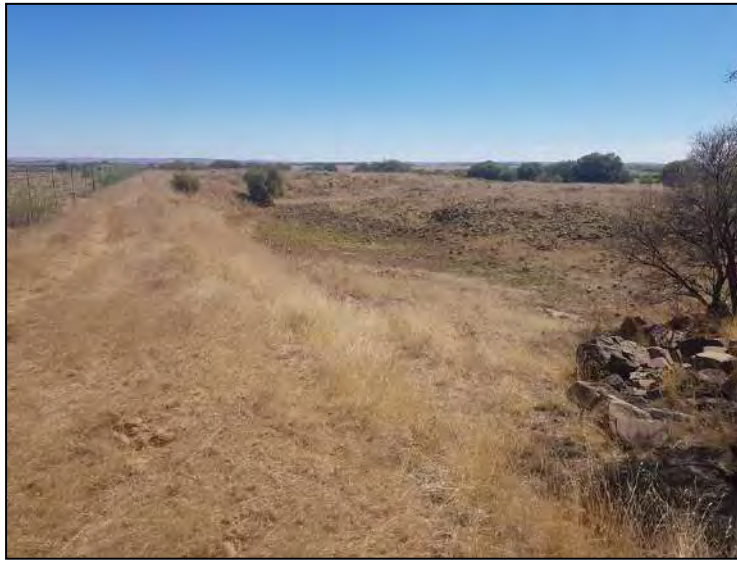
Figure 2-23: View of an old burrow pit at BP 56.3 on the farm Welgevonden.

The farm is located south of the Candy/Jossepinesdal intersection. The proposed borrow pit borders the N1 on the western side. The portions of the farms are currently used as a grazing camp for cattle and sheep. An existing borrow pit was not rehabilitated. The grassed area were used as a grazing camp for sheep but after the use of the borrow pit the area was not sufficient anymore. The entire borrow pit is located on a “koppie” with regular outcrops of dolerite and the area in general can be described as typical Free State grasslands.

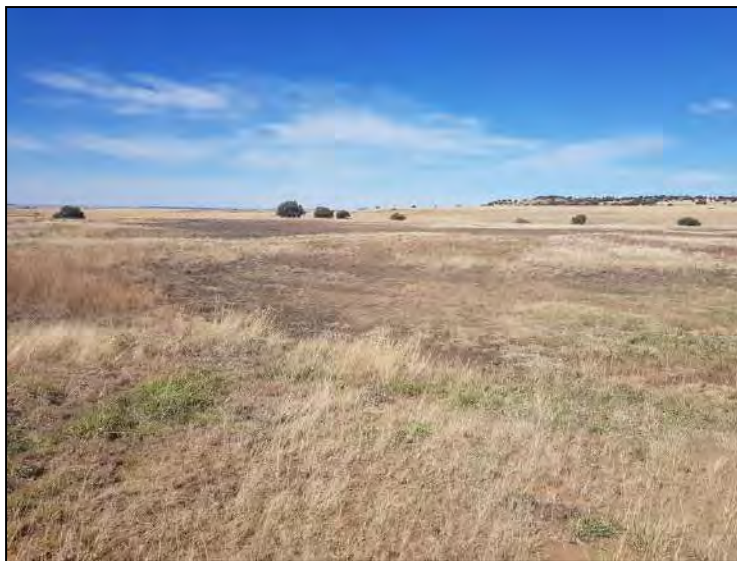
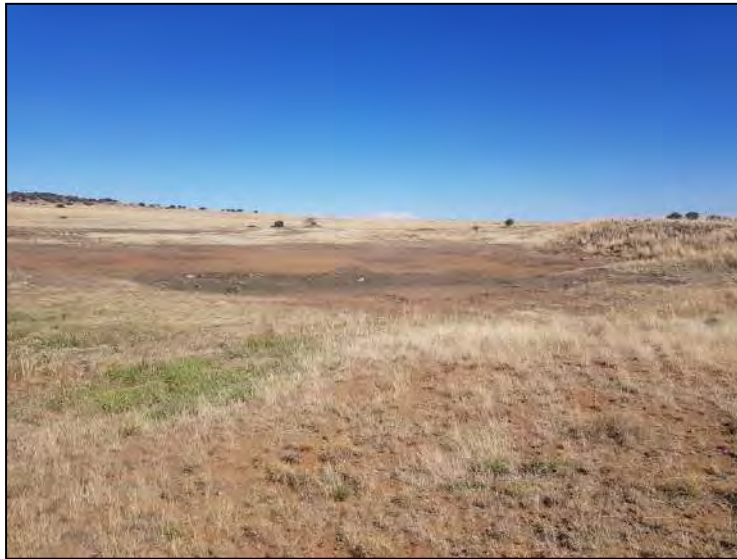
Figure 2-24: View of old quarries at BP 57.9 on the farm Kraal.

The borrow pit area is situated 2.4 km south-east on the S105 from the N1. The portion of land is not currently utilized due to the small area of the existing borrow pit that is still surrounded by the initial fence. The existing borrow pit was rehabilitated and the old fence surrounding the borrow pit still remained in place. The area is grassed and can be described as typical Free State grasslands.

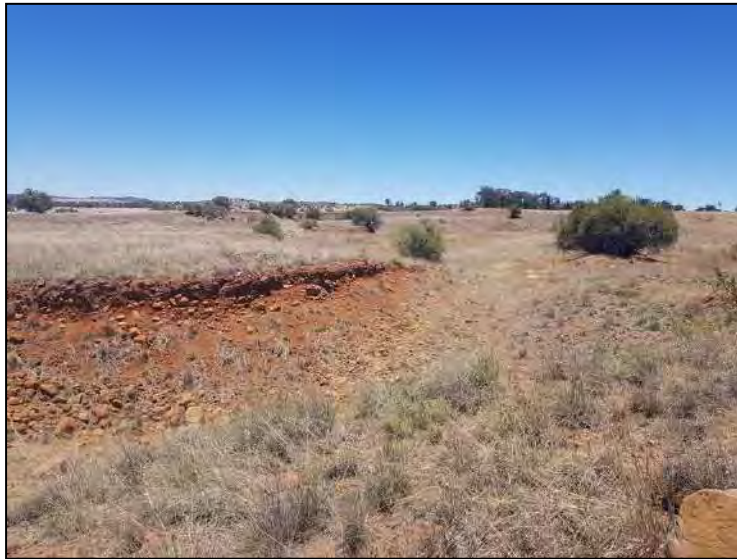
Figure 2-27: View of old quarries at BP 64.2 on the farm Welkom.

The borrow pit is located just south of the Groot Vet river, approximately 1.2 km east of the N1. The portion of the farm is currently used as a grazing camp for cattle and antelopes. The grass has not completely been established on the un-rehabilitated borrow pit. The existing borrow pit was not rehabilitated. Water gathered in some parts of the borrow pit due to no rehabilitation. The area is grassed and can be described as typical Free State grasslands. Scattered scrubs and trees are evident closer to the river.

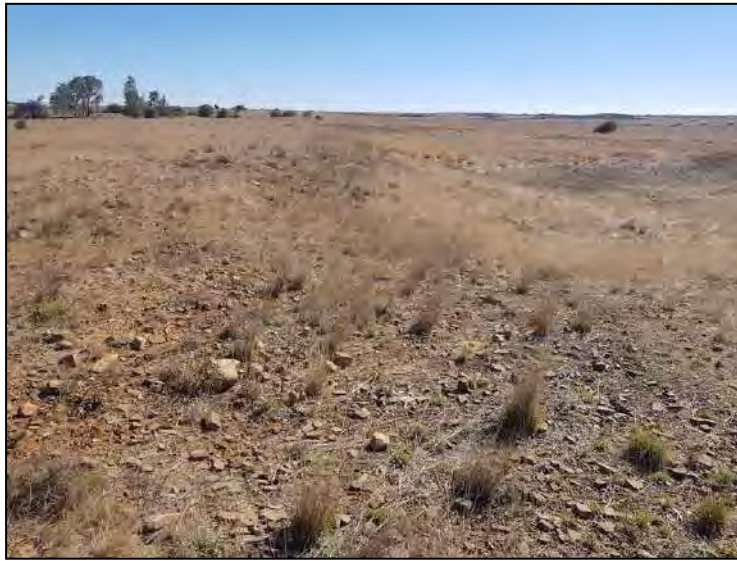
Figure 2-29: View of an old burrow pit at BP 67.3 on the farm Pleasant View.

The borrow pit is located just north of the Kareedam/Ceylonia interchange, approximately 150 m east from the road reserve. The portion of the farm is currently used as a grazing camp for cattle. The existing borrow pit has been rehabilitated and well worked off. The existing borrow pit was rehabilitated and grass have been established in the borrow pit area. Vegetation consists of typical Free State grass, smallish shrubs and bushes and scattered trees.

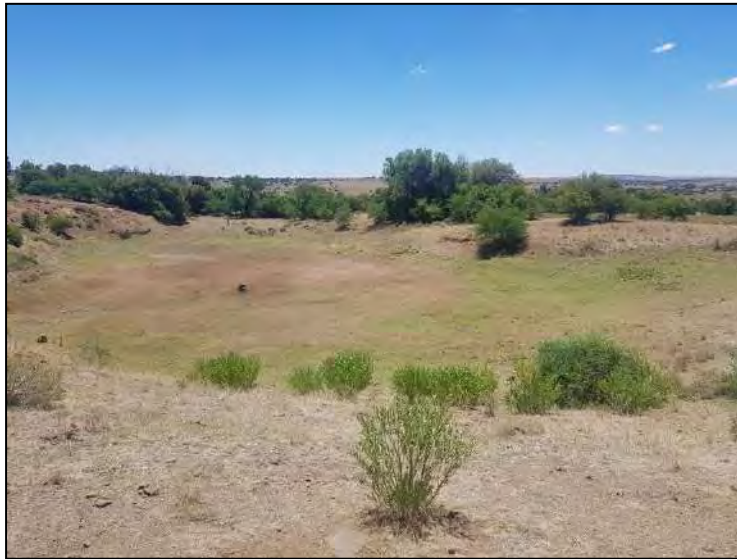
Figure 2-33: View of a large burrow pit at BP 72.7 on the farm Kruidbaden.

The farm is situated west of the R703 and approximately 1.9 km perpendicular from km 72.6 of the N1-16. The existing borrow pit was un-rehabilitated and left approximately 9 m deep. The faces were also left steep. This causes a threat for cattle that can possibly fall into the borrow pit. The area is grassed and can be described as typical Free State grasslands with regular outcrops of dolerite on the ridge side of the borrow pit. Shrubs and bushes and scattered trees are also visible. The borrow pit was previously used for a previous road construction project.

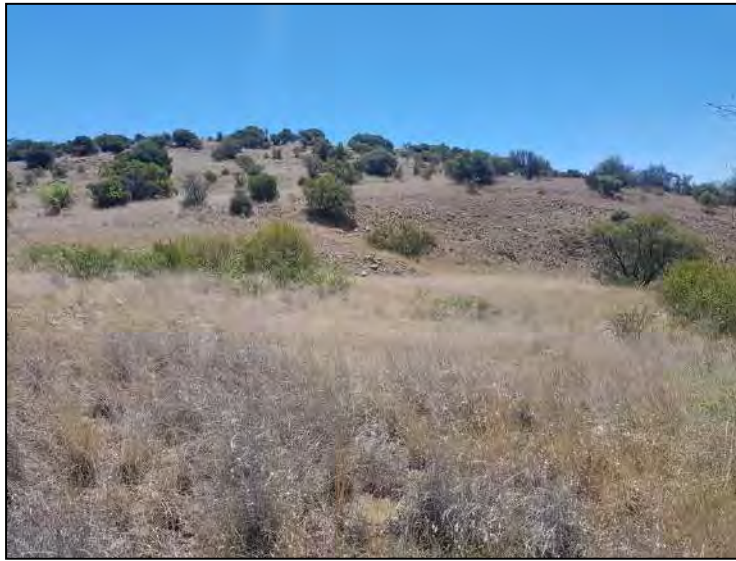
Figure 2-37: View of old burrow pits at BP 77.7 on the farm Hartplaats.

The farm is situated just south of the Winburg/Brandfort interchange approximately 180 m west of km 77.7. The greater part of the area is untouched and lies in its natural state. There is a small existing borrow pit where the grass is re-established. The area is grassed and can be described as typical Free State grazing grass. Dolerite outcrops is visible at the foot of the “koppie”. Shrubs and bushes and scattered trees are also visible. The portion of the farm is currently used as a grazing camp for horses. The part of the existing borrow pit has not been used for a long time and the grass has been re-established.

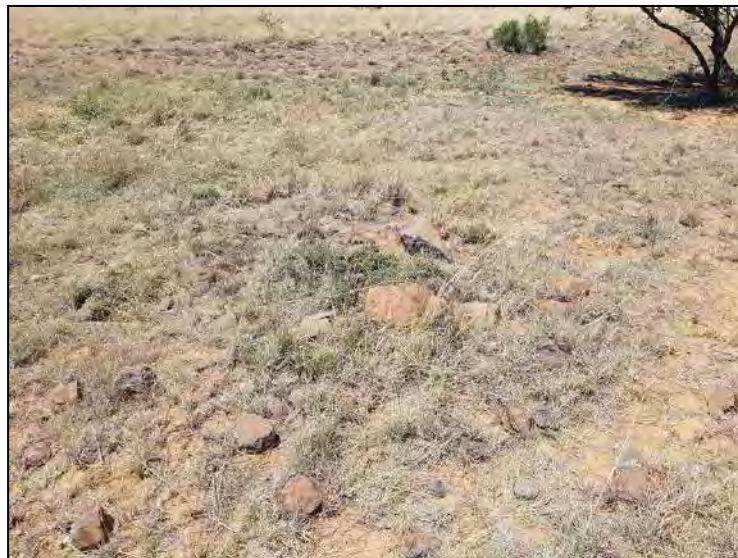
An elongated stone heaps was documented along the proposed BP39.6 access road on the farm Kleinfontein. No associated material culture was observed near the structure. The function and context of the feature is not known but the stones might have been removed from the nearby cultivated fields. In addition, the possibility of the feature indicating an informal human burial should not be excluded and the feature should be closely monitored during development phases. Since the age of the structures is not known and related contextual heritage artefacts or features are absent from the site, the occurrence is probably of low heritage significance since it does not implicitly display any social or cultural meaning.

Figure 5-1: View of a stone feature at Exigo-BP39.6-FT01.

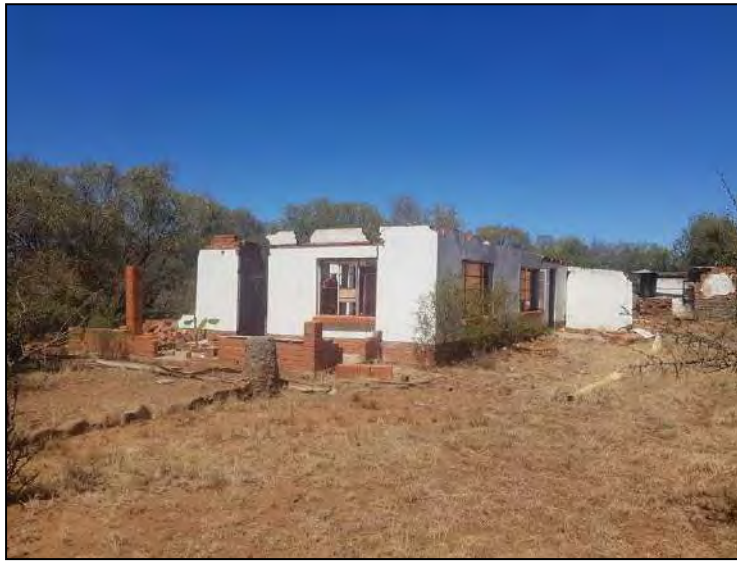
During the survey, the dilapidated remains of a farmstead were documented along the north-eastern periphery of BP 52.8 on the farm Helpman 1438. The farm is located south of the Candy/Josephinesdal intersection. Here, the poorly preserved wall remains of a brick house and livestock stables constructed out of stone and cement as well as material culture in the form of artefact remains (glass, metal, plastic) were noted. Even though an absolute age for the structures could not be ascertained, a relative recent temporal context is provided by an analysis of historical aerial photographs and topographic maps, which suggest that the farmstead was not present in the landscape at around 1950 (see Figure 5-2). It is therefore highly likely that the structures at the farmstead are younger than 60 years - and not protected under the National Heritage Resource Act (NHRA 1999).

Figure 5-2: View of farmhouse remains at Exigo-BP52.8-CP01.

- *No further action is required for the Contemporary Period remains of a farmstead (Exigo-BP52.8-CP01) in the project area but it should be noted that human burials might occur in association with the farmstead at precisely undated locations.*
- *For various features found across a number of properties in the project area rated as of low significance (Exigo-BP39.6-FT01, Exigo-BP52.8-FT01, Exigo-BP52.8-FT02, Exigo-BP56.3-FT01, Exigo-BP73.8-FT01) within the project area the following are required in terms of heritage management and mitigation:*

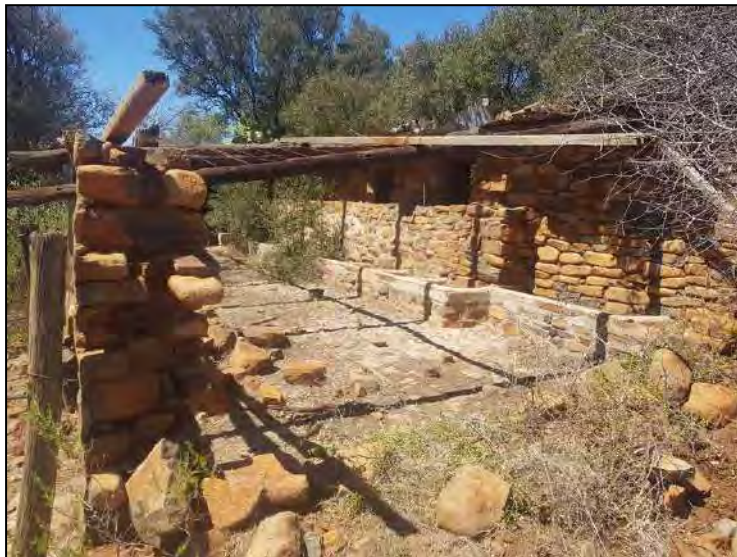
Figure 5-3: View of stone structure remains of livestock enclosures at Exigo-BP52.8-CP01.

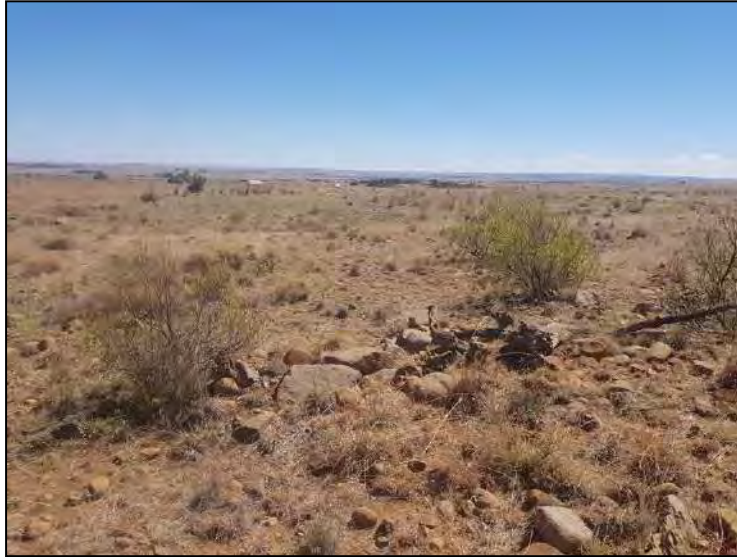
The remains of a rough and irregular stone wall foundation were noted north of a deep excavated pit north-western periphery of BP 52.8 on the farm Helpman 1438. No material culture was noted in

association with the poorly preserved structure and a temporal and cultural context for the feature is not known. The site, which is located within areas demarcated for the proposed development is rated as of low heritage significance

Figure 5-4: View of a stone wall foundation at Exigo-BP52.8-FT01.

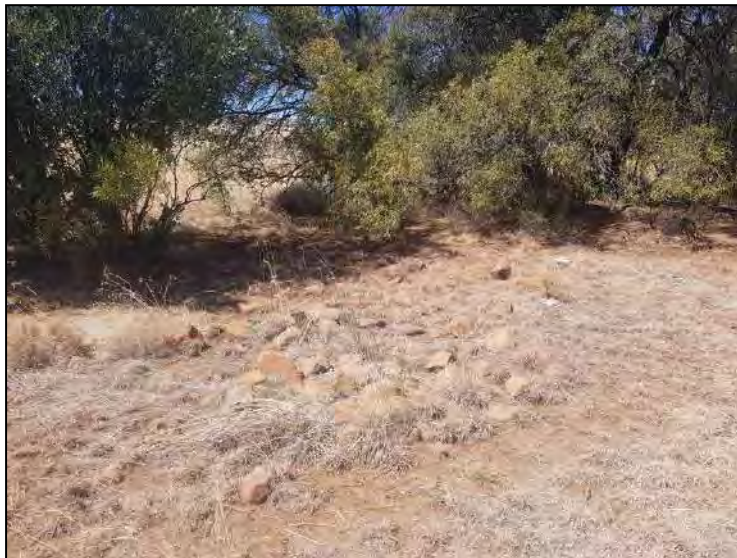
An elongated stone heap was documented near the farmstead remains along the north-eastern periphery of BP 52.8 on the farm Helpman 1438. No associated material culture was observed near the structure and no function or context for the feature could be ascertained but the possibility of the stones indicating an informal human burial should not be excluded. As such, the feature should be closely monitored during development phases. The occurrences are probably of low heritage significance since it does not hold known social or cultural meaning.

Figure 5-5: View of a stone feature at Exigo-BP52.8-FT02.

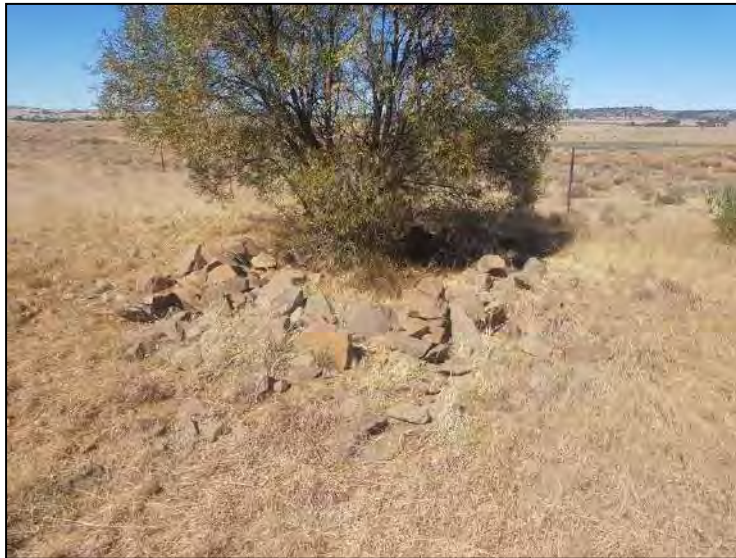
A small, circular stone enclosure approximately 3m in diameter was documented at the proposed BP 56.3 site along a border fence on the farm Welgevonden 64. The stone structure, which is poorly preserved, occurs approximately 100m east of exiting diggings and burrow pits and its function is not known. An analysis of historical topographical maps and aerial photographs does not indicate the presence of the feature and no material culture were observed in association of the enclosure remains. As the site is poorly preserved and generally devoid of material culture it carries limited heritage significance.

Figure 5-6: View of a rough stone enclosure at Exigo-BP56.3-FT01.
