**APPENDIX C1 -
AQUATIC IMPACT ASSESSMENT**

**N1 Section 16 Zandkraal (km33.8) to Winburg South (km78.0) upgrade in the
Free State Province**

AQUATIC IMPACT ASSESSMENT

16 November 2020

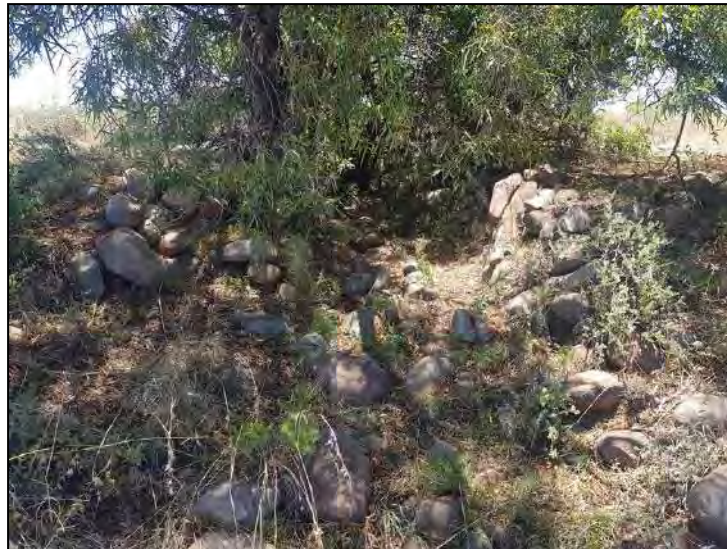
An excavation trench or horizontal shaft of approximately 10m was documented in the proposed BP 73.8 site on the farm Kruidbaden 1245. The trench is lined with round stones and the site is overgrown with trees. An analysis of historical topographical maps and aerial photographs does not indicate the presence of the feature and no material culture were observed in association of the enclosure remains. As the site is poorly preserved and generally devoid of material culture it carries limited heritage significance

Figure 5-9: View of a stone-lined trench at Exigo-BP73.8-FT01.

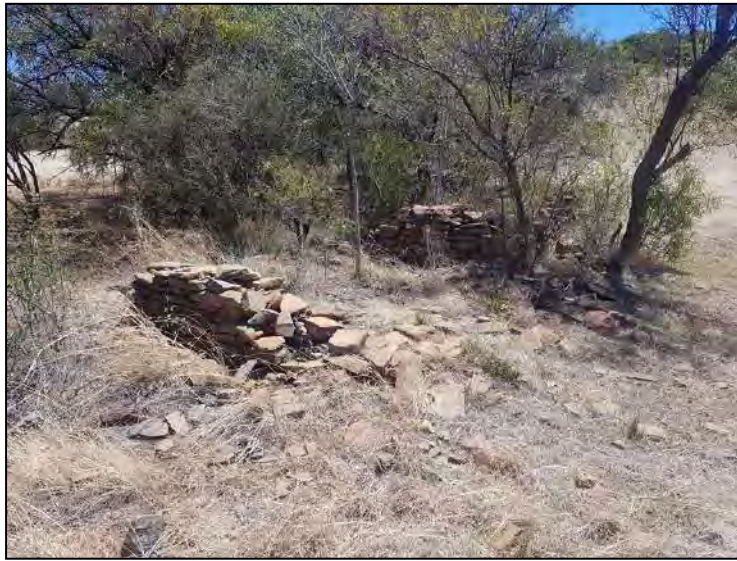
The remains of a multi-room stone and mud structure were noted along the western periphery of the proposed BP 77.7 site on the farm Hartplaats 77. Here, a number of rooms measuring approximately 2m x 2m were constructed in the dwelling, the walls of which are poorly preserved. No material culture were noted at the site but the area is densely overgrown with tall grasses and it is likely that artefacts, middens and associated structures could occur in association with the building remains. As farming communities settled in the Free State in this landscape during the Colonial Period in the last centuries, this structure might be remnants of an old farmhouse dwelling. In addition, aerial imagery dating to the first part of the 20th century suggest the presence of the feature at that time and it is therefore highly likely that the structure is older than 60 years - and protected under the National Heritage Resource Act (NHRA 1999). The site might afford a better understanding of social, cultural and architectural developments of the Historical period landscape around Windburg and it is rated as of medium significance.

Figure 5-10: View of a Historical Period structure at Exigo-BP77.7-HP01.

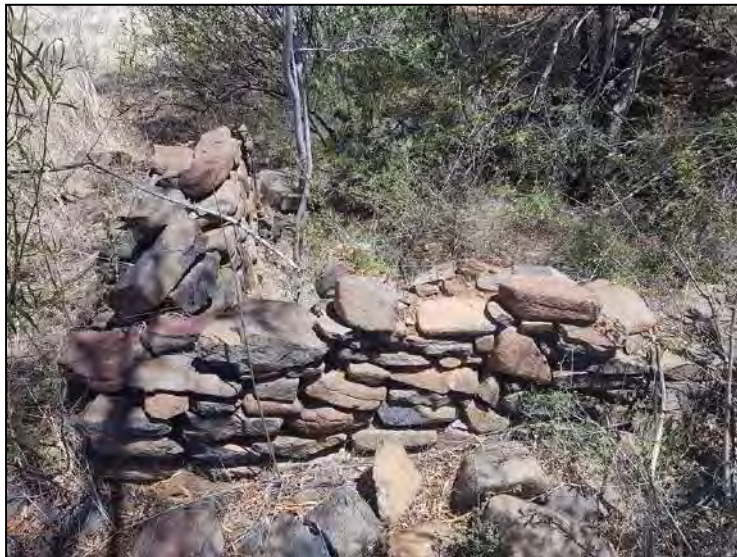
Figure 5-11: A Square stone wall room at Exigo-BP77.7-HP01.

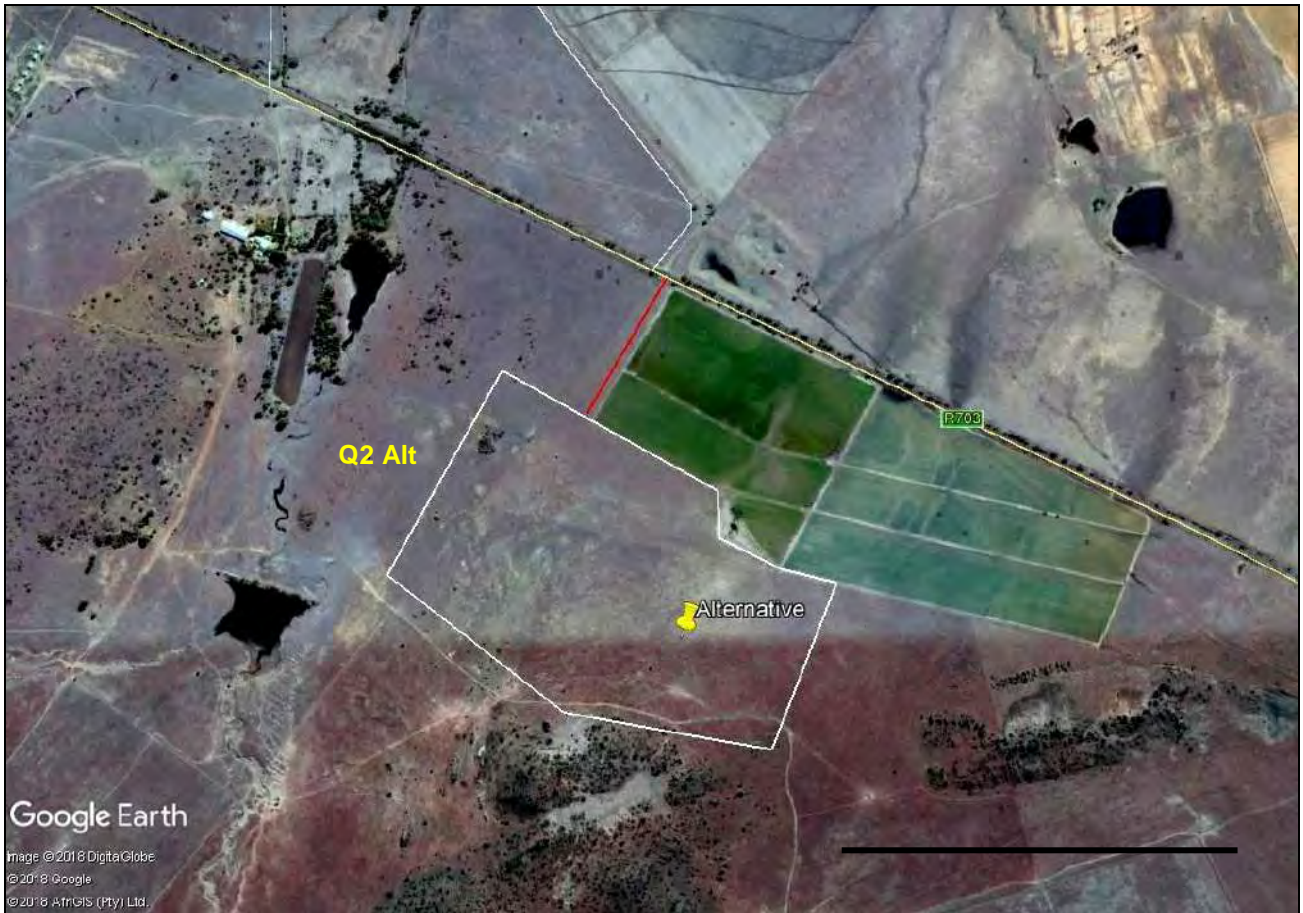
Figure 2. Google Earth© satellite image showing the Quarry 2 Alternative site on farm Verkeerde Vley 59 (white polygon) (Scale bar = 800 m). Access roads shown in red.

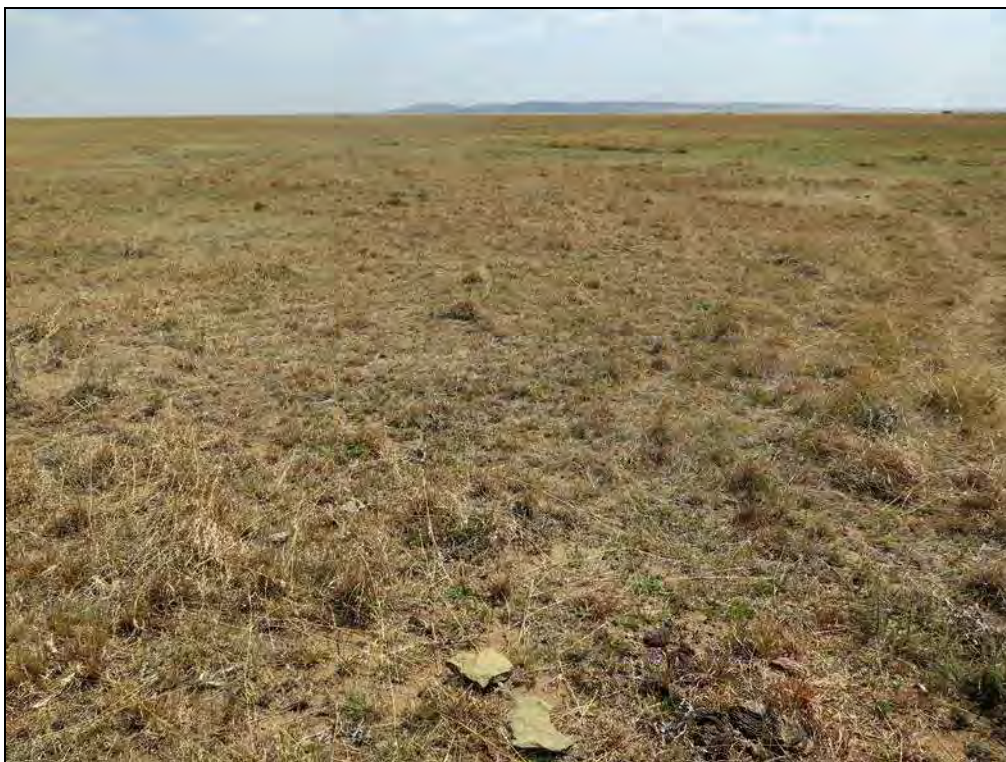
Figure 13. Typical low-relief terrain with little or no bedrock exposure and sparse downwasted surface gravels as encountered in many of the borrow pit and quarry study sites (here BP14).

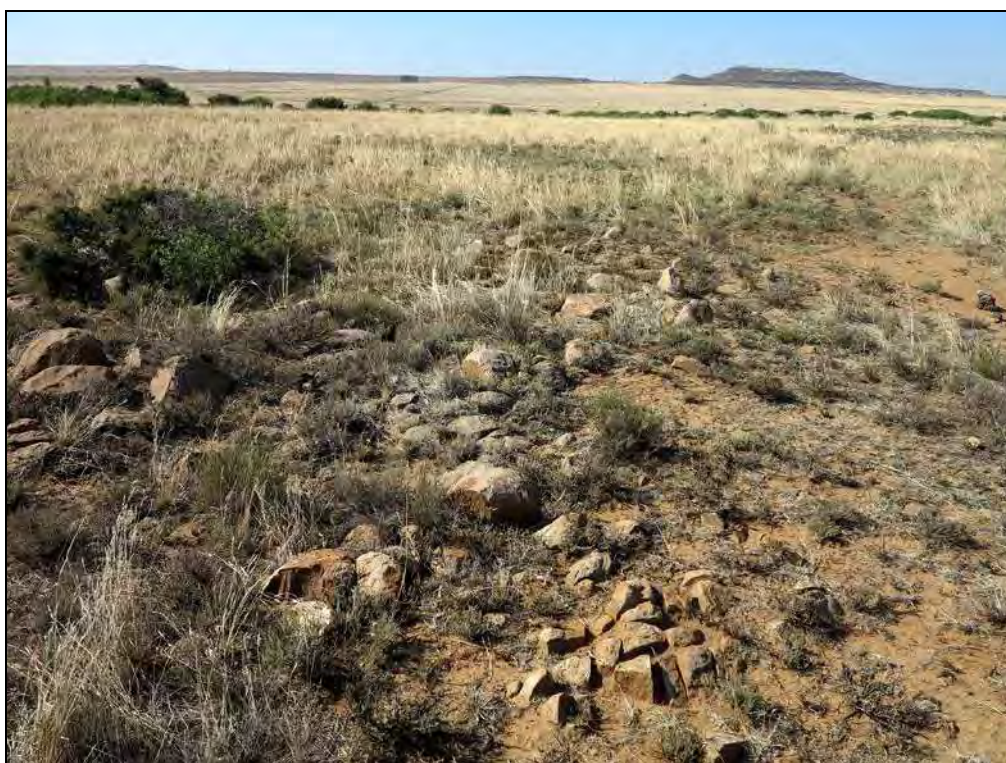
Figure 14. Low exposure of Normandien (Lower Beaufort Group) channel sandstones in the BP2B study area.

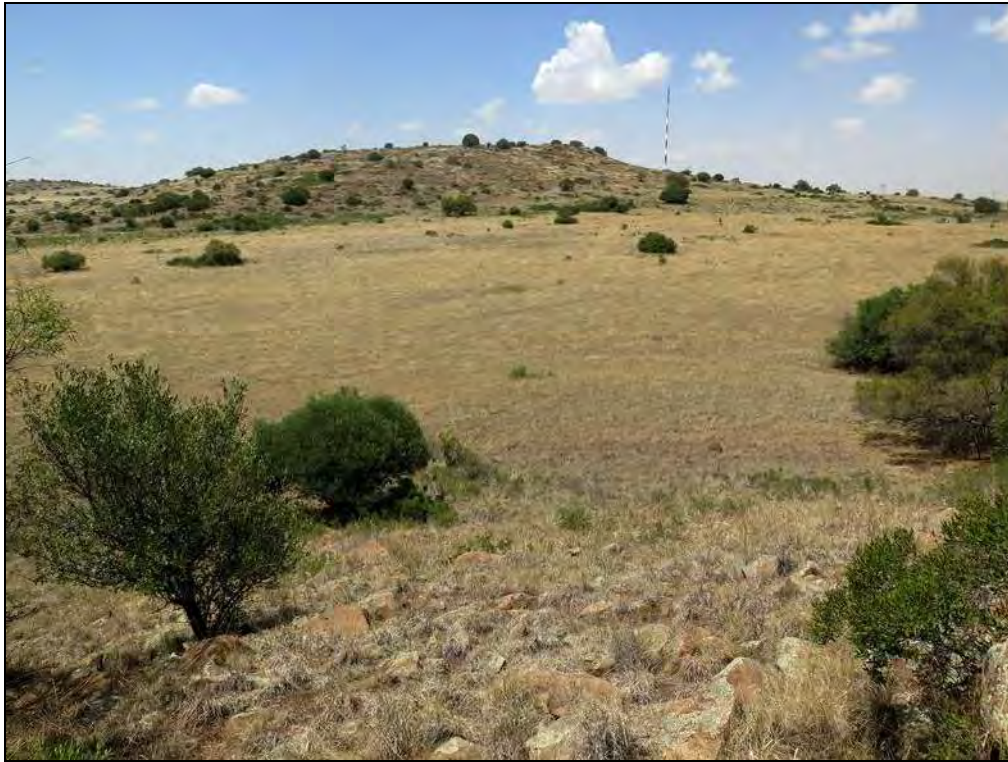
Figure 15. View eastwards across the BP25 study area showing dolerite exposure in the foreground and background separated by featureless grassy terrain.

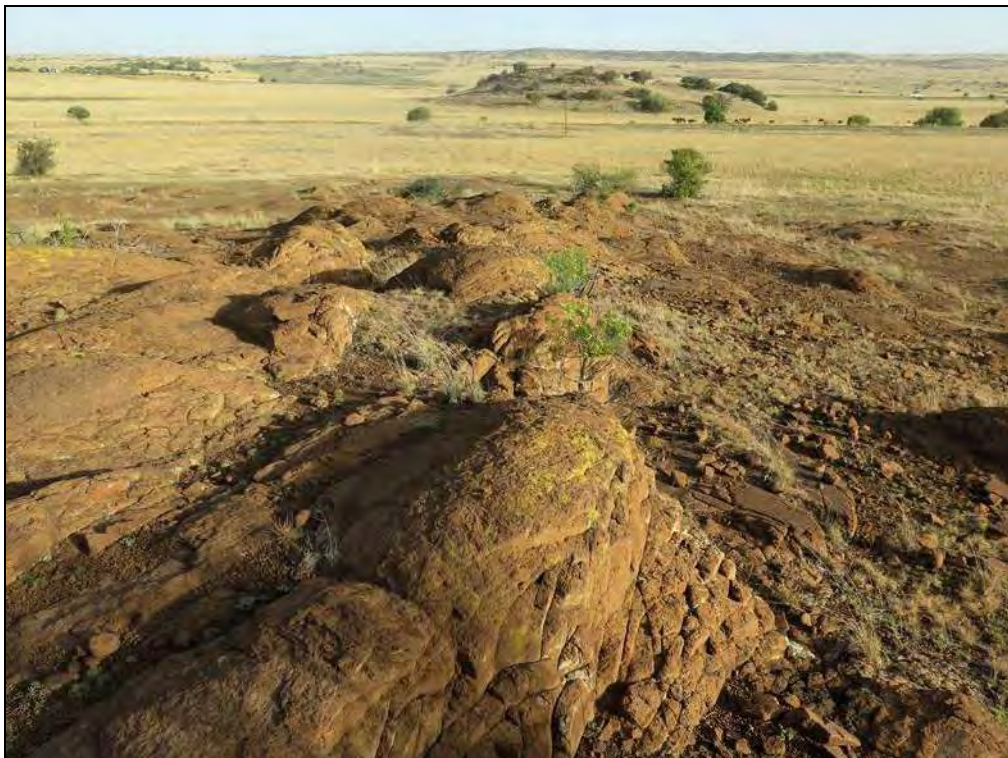
Figure 16. Low *koppies* of Karoo dolerite within the outcrop area of a major sill to the SE of the Erfenis Dam (QAlt to 1A & 1B study area in foreground, BP21 study area in background).

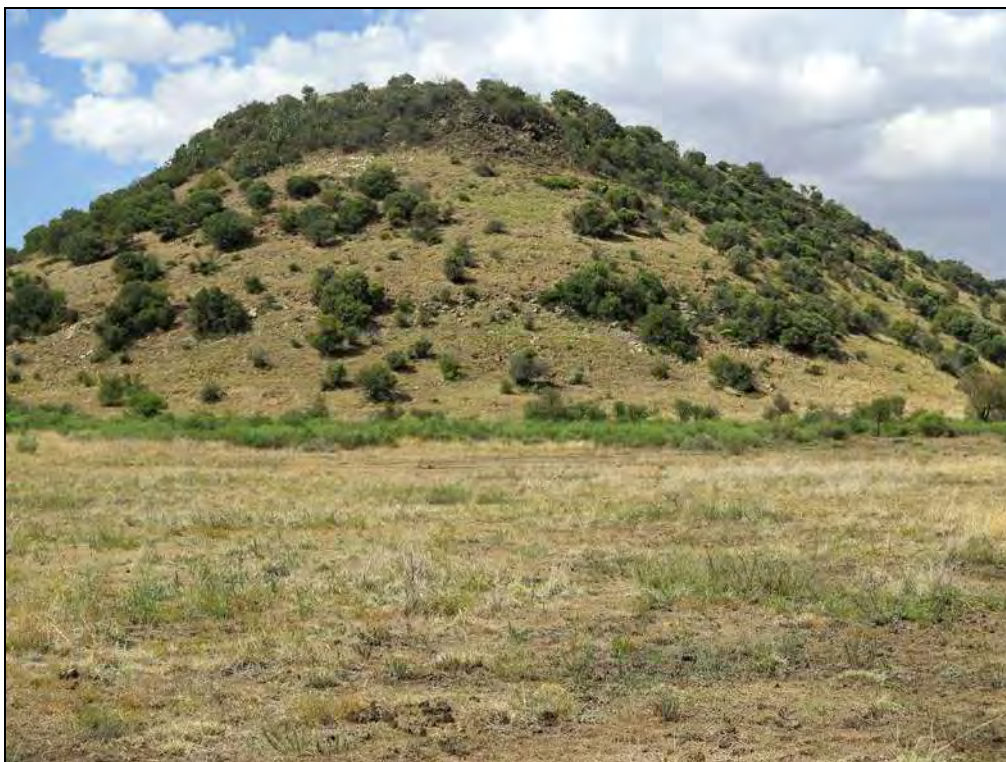
Figure 17. SE-facing escarpment formed by a major dolerite sill and minor Normandien Formation bedrocks (including xenolithic channel sandstone bodies) near BP24 study area SW of Winburg.

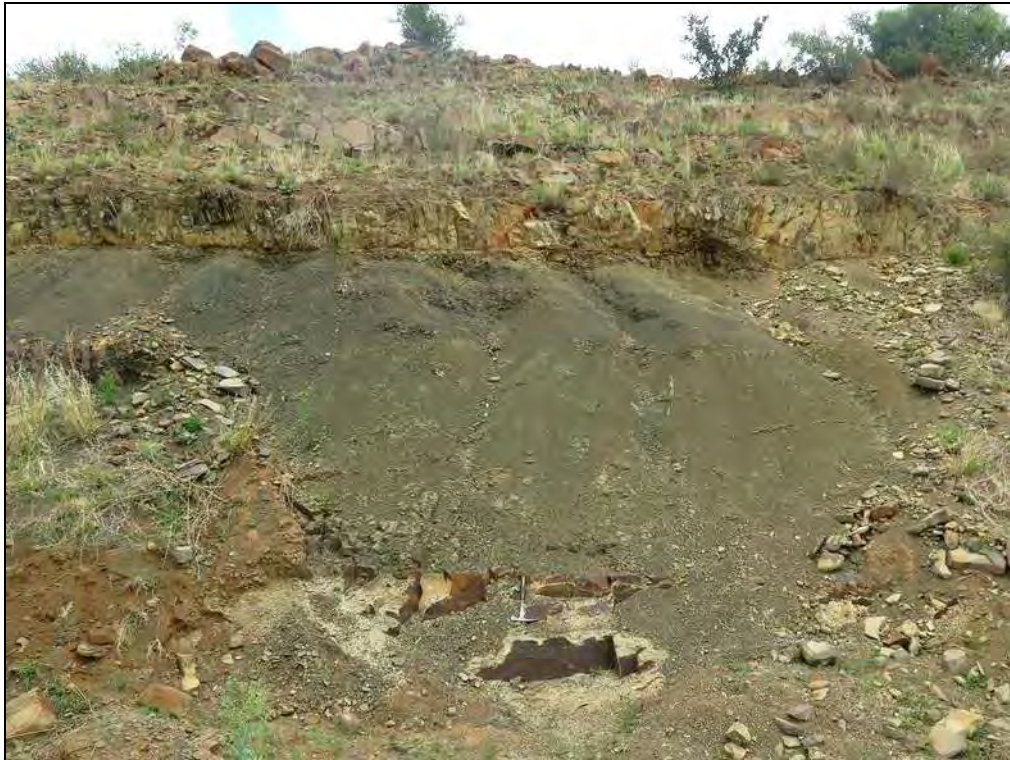
Figure 19. Rare exposure of hackly, grey-green Normandien Formation mudrocks, here capped by a dolerite sill, road cutting on southern outskirts of Winburg (Hammer = 30 cm).

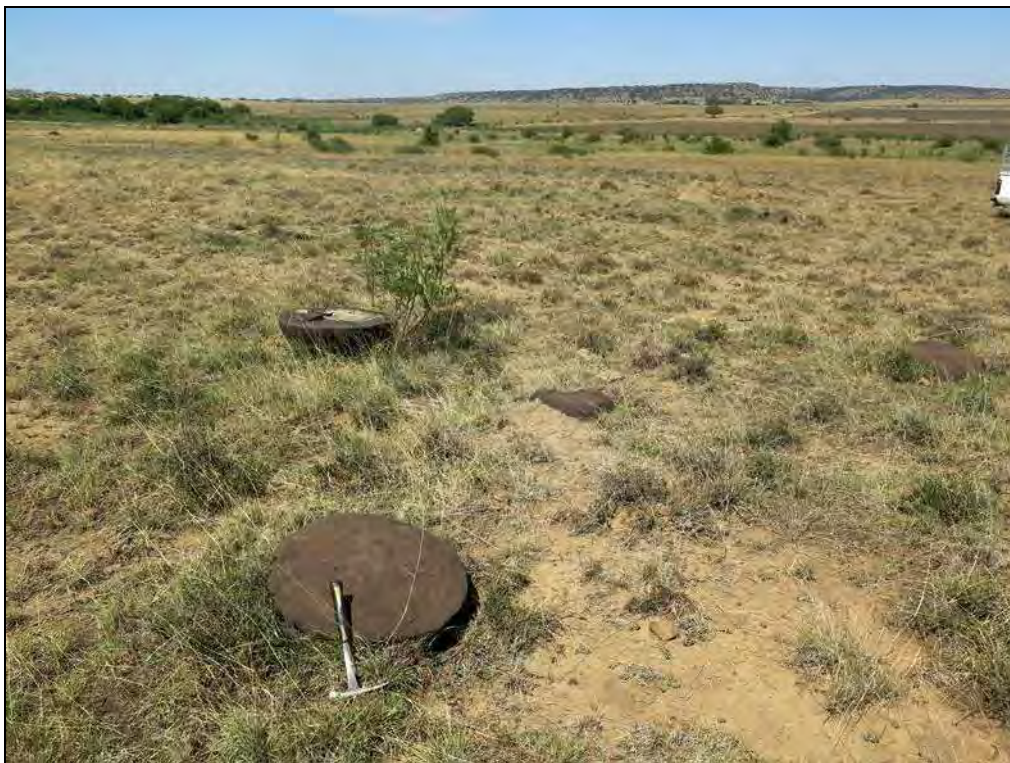
Figure 20. Large oblate spheroidal nodules of rusty-brown diagenetic ferruginous carbonate weathered out from the Normandien Formation, area just N of BP5 study area (Hammer = 30 cm).

According to Nolte (1995) the Normandien Formation (Adelaide Subgroup) in the Winburg 1: 250 000 sheet area consists of alternating packages of tabular-bedded, blue-grey overbank mudrocks (Fig. 51) and pale brown lenticular channel sandstones. Large (m-scale) oblate ferruginous carbonate concretions commonly occur within sandstone facies low down in the succession (Fig. 20). The sandstone facies are markedly immature (coarse-grained, feldspathic, poorly-sorted) and locally contain well-rounded to angular extra-basinal clasts up to 5 cm in diameter composed of basement lithologies (granite, gneiss, quartzite) as well as mudrock intraclasts. Sedimentary structures include horizontal lamination, tabular cross-bedding with a few ripple cross-laminated beds as well (Figs. 21 to 27). Palaeocurrents are predominantly towards the west and a nearby granitic provenance in the east or southeast is inferred. The sedimentology of the uppermost Normandien Formation and its erosional contact with the overlying Verkykerskop Formation near Senekal, c. 60 km east of Winburg, has been described in detail by Hancox *et al.* (2000).

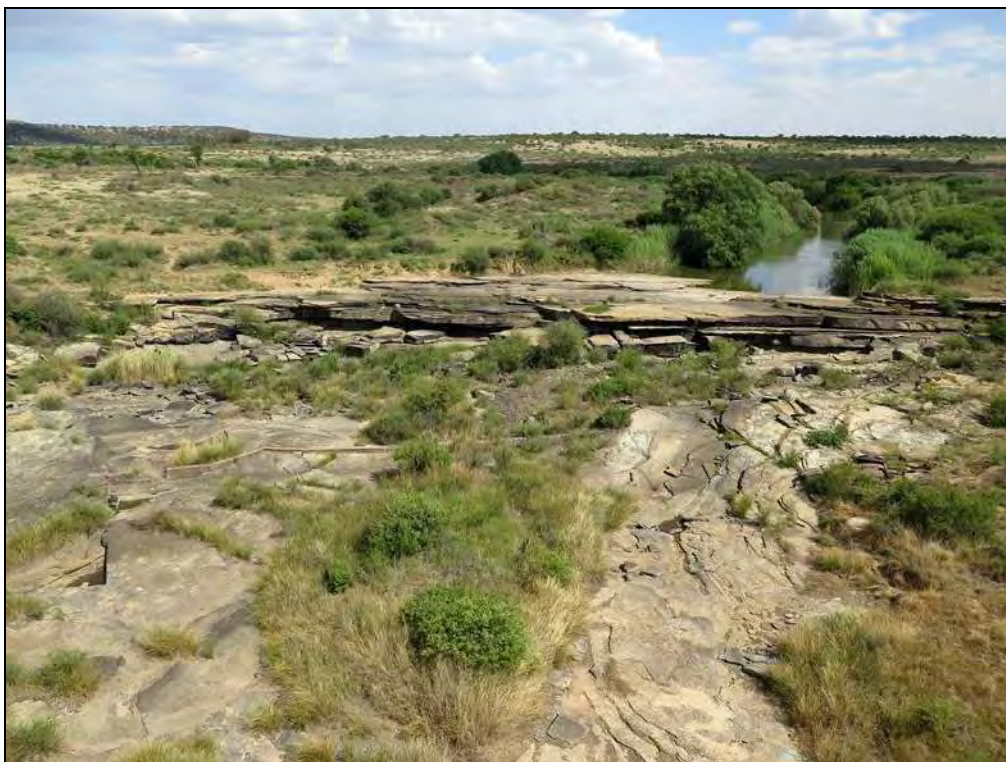
Figure 21. Good riverine exposures of Normandien Formation channel sandstone body showing large-scale cross-bedding, Klein-Vetriver SW of Winburg.

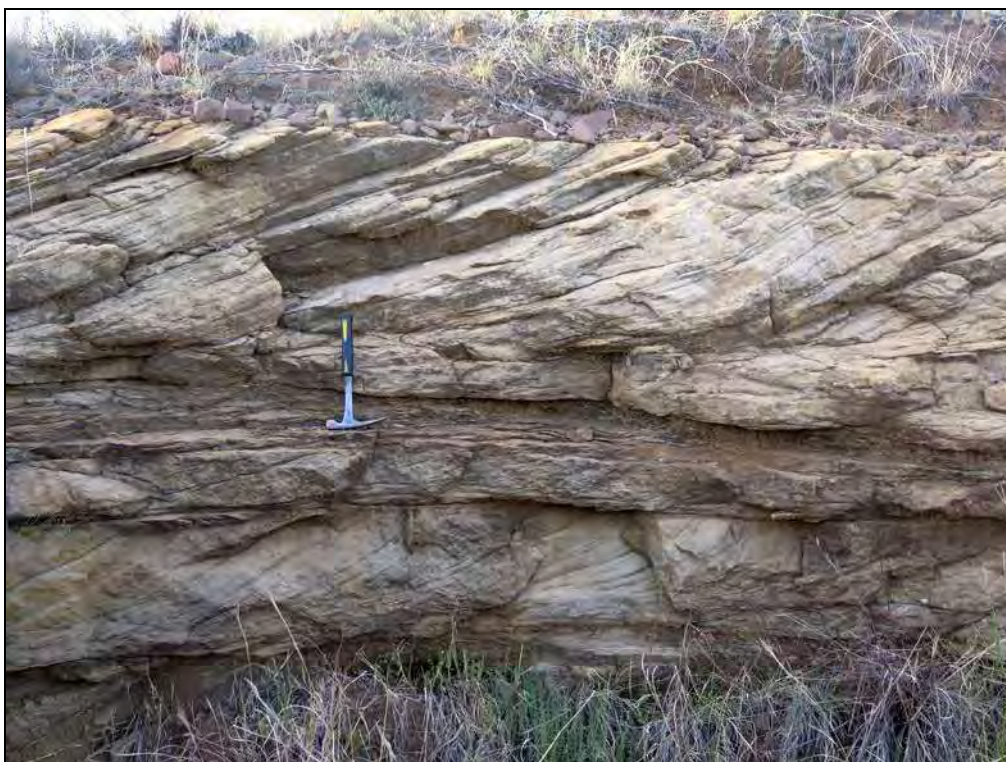
Figure 22. Tabular cross-bedded gritty channel sandstone of the Normandien Formation, road cutting near SW corner of QAlt to 1A & 1B site (Hammer = 30 cm). Palaeocurrents due SW.

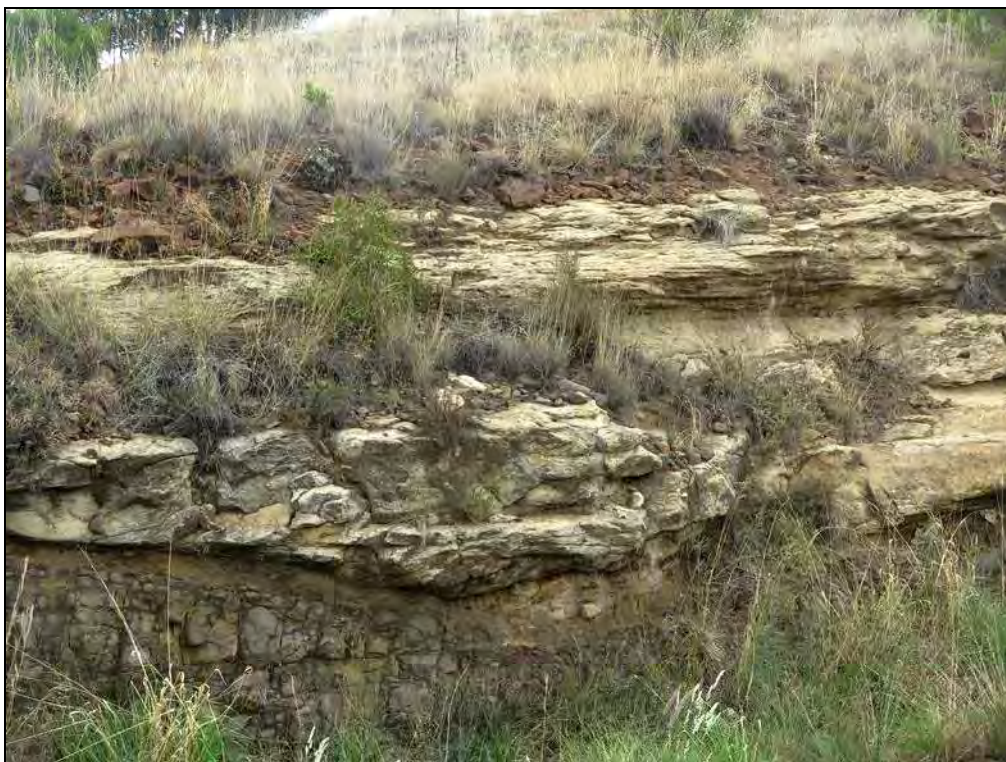
Figure 23. Channel sandstone body of the Normandien Formation enclosed as xenolith within a major dolerite sill, road cutting along Bell's Pass, SW of Winburg.

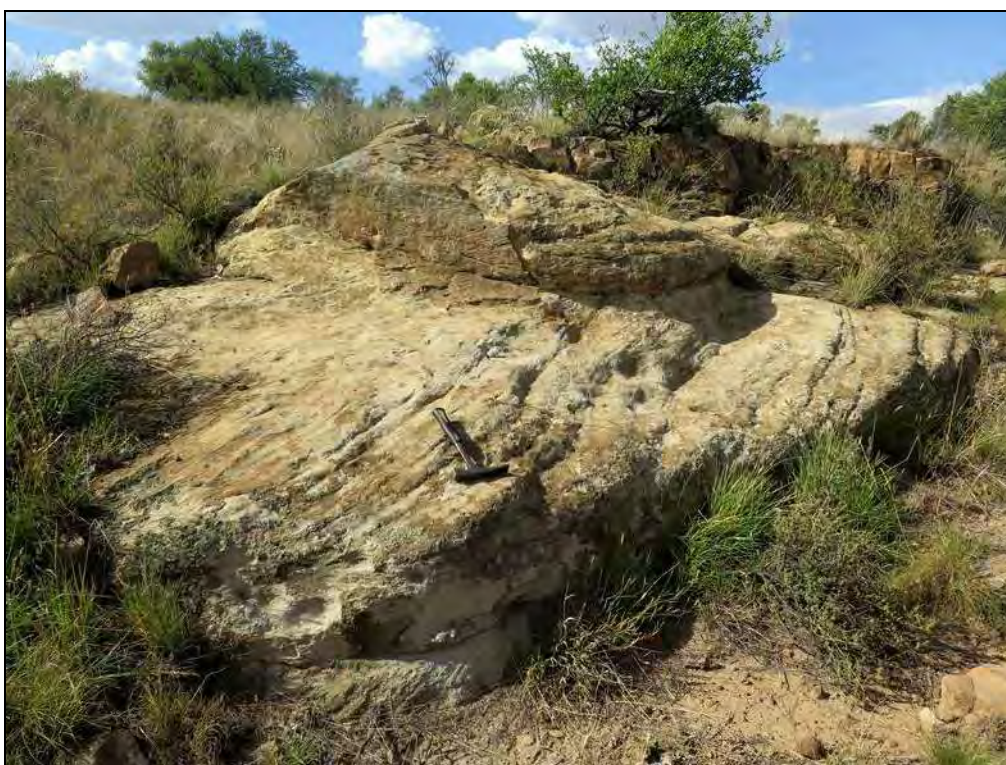
Figure 24. Large-scale tabular cross-sets (SW-palaeocurrents) within gritty Normandien Formation channel sandstone, BP19 study area (Hammer = 30 cm).

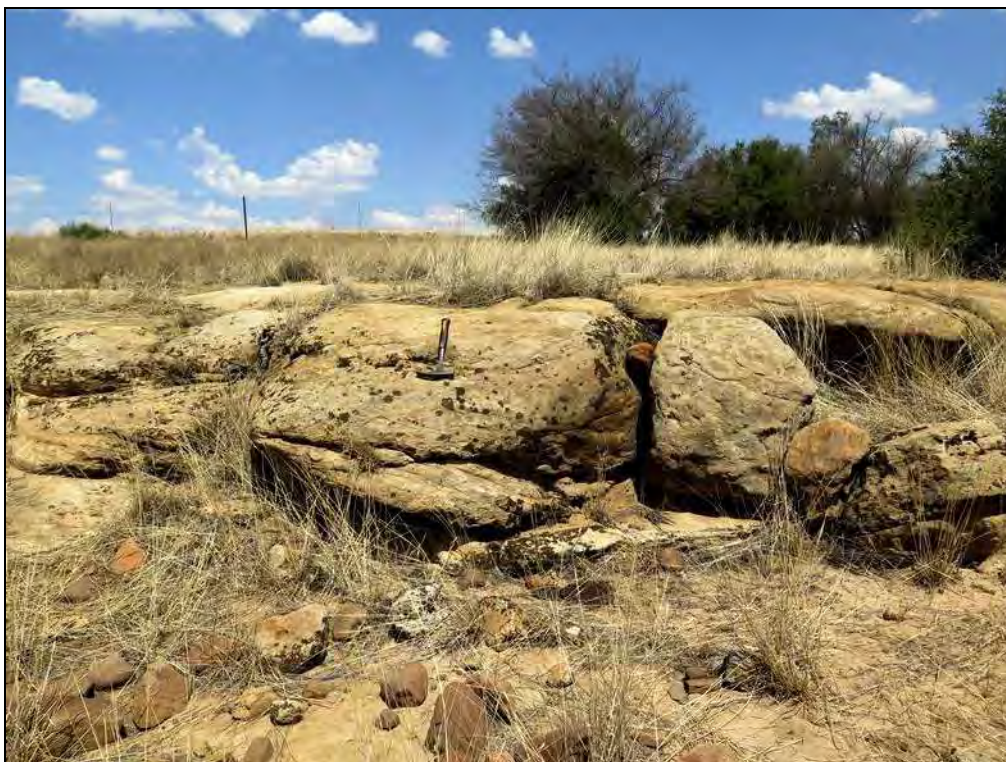
Figure 25. Normandien Formation cross-bedded channel sandstone exposed along the SW margins of the BP9 study area (Hammer = 30 cm).

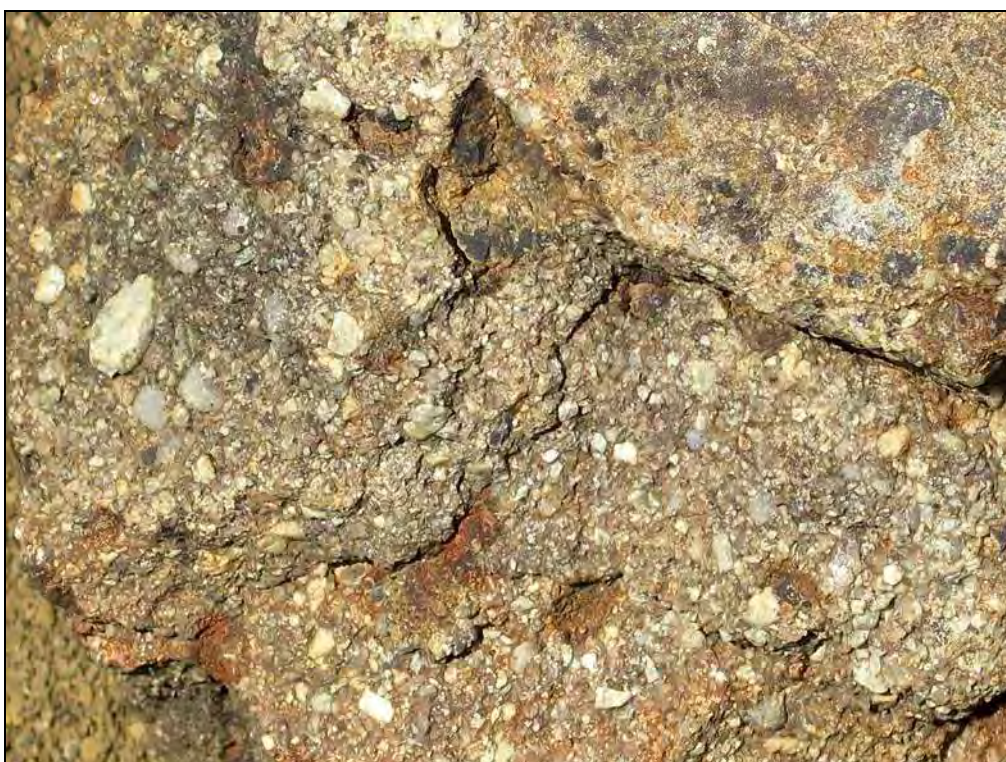
Figure 26. Close-up of immature, gritty, feldspathic Normandien channel sandstone facies seen above showing kaolinitised feldspar clasts up to 1 cm long.

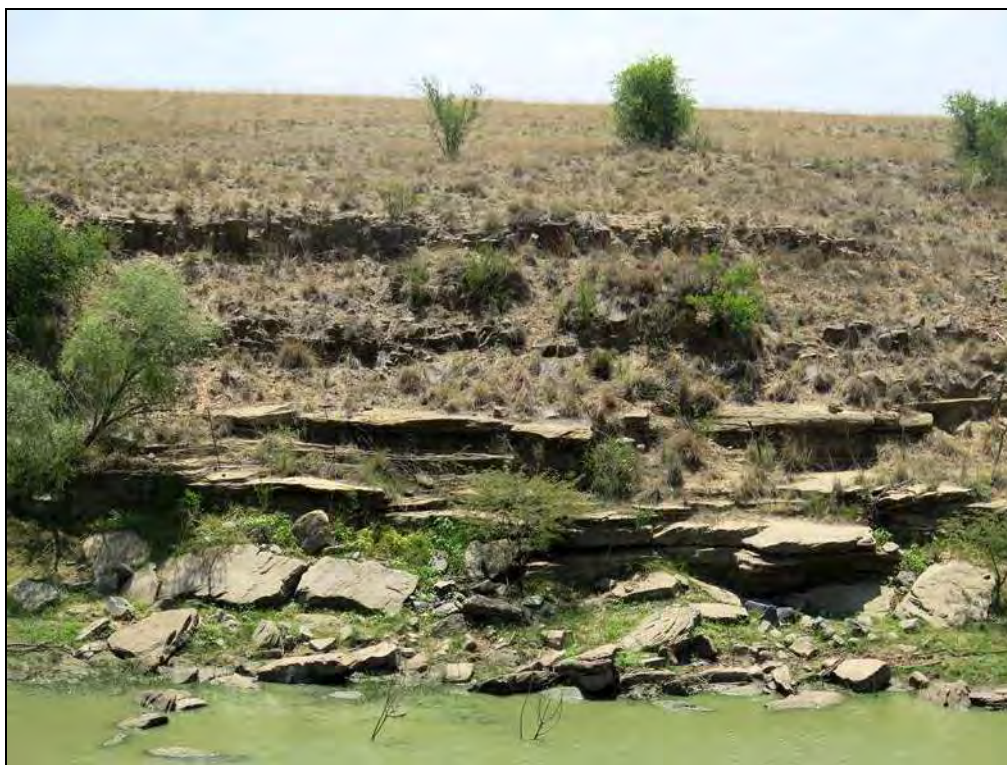
Figure 27. View across the Groot-Vetriver NW into the BP7 study area showing a thick dark brown, rubbly dolerite sill overlying a paler, well-bedded channel sandstone of the Normandien Formation.

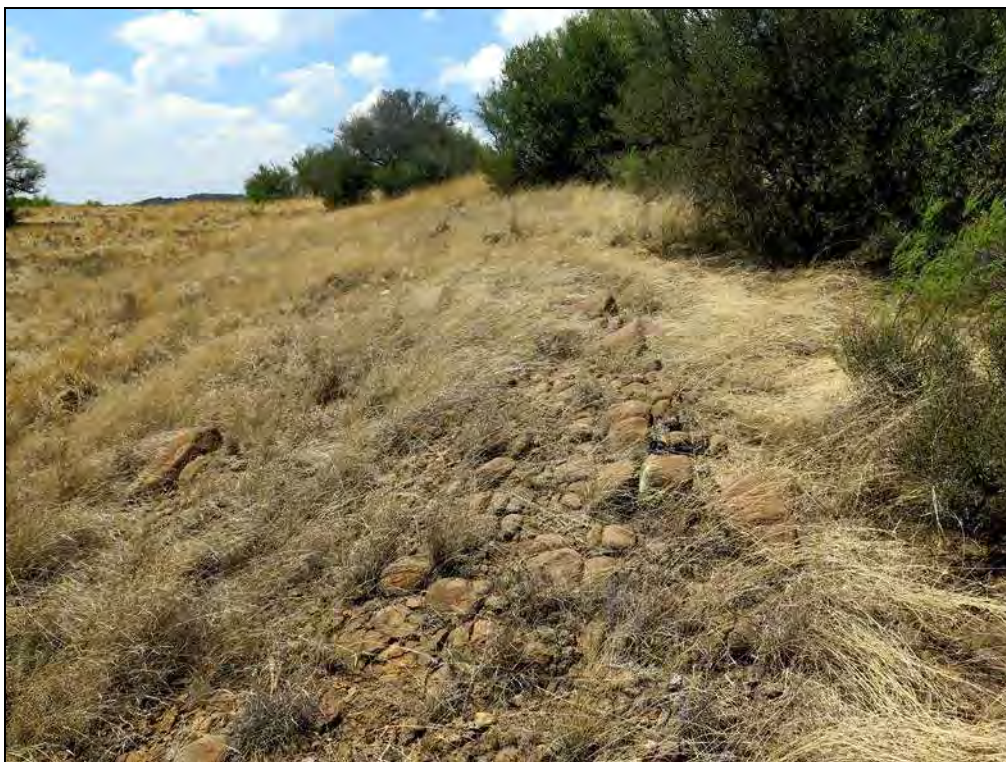
Figure 28. Probable dolerite dyke intruding Normandien Formation country rocks just SW of the BP8 study area.

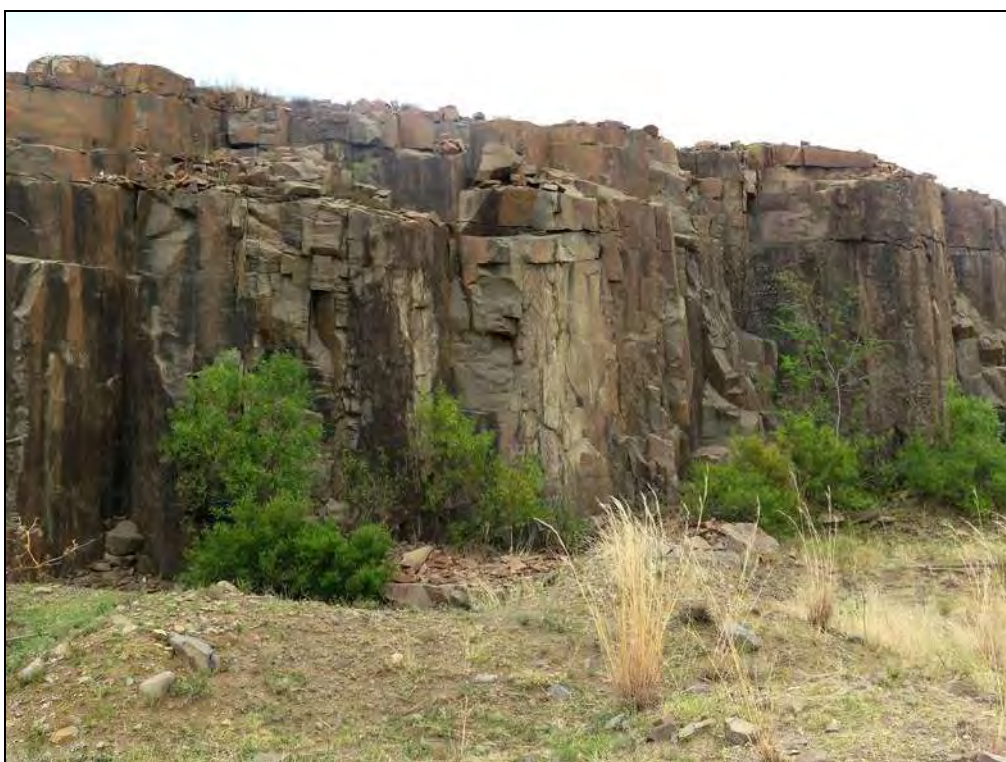
Figure 29. Cut face of existing quarry in the Q2 study area showing dolerite bedrocks with well-developed vertical sheet-like jointing.

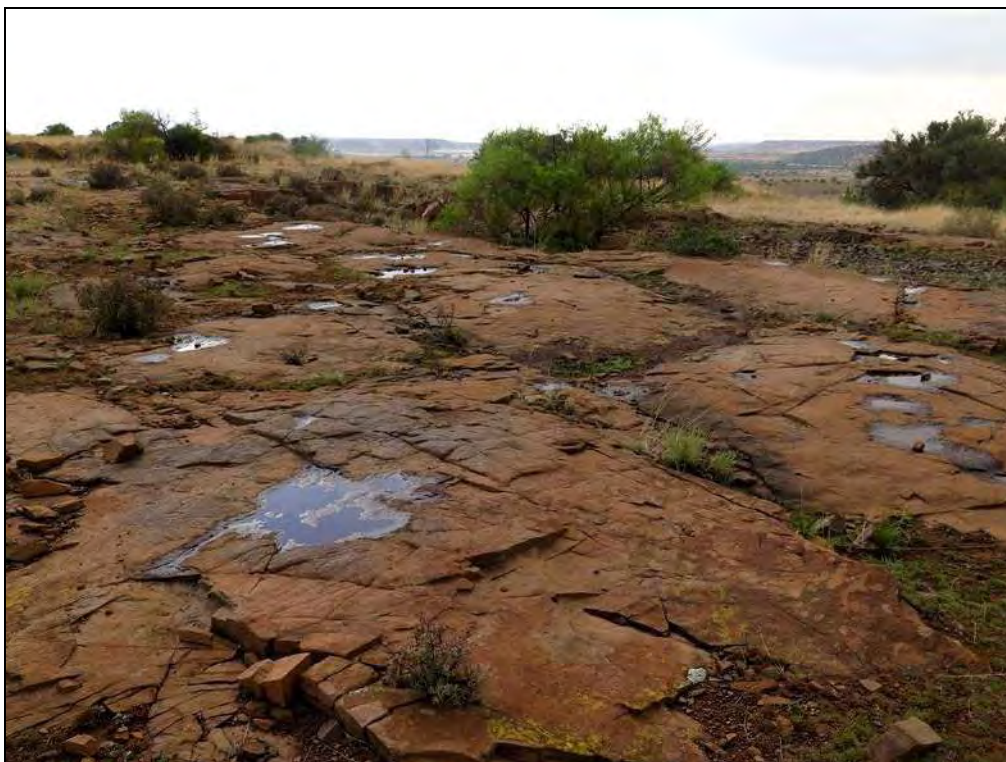
Figure 30. Surface exposures of the top of a major dolerite sill in the Q1 study area.

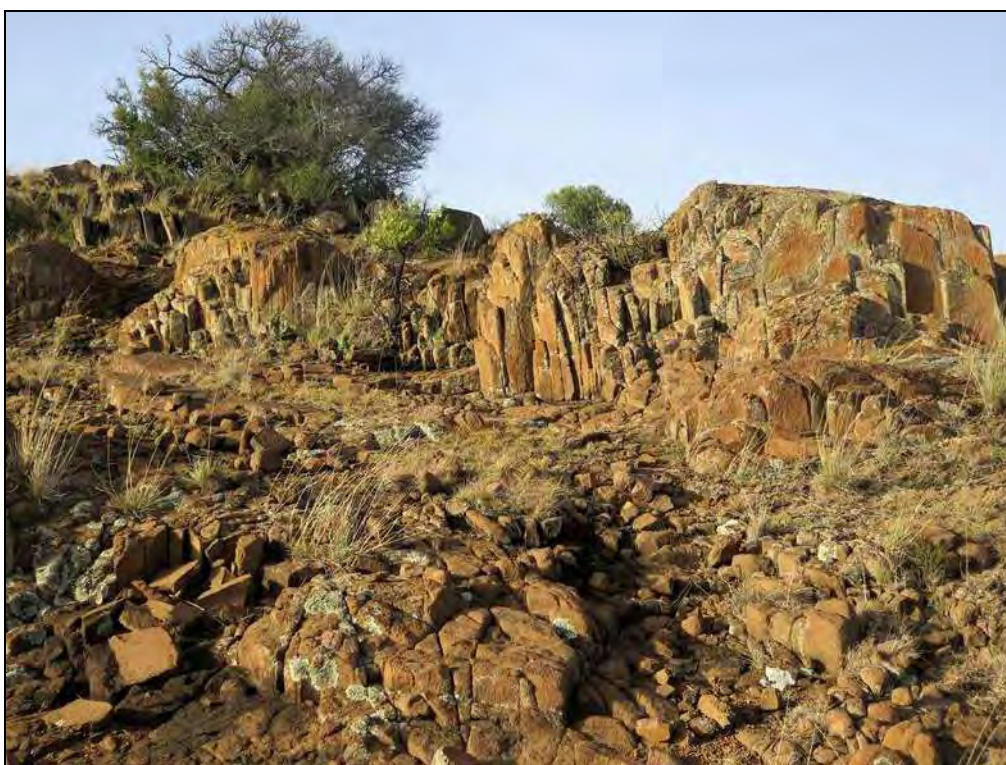
Figure 31. Possible small-scale columnar jointing within a major dolerite sill, QAlt to1A &1B study area.

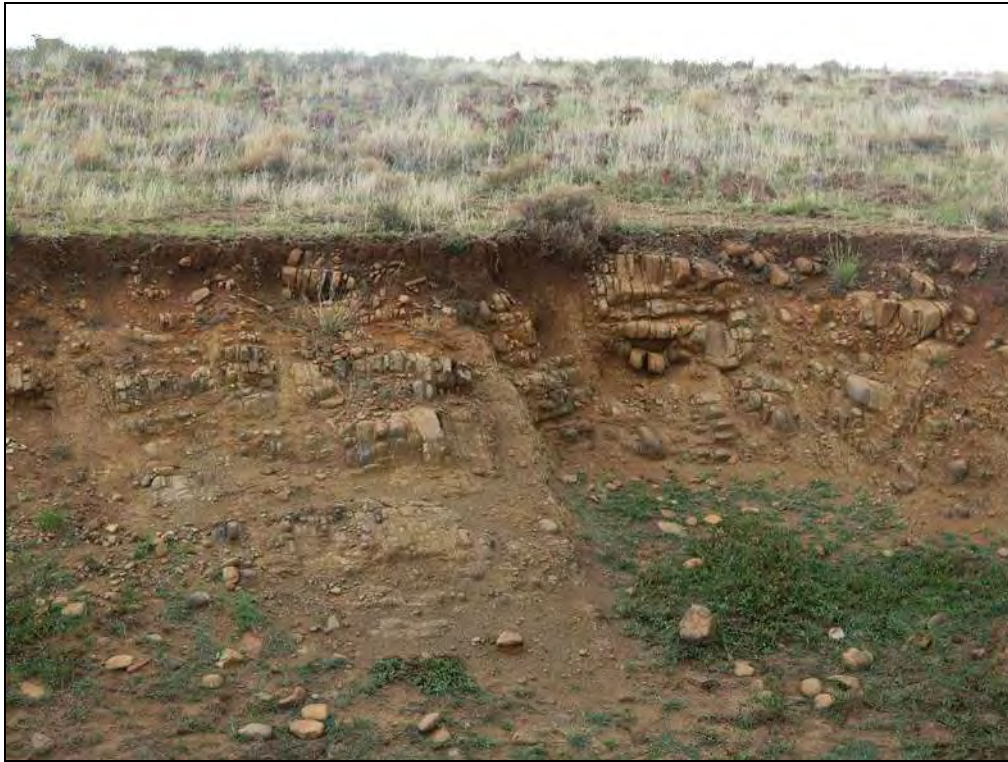
Figure 32. Quarry exposure of well-jointed, weathered dolerite bedrocks overlain by corestones and orange-brown lateritic soils, possible replacement site for Q1B near Winburg.

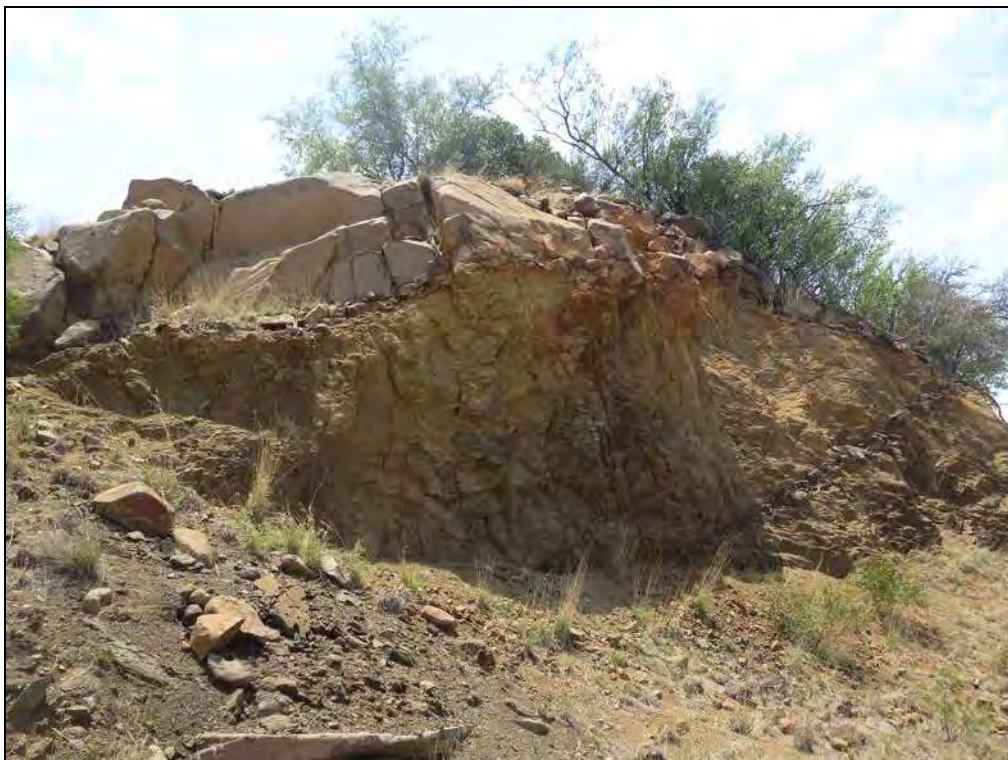
Figure 33. Cut face in existing quarry, BP25 study area showing deeply-weathered massive dolerite (*sabunga*) cut by an inclined dolerite dyke with fresher dolerite at surface.

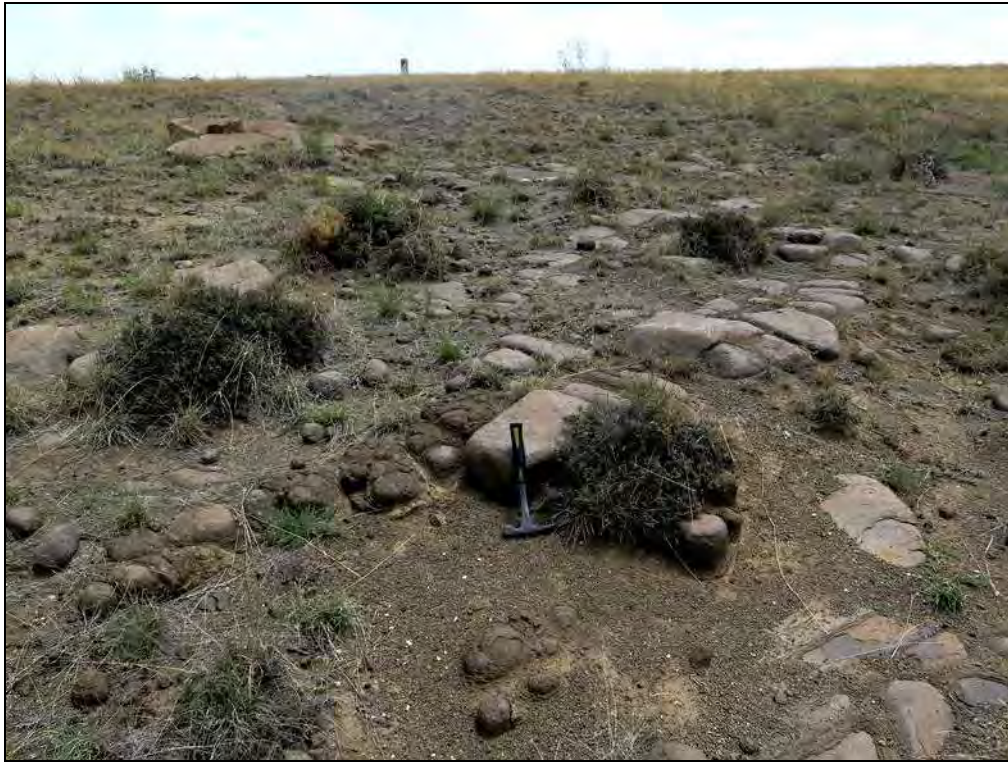
Figure 34. Well-developed dolerite corestone weathering, BP11 study area (Hammer = 30 cm).

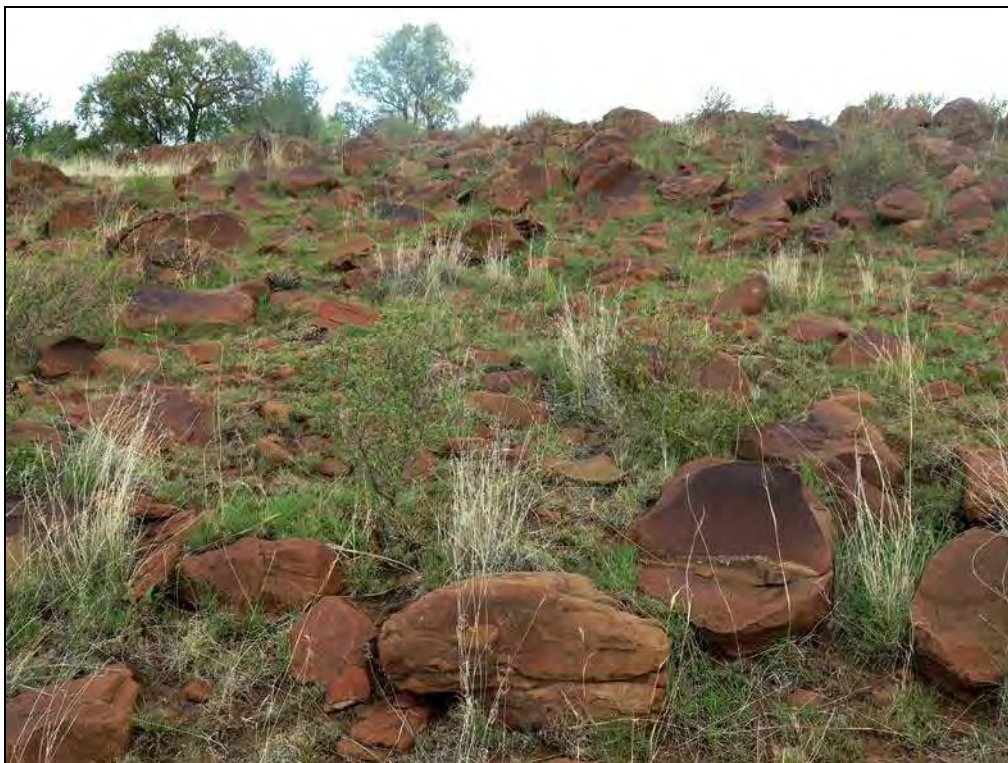
Figure 35. Rubbly downwasted dolerite corestones overlying a major dolerite sill on the southern outskirts of Winburg, possible Q1B replacement site.

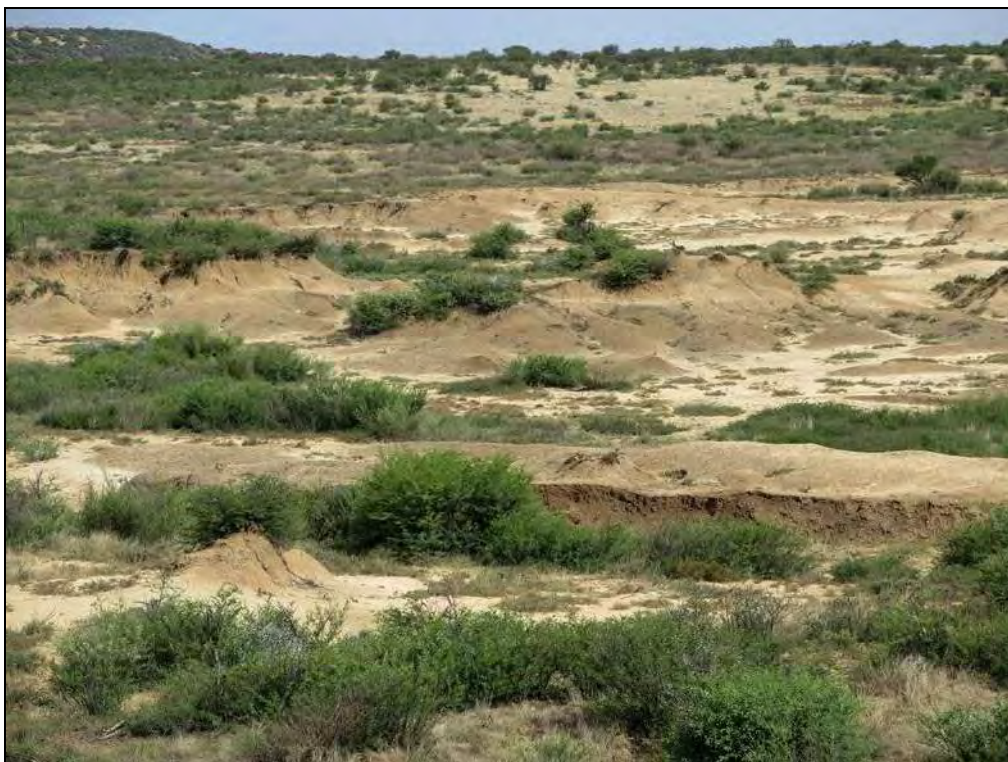
Figure 36. Extensive, gulley-eroded sediments of the Klein-Vetriver just east of the BP19 & 20 study area. Calcretised older alluvium in such areas might contain fossil mammal remains.

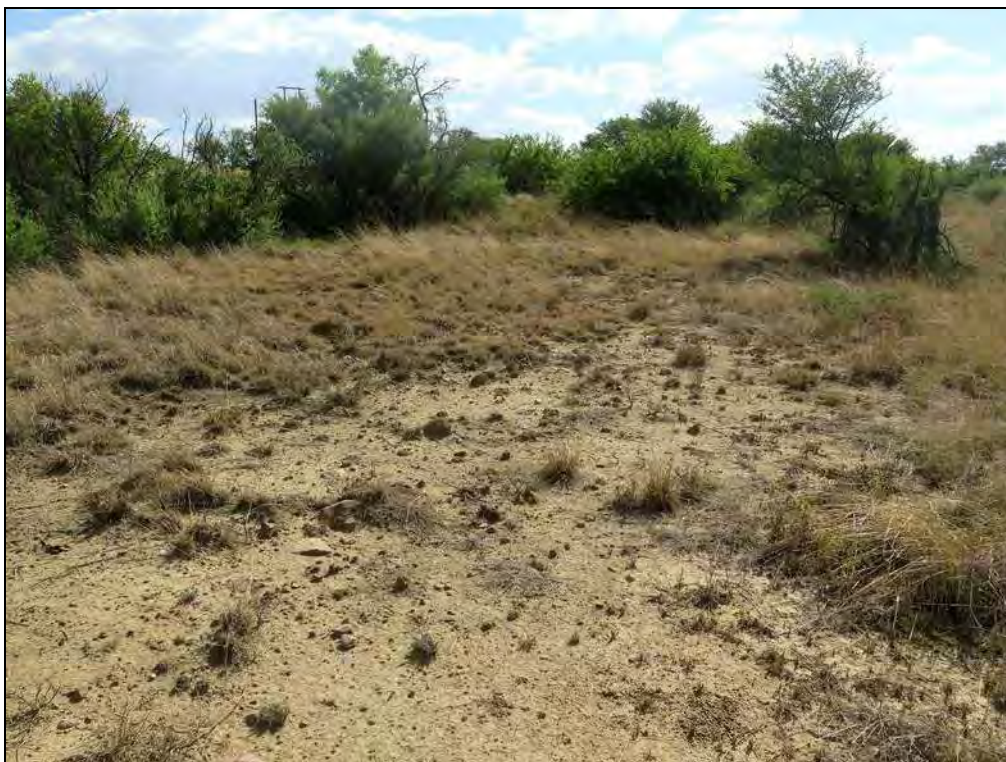
Figure 37. Sparsely gravelly alluvial deposits close to the proposed access road to the BP19 & 20 study areas. The gravels include small reworked blocks of petrified fossil wood (See Fig. 41).
