**APPENDIX C1 -
AQUATIC IMPACT ASSESSMENT**

**N1 Section 16 Zandkraal (km33.8) to Winburg South (km78.0) upgrade in the
Free State Province**

AQUATIC IMPACT ASSESSMENT

16 November 2020

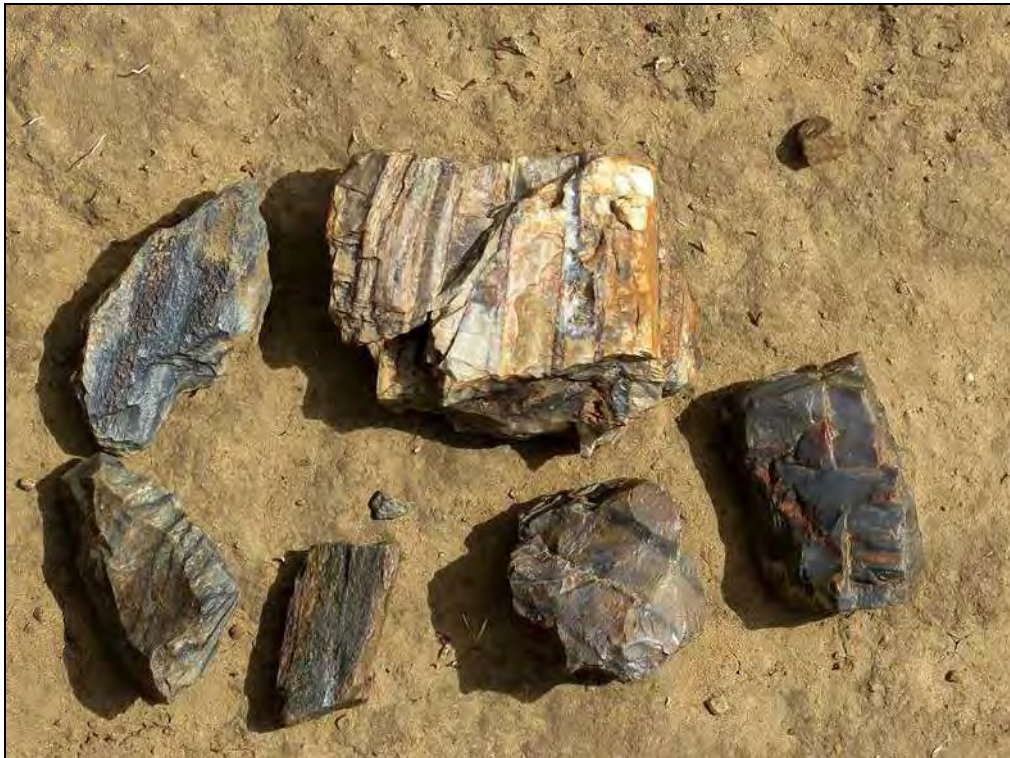
Figure 40. Small angular blocks of petrified wood among surface gravels in the Q2Alt study area. The largest block is 5 cm across.

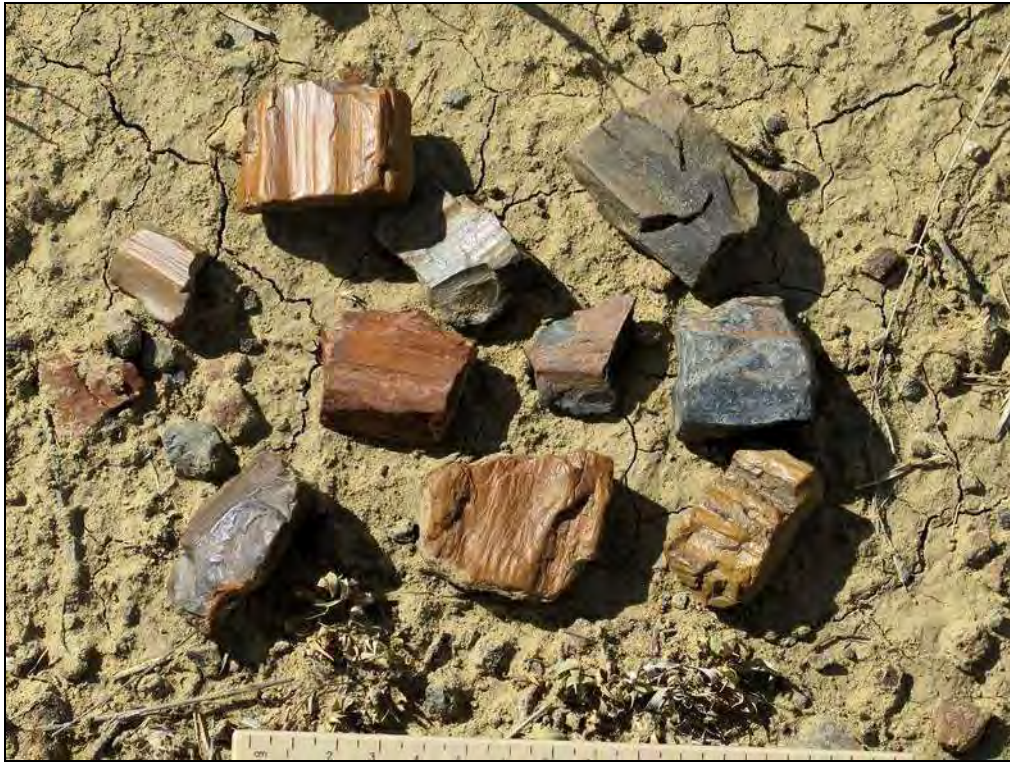
Figure 41. Selection of small blocks of petrified wood weathering out of alluvial sediments close to the access road to the BP19 & 20 study areas (See Fig. 37) (Scale in cm).

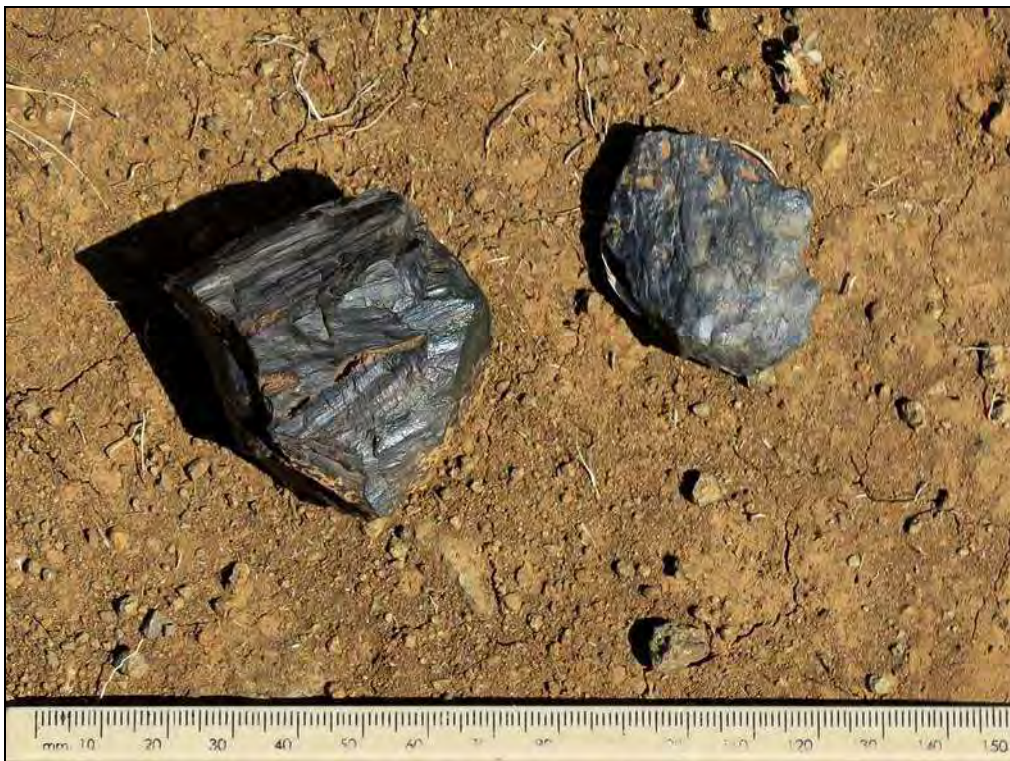
Figure 42. Small blocks of reworked petrified wood among surface gravels in the BP5 study area (Scale in cm and mm).

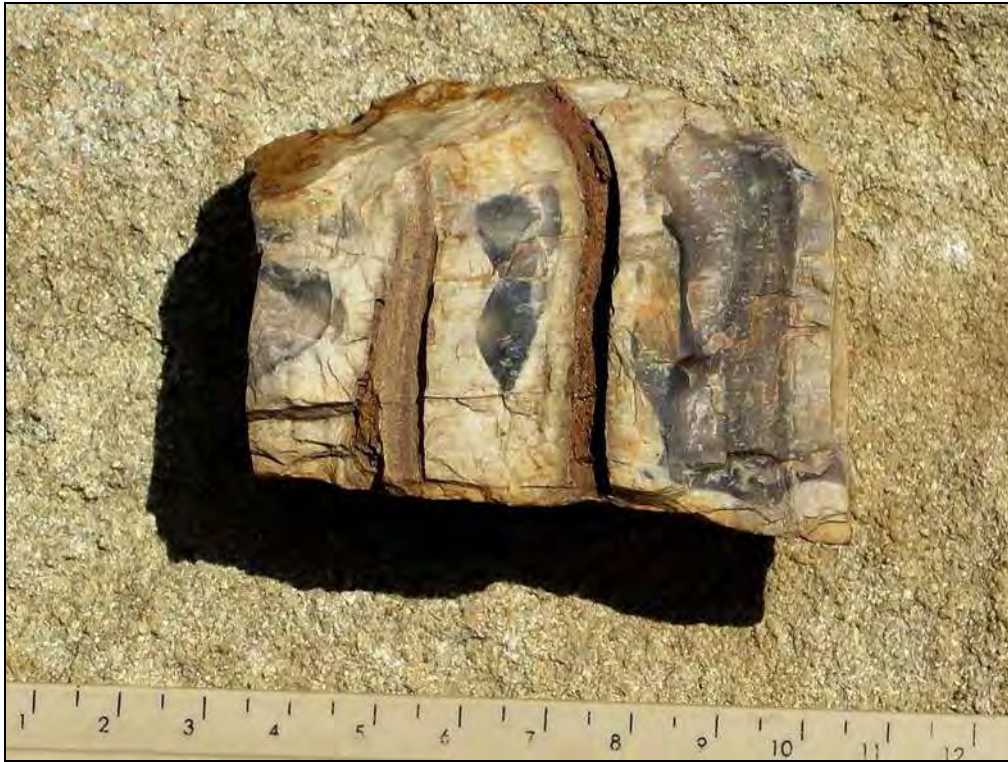
Figure 43. Angular block of petrified wood showing broad growth rings – presumably part of a sizeable tree – from float gravels in the BP8 study area (Scale in cm).

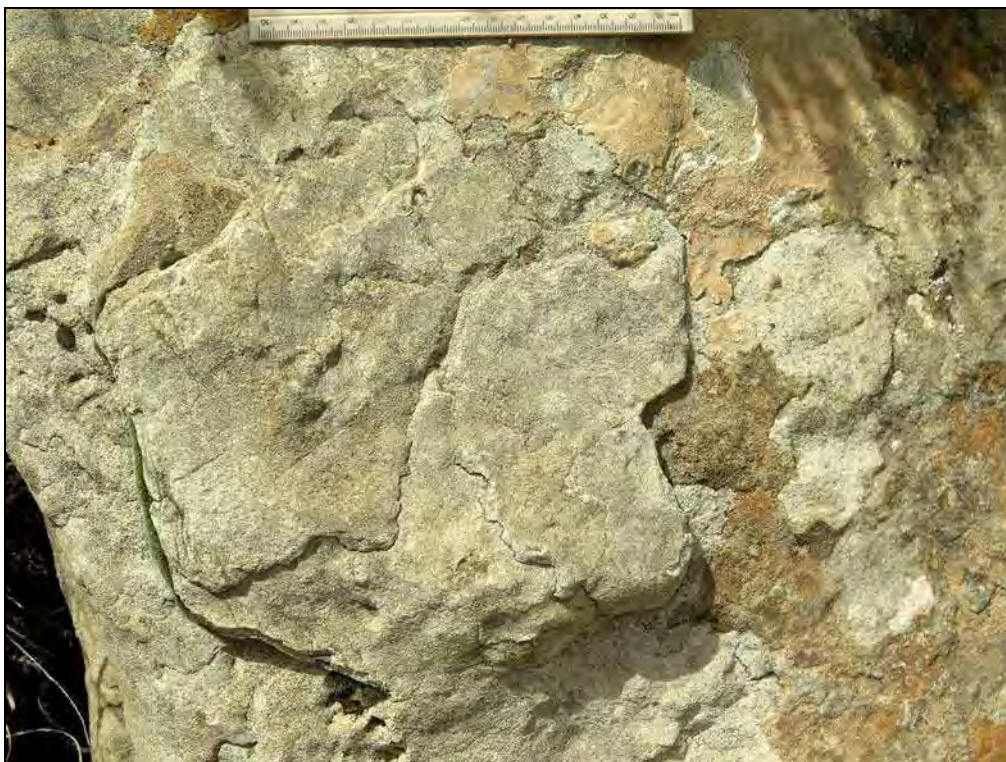
Figure 45. Surface etching of weathered Normandien channel sandstones attributed to epilithic lichens, BP24 study site (Scale in cm and mm). These features are better known from the younger Katberg Formation of the Free State (e.g. Golden Gate National Park).

An interesting geo-biological feature observed on weathered Normandien channel sandstone surfaces are shallow subcircular to irregular etched depressions generated by epilithic lichens (Fig. 45). They have been well-studied on younger Clarens Formation feldspathic sandstones in the Golden Gate National Park (Grab *et al.* 2011) and have since been reported on Katberg and other Beaufort Group sandstone units in the Main Karoo Basin.
