## **RE: AMENDMENT OF ALBANY WIND FARM APPLICATION – AVIFAUNAL**

'WildSkies Ecological Services (Pty) Ltd' (WildSkies) previously assessed the avifaunal impacts of the proposed Albany Wind Farm near Grahamstown in the Eastern Cape (WildSkies, 2018; & updated 2020). The avifaunal impact assessment was conducted under contract to 'Coastal & Environmental Services (Pty) Ltd' (CES). The project proponent, 'EDF Renewables (South Africa)' (EDFR) has decided to amend the application to reduce the number of proposed turbines from 66 to 43. WildSkies has been asked to provide a comparison of the avifaunal impacts of the previous versus new proposed layouts.

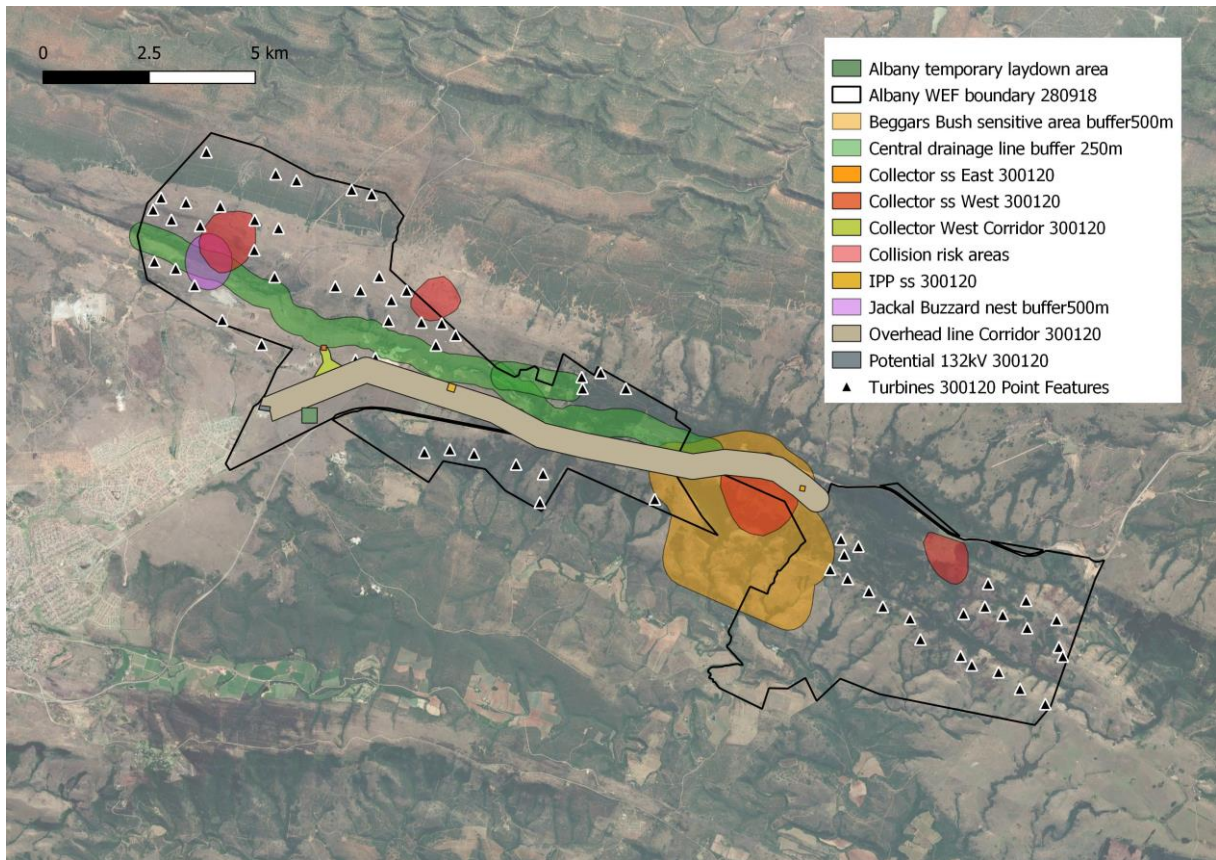
Figure 1. The original proposed layout with avifaunal sensitivity mapping.

Due to the reduction from 66 to 43 turbines a change in the layout of the facility is necessary. Figure 1 shows the original layout and Figure 2 shows the new layout. The new proposed layout avoids all avifaunal sensitive areas identified previously.

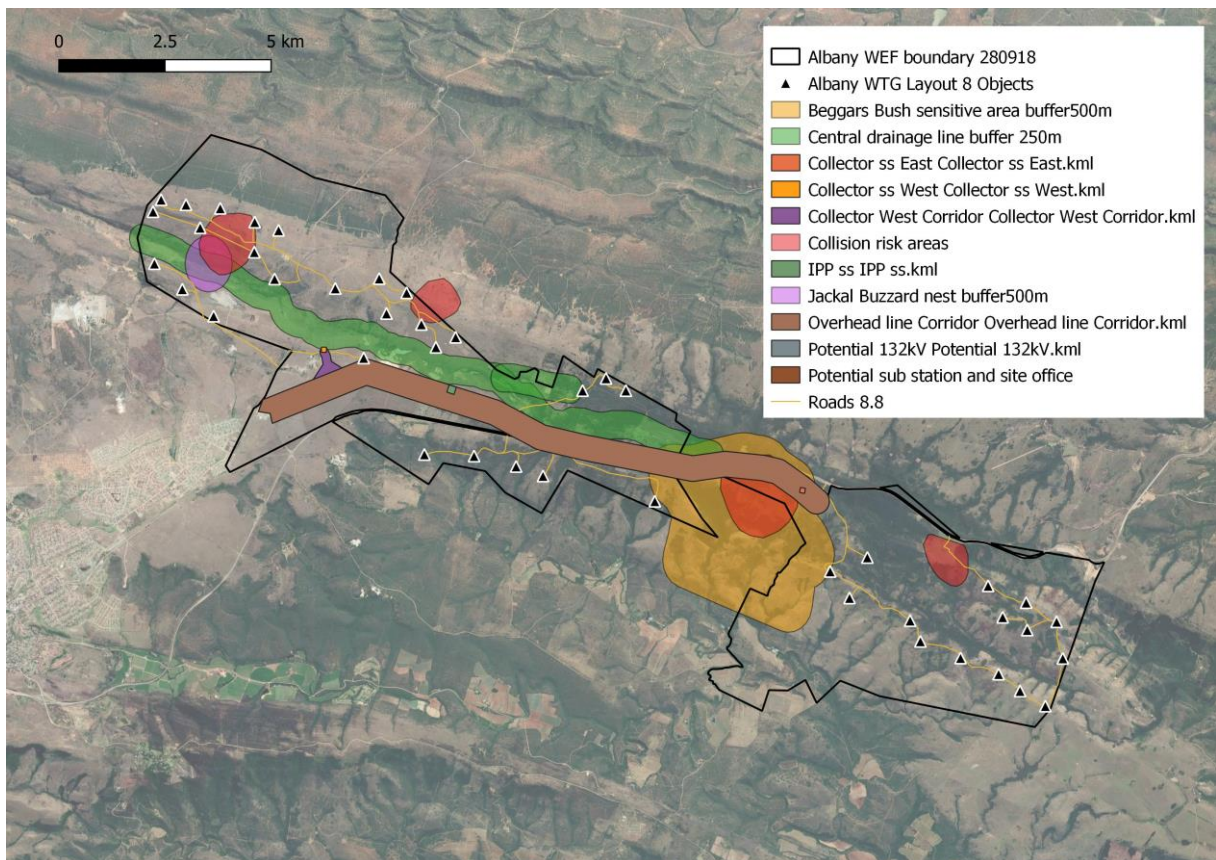
Figure 2. The new proposed layout with avifaunal sensitivity mapping.

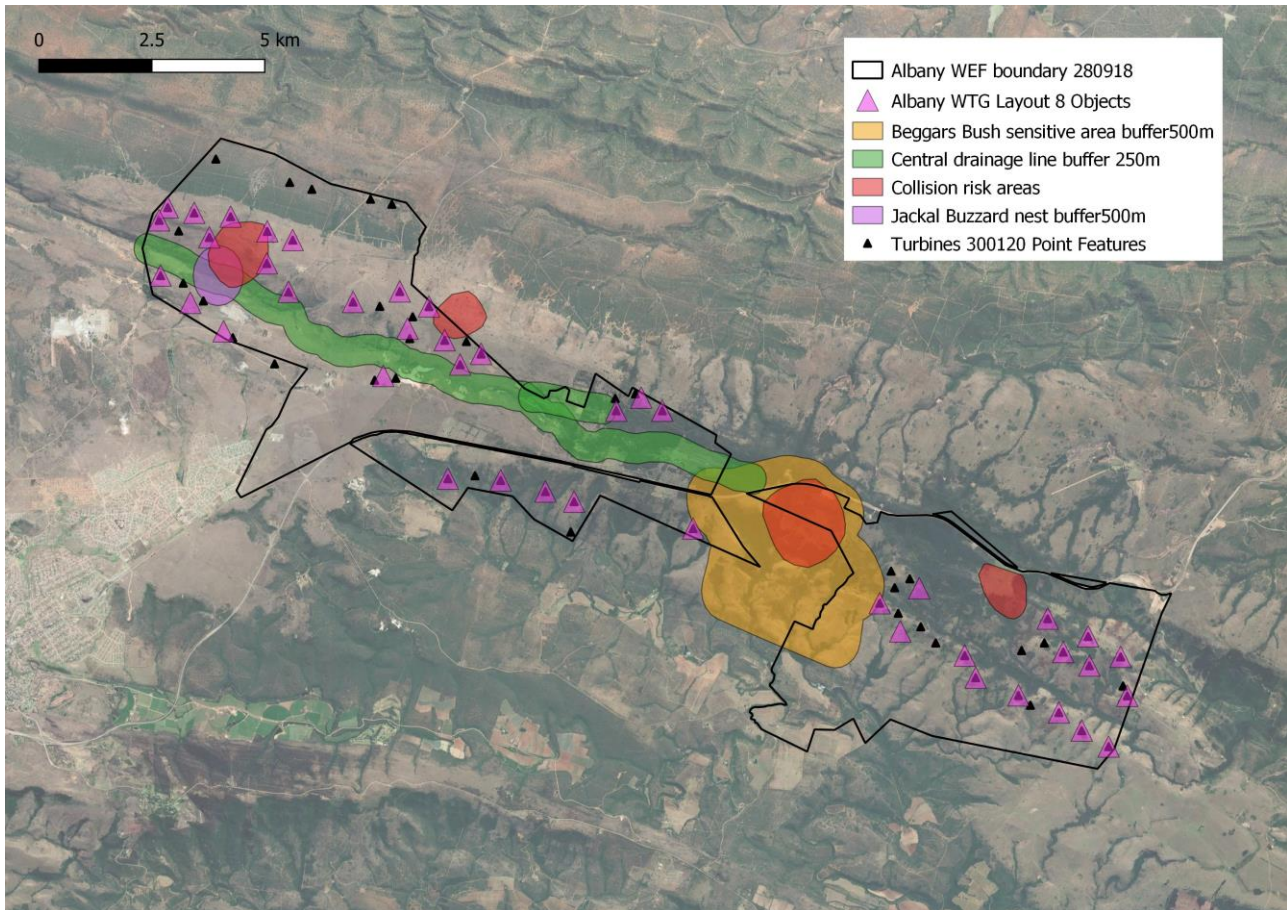
Figure 3. The two turbine layouts together.

Figure 3 shows turbines only (both original & current proposed) in order to more clearly demonstrate the difference between the original 66 turbine layout and the new 43 turbine layout. Pink icons show the new proposed positions and black icons show the original positions. It is clear that a number of turbines in the far north-west have been dropped, as well as in the centre of the site. A number of turbines have also moved slightly. A summary of the changes is presented in Appendix 1.
